# Large scale driving of concrete piles in stiff to very stiff clay

## ABSTRACT

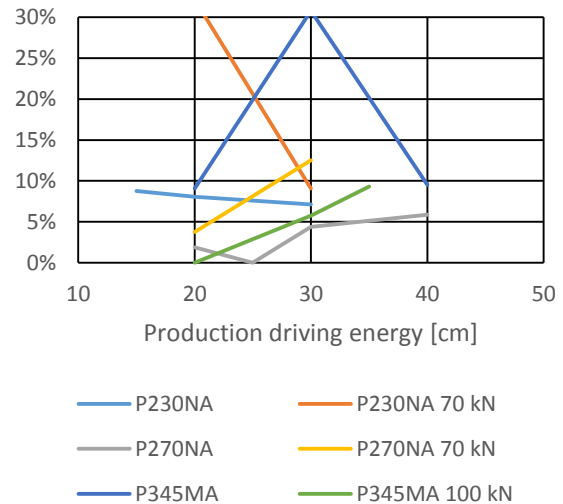
Figure 9 illustrates the percentage of broken piles by driving energy. Combinations with fewer than 10 piles (ref. Table 2) are left out of the diagram. The hammer-pile-combinations P230NA-70 kN and P345MA-90 kN obviously stand out as generally unfavourable. For other combinations,

reducing the energy during driving clearly reduces the number of broken piles. Reducing the energy increases the number of blows required to get the pile down to bearing layers, increasing the sum of dynamic loading on the pile during installation. From reduced energy also follows reduced stresses in the pile during driving, and the reduced stresses means less chance of the pile breaking over time.

Figure 9: Percentage of broken piles by cross section, hammer size and driving energy

The effect was especially significant when reducing energy from 30 to 20 cm for P270NA piles driven with 70 kN hammer. This combination was used for about 1/3 of the total number of piles in the project (Table 1).

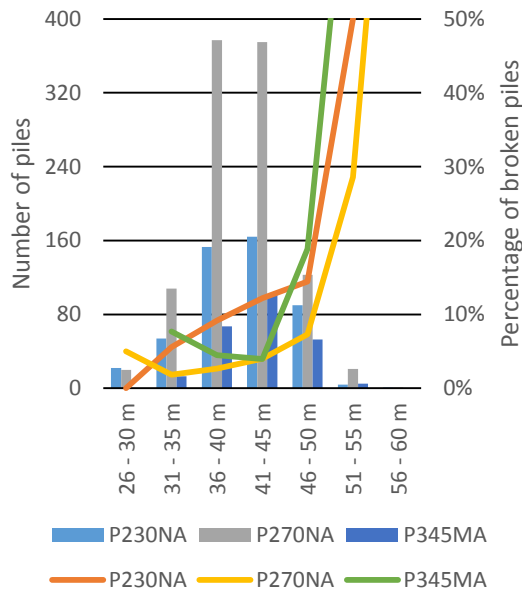
The columns in Figure 10 show an overview of the total number of piles for each cross section and total pile length interval. The graph lines illustrate the percentage of broken piles for the corresponding cross section and total pile length interval.

According to figure 9, the number of broken piles increases significantly when the total pile length increases over about 46-50 m. Almost all P230NA and P345MA piles and about 30 % of P270NA piles longer than 50 m were broken. About 15 to 20 % of P230NA and P345MA piles and 7 % of P270NA piles between 46 to 50 m long were broken.

Figure 10: Number of piles and broken piles by pile length

An increasing pile length increases the risk of some kind of unfavourable curvature of the pile, increasing the risk of breakage. The increased length also comes with an increase in total number of blows and cycles of dynamic stresses.

Broken concrete piles, or piles which were suspected to be broken, were replaced by drilled steel core piles. Due to earthquake design, some piles for the warehouse structure needed tension capacity, and the steel core piles were therefore always a part of the plan. The logistics and equipment was available at the site, and pile replacement could be designed immediately as the contractor reported broken piles.

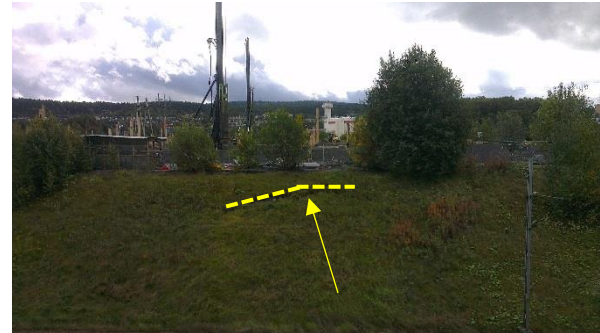
In September 2012, after a heavy rainfall, surface cracks were observed in the slope towards the railway line. The appearance of the crack coincided with pile driving near the top of the slope. Figure 11 shows a picture taken from the other side of the railway cut, with the pile driving cranes working in the background.

Figure 11: Surface crack in slope (marked with yellow dashed line)

Even shallow surface slides could cause concerns regarding operation of the railway line, and driving of concrete piles near the slope was stopped immediately. The slope was instrumented with electronic piezometers and inclinometer casing. The piezometers measured a very high pore pressure, with a magnitude in the order of the same as the vertical overburden (meaning that the effective stresses were very small). Inclinometer measurements were done with short time intervals for the first period of time after installation, but indicated no significant movement in the slope.

For the slope to have a sufficient factor of safety in a permanent situation, the top couple of meters of the slope was planned to be removed and replaced by lightweight fill material. This operation was expedited to increase the safety during the construction phase. Drilled steel core piles replaced the concrete piles within a safety zone from the slope, in order to prevent further build-up of horizontal stresses and pore pressures. The drilled steel core piles were installed as gently as possible (low air pressure and drill speed)

to reduce the risk of further set up of excess pore pressure.
