# The Refne landslide, Halden, Norway: case history and use of risk assessment

T. F. Smaavik  
NGI, Norway, [tone.fallan.smaavik@ngi.no](mailto:tone.fallan.smaavik@ngi.no)

*In 2014, a landslide in a steep slope beneath an apartment block in Refne in the city of Halden, Norway led to the evacuation of over 60 residents from their homes.*

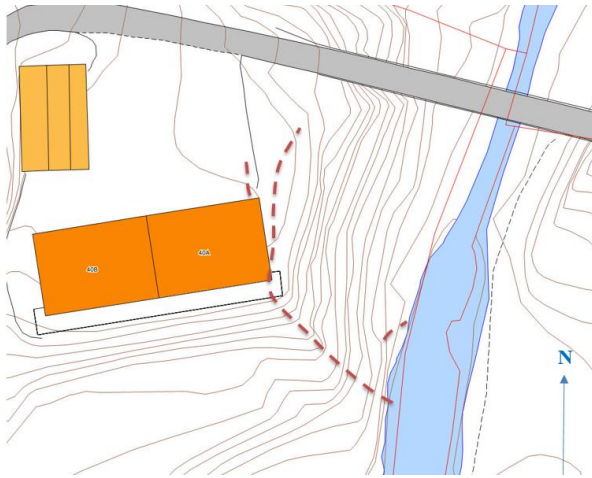
NGI was first contacted by local residents regarding cracks and displacements on top of a 16 m high, steep slope beneath the apartment block. An inspection was carried out by NGI and it was discovered that a large slope instability had developed. The slope had deformed visibly and a continuous crack had developed covering the full width of the slope beneath the apartment block. Along the crack, the slope had a vertical deformation of approx. 0,5-1 m. The southern part of the crack followed a ridge leading down to the Refne stream (Figure 2).

Figure 1 Location of the apartment block and approximate location of cracks in slope. The slope was 16 m high.

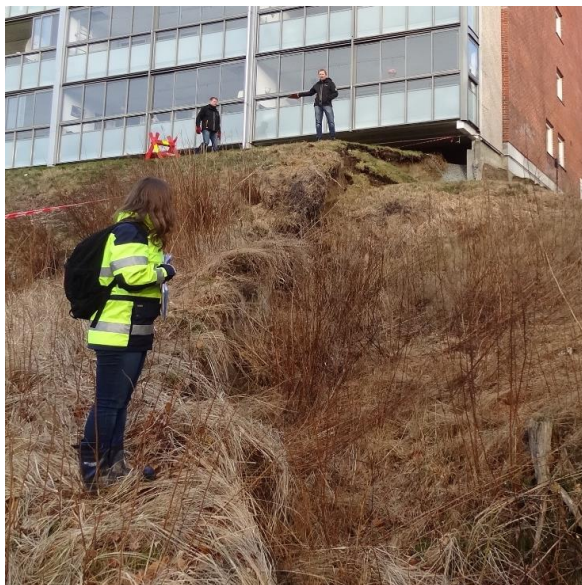
Figure 2 The backscarp of the slide. Vertical deformation 0,5-1 m.

Deformations along the side of the block were approx. 1,5-2 m. The backscarp of the slide coincided with the corner pile of the block partially exposed the corner pile foundation (Figure 3). The pile guided the crack in the way that the direction of the backscarp was forced outside the pile.

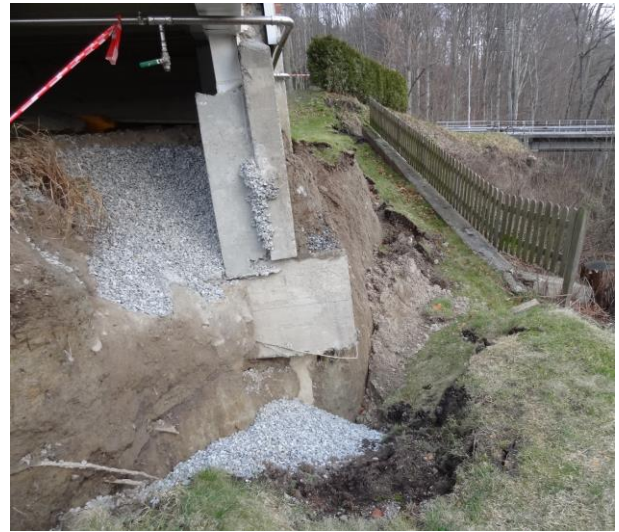
The deformations of the slope had uncovered the corner pile foundation, situated at the brink of the slope (Figures 1, 2 and 3).

Figure 3 Backscarp of the landslide restricted by the pile foundation. Concrete pile supporting the corner foundation visible.

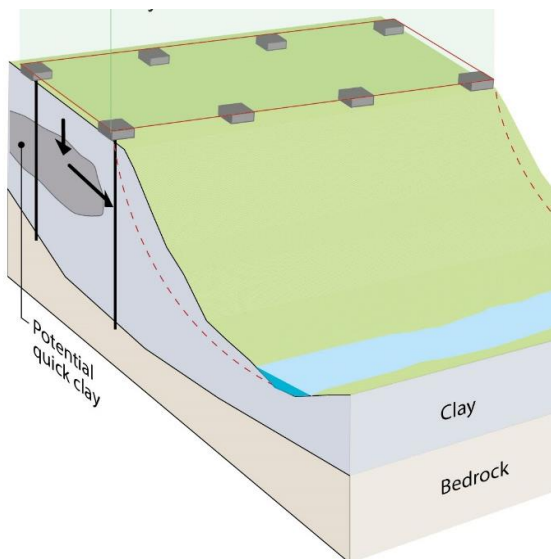
If potential quick clay under the block was to slide, all piles would likely follow the slide, break or buckle (Figure 4). Soundings performed in the first phase of the SI did not indicate quick clay underneath the building, but the scenario could not be eliminated before samples were taken and analysed. However, it was deemed unlikely that quick clay could be exposed as a result of further development of the landslide, thereby triggering a major quick clay landslide involving the building, i.e. the lowest probability class P1 was assigned.

Figure 4 Scenario A - quick clay slide

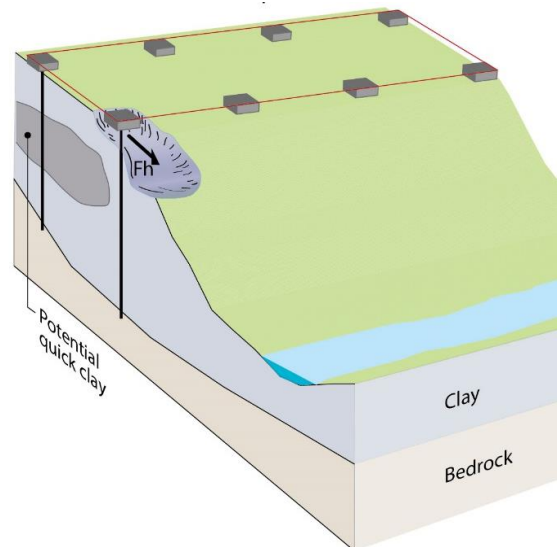
One of the concrete piles under the block was partly exposed by the landslide (Figure 3). A further development of the landslide would increasingly expose the pile, leaving it vulnerable to excessive lateral loading or horizontal displacement (Figure 5). The probability of damage to the corner pile was evaluated to be in the highest probability

class P4, i.e. damage to the pile was expected to occur within 1 year. Further movement of the landslide would certainly be expected in connection with heavy rainfall events.

Figure 5 Scenario B - Damage to corner pile

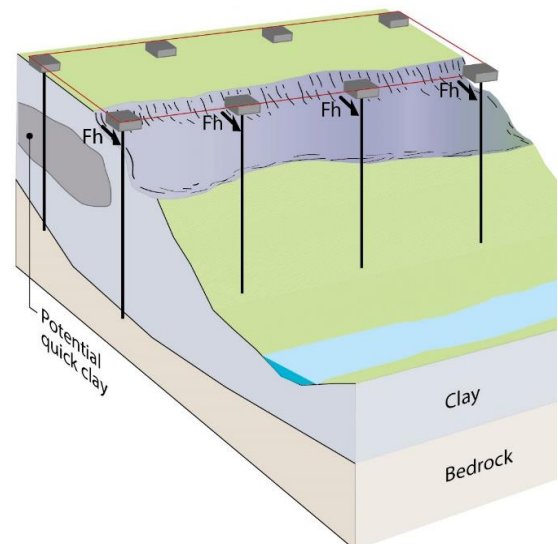
Should the landslide develop along the length of the slope, more of the piles in the pile row closest to the slope could be exposed or affected (Figure 6).

Figure 6 Scenario C - Damage to several piles in 1st row

Due to the orientation of the building not quite parallel to the slope (Figure 1), the distance from the closest piles to the slope edge increases slightly towards the north. This makes a scenario damaging several piles

slightly less probable than damage to the corner pile. For this scenario, the second highest probability class P3 was therefore assigned.

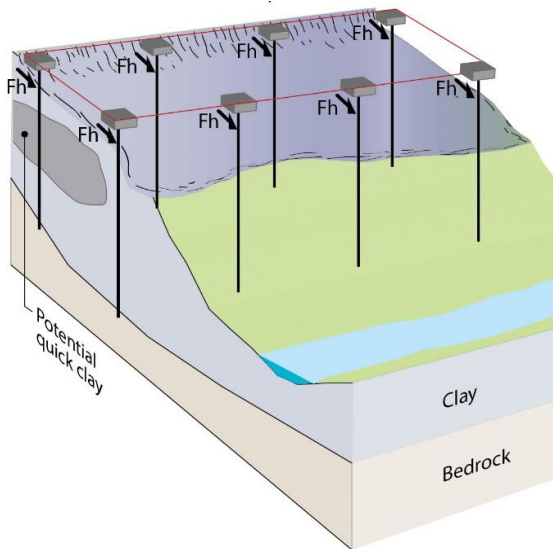
The distance between the rows of piles was approx. 6 m. Based on the SI it was considered less likely that the landslide would develop backwards to that extent and cause direct damage on the piles in the second row (Figure 7), i.e. the second lowest probability class P2 was assigned.

Figure 7 Scenario D - Damage to several piles in 2nd row

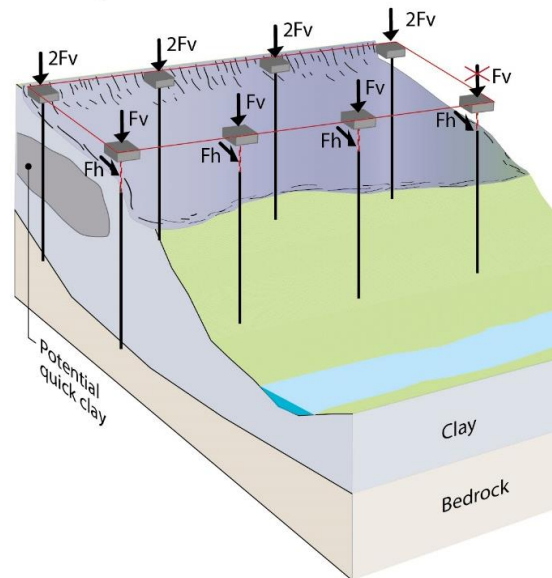
A "domino effect" may occur from redistribution of horizontal and vertical loads. It is a relevant scenario if failure of one or several piles leads to deformations that cause additional load on, and potential failure of, the next row of piles (Figure 8). The second highest probability class P3 was assigned for this scenario.

Figure 8 Scenario E - Domino effect - failure of all piles
