Lessons learned from the 2015 Soerkjosen shoreline landslide in Norway

Steinar Nordal, *Norwegian University of Science and Technology*, steinar.nordal@ntnu.no

Jean-Sébastien L'Heureux (*NGI*), Arne Å. Skotheim (*Norconsult*), Arnfinn Emdal (*NTNU*), Einar Lyche (*NVE*), Stein Christensen (*SINTEF*), Øyvind S. Hellum (*Norwegian Public Roads Administration*)

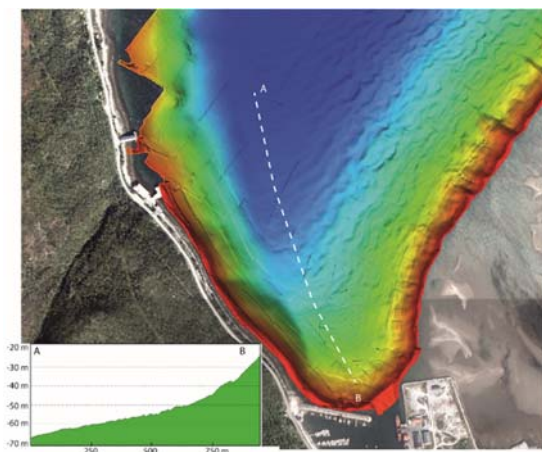
Figure 2. Bathymetry image prior to the landslide showing a smooth seafloor with no traces of previous slides. The wave pattern is related to sedimentation of sand (i.e. sand waves) and is normal in delta areas. Data courtesy of the Geological Survey of Norway (NGU).

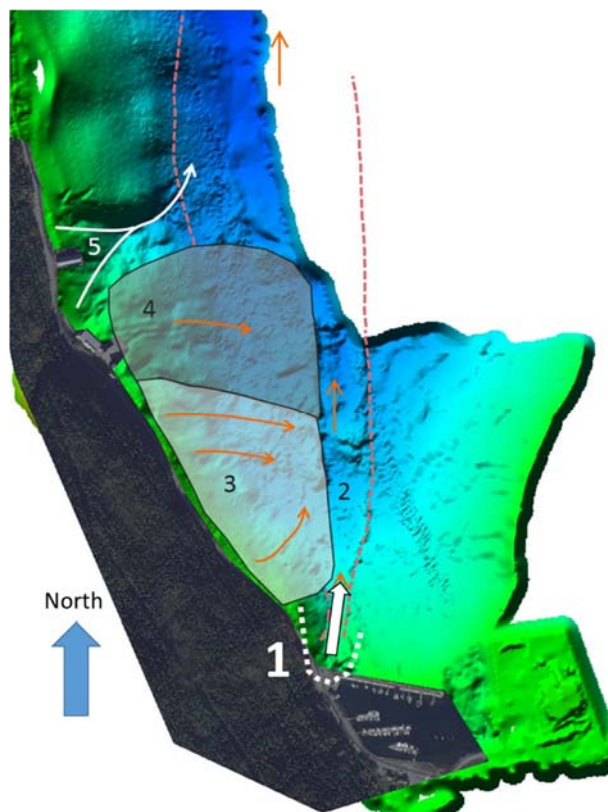
A morphological analysis of the seafloor showed that the landslide started in south (lower end) at the harbour, where the fill placed in November 2014 slid into the fjord. This initial slide moved about 200.000 m³ of soil dominated by loose to medium dense silts and sands. The slide rapidly transformed into a debris flow as it accelerated northwards on the seabed due to the large elevation differences (more than 50 meter). The erosive force of the debris flow is thought to have removed the toe of the slopes along the western shoreline which then became unstable and subsequently failed. While the initial slide was

deep, the secondary slides (3 – 5 in Fig. 3) were rather shallow. Bathymetry data shows that the soil mass from slide 3 to 5 is flowing over the mass from the initial slide, marked 1 on Fig. 3.

Figure 3. High resolution bathymetry with aerial photo after the slide. The interpreted sequence of event based on morphological analysis of the seafloor is shown with arrows and indicated by the numbering.

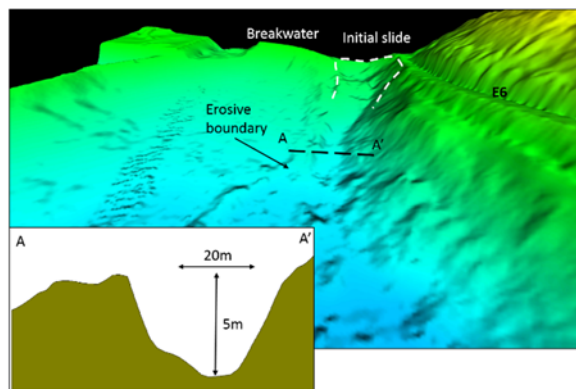
Figure 4. The initial slide left a scar and an erosion channel along the foot of the mountainside slopes when the mass accelerated downslope and changed into a disintegrated debris flow.

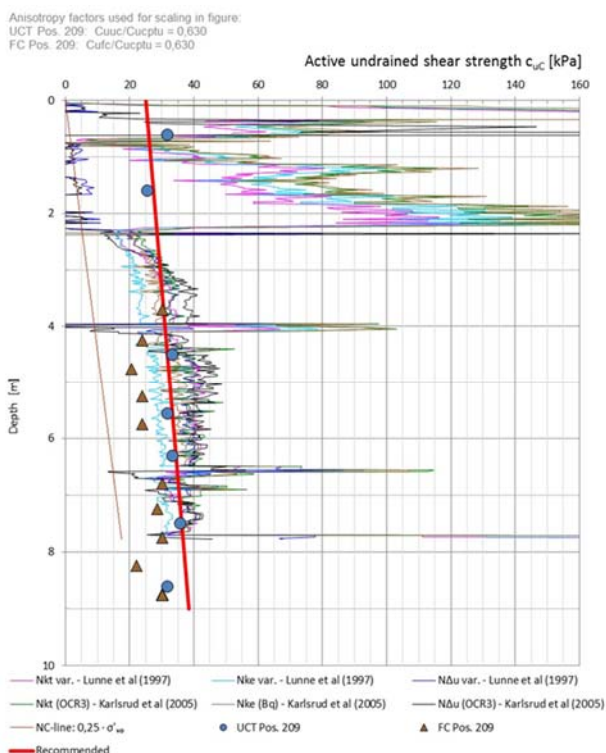
the area that was missed in the original investigations. The soft clay layer is rather shallow behind the backscarp of the initial slide, but is found deeper towards the north under thick layers of silt and sand (up to 20 m). This may explain why the clay layer was missed in the original investigation. The original investigations did not go sufficiently deep in this area to encounter the clay layer. Figure 5 presents undrained shear strength interpretations in the clay based on CPTU results and laboratory investigations. The sounding on Fig. 5 was carried out in the fjord inside the evacuated landslide scar near the pier at a water depth of 7 m. Before the landslide, this location was covered by 14 m of sand and rock fill up to an elevation of +4 m.a.s.l. In the sounding on Fig. 5 the top of the clay has an undrained shear strength varying between 25 to 30 kPa and is covered by sand and debris from the landslide.

Figure 5. Undrained active shear strength results from soil investigations performed after the slide within the evacuated scar. The failure surface corresponds to the top of the clay layer now covered by sand and landslide debris.

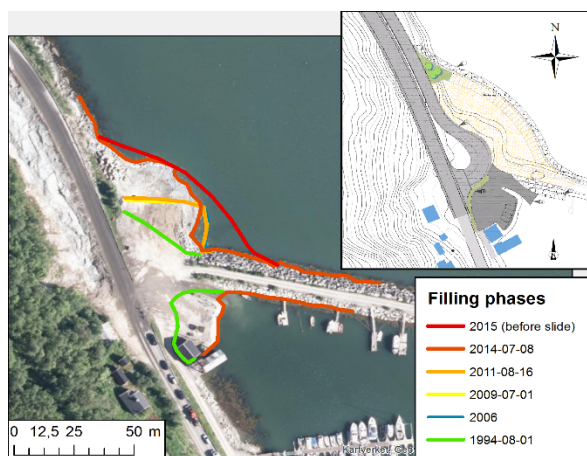
Figure 6. Map showing the widening of the breakwater and road crossing since 1994. The 2015 landslide started in this area. The area sunk and moved north into the sea. The extent of the fill has been defined from available aerial photography and satellite imagery.

The breakwater at Soerkjosen was first constructed in 1977. Satellite imagery and aerial photography also show that there has been filling in several phases between 2006-2014 (Figs. 6-7).

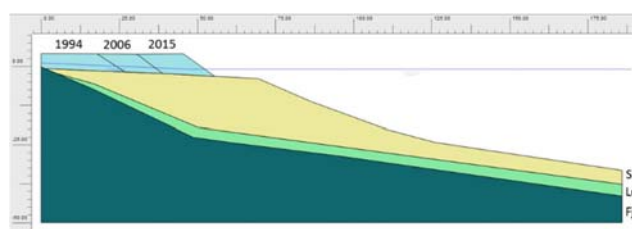
New slope stability calculations were performed by the investigation group on several cross sections along the 1000 meter long slide-affected shoreline. The stability calculations confirmed most of the work done during the original design of the road work, with one exception. The newly discovered clay layer under the breakwater was shown to be critical for the stability of the slope. Calculations were performed using the limit equilibrium package GeoSuite and the finite element code PLAXIS. The two programs gave almost identical results with a safety factor slightly above 1.0 after the last phase of filling in November 2014. Adding the effect of the rain in May 2015 a safety factor of 1.0 was computed.

Figure 7. A cross section in NE-SW direction through the harbor pier showing soil layering and the extension of the fill since 1994. The 1994 condition was probably unchanged since 1977, when the pier was first built. The 2015 case includes water saturation and high pore pressures.

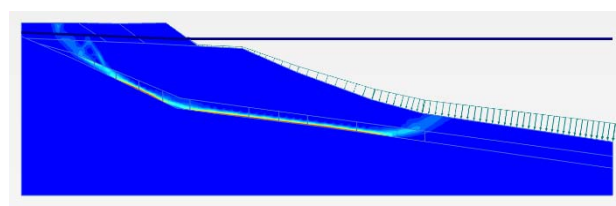
Figure 8. Adding the fill of 2014 and introducing the water and pore-water conditions of May 2015 gave this failure mechanism and a safety factor of 1.0 from PLAXIS. The failure mechanism compares well with the morphology of the landslide and changes in water depth observed from high resolution bathymetry data.

In order to simulate the conditions at the time of the slide in May 2015, the external water level was lowered by 1 meter to fit with the tidal level just before the slide. The unit weight of the fill above the sea level was increased to 19,5 kN/m³ to simulate full saturation while the pore pressure in the silt and sand was kept at 1 meter excess pressure at depth. The pore pressure changes at depth had almost no effect since here the undrained strength of the clay controlled the problem.

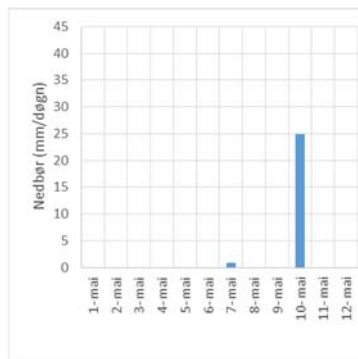
It was raining heavily in the afternoon on the 9th of May at Soerkjosen and a significant snowmelt took place during that period of time adding to the amount of water that came down

the steep mountainsides and filled all ditches and culverts with water. Eye witnesses have described the amount of water as extraordinary.

Figure 9. Precipitation in mm in the last 24 hours before 7 am on the 10th of May. Significant snowmelt must be added to understand the effect of this rain.

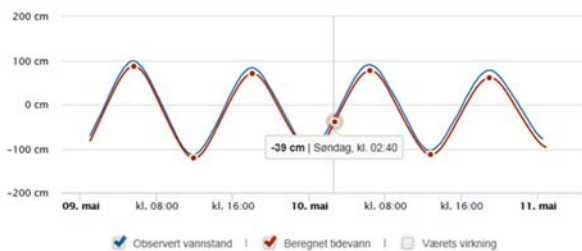
Previous studies have shown that near-shore landslides frequently occur during periods of low tide through a mechanism similar to that of the rapid draw-down condition in earth dams. (i.e., the pore pressure in the sub-aerial part of the deposits does not have time to reach steady state conditions for the groundwater flow; Kramer 1988). The support along the slope is minimum at low tides. In the case of Soerkjosen, a combination of low tide, high pore pressures and full saturation of the embankment material is an unfavourable condition. In extreme cases as here, where the embankment had an minimal safety margin after extending it in November 2014 the unfavourable combination is believed to have triggered the landslide. The consequences were large due to existence of sensitive clay and flow susceptible materials.

Figure 10. The graph shows the variation in sea level due to tidal variations. The tide was just 39 cm below the mean water level when the slide was observed. Around midnight the sea level was about 1 meter below mean water level.
