# THE SVALBARD FATAL ACCIDENT 19<sup>TH</sup> DECEMBER 2015 – ASSISTING LOCAL AUTHORITIES IN THE ACUTE PHASE

Kjetil Brattlien\*, Erik Hestnes and Ulrik Domaas

Norwegian Geotechnical Institute (NGI), Oslo, Norway

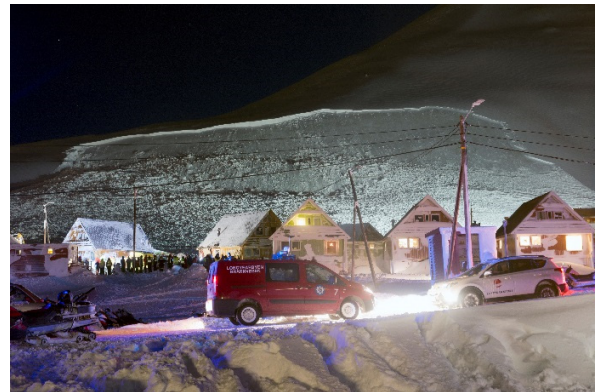
Saturday 19<sup>th</sup> December at 10:25 a.m. an avalanche hit part of the village Longyearbyen at Svalbard (Fig. 1). The avalanche killed two persons, destroyed 11 houses and numerous cars and snowmobiles (Fig. 2).

Figure 2: The avalanche shortly after the accident. Photo: Svalbardposten.no.

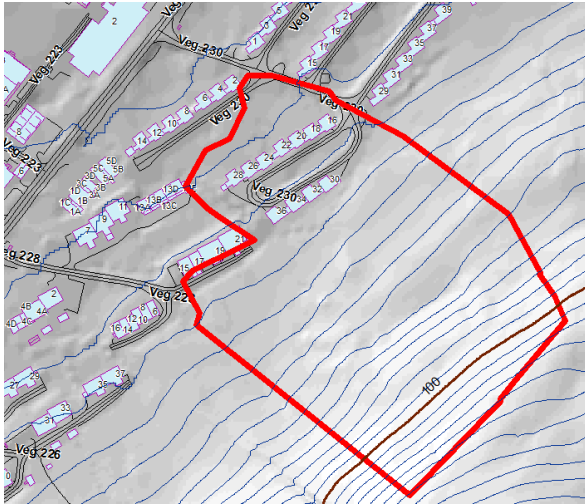
The about 200 m wide avalanche started at the top of the steep terrain about 90 vertical meters above the houses. It is estimated that the initial release volume was some 20.000 m<sup>3</sup> supposing the

starting zone being 200 x 50 m with average 2 m release thickness. The steepness in the release area was typical 30-40 degrees. NGI measured the runout angle to 15.6 degrees when arriving at the site.

The avalanche was later measured to have started about 125 m a.s.l. and stopped about 35 m a.s.l. (Fig. 3).

Figure 3: Red line indicating avalanche runout destroying the upper two rows of houses in road 230.

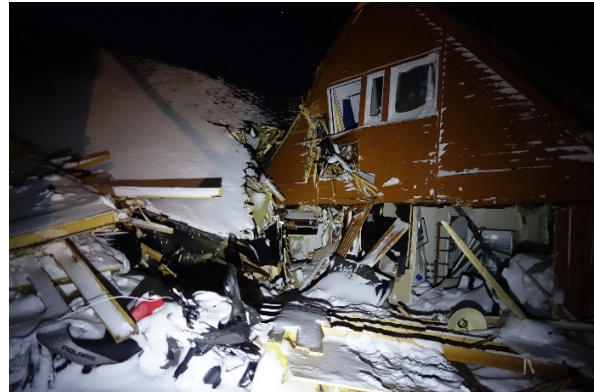
The relatively small terrain above the houses produced a massive slide that caused extensive damage. The power of the avalanche gave an absurd impression of a "chain collision" of houses that were moved up to 80 m (Fig. 4 and 5). The runout was longer than expected on NGIs 1992 hazard map.

Figure 4: Example of massive damage. Photo: Kjetil Brattlien, NGI.

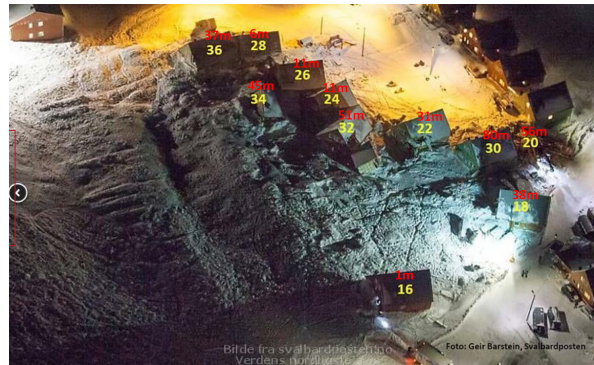
Figure 5: House number (yellow) and preliminary measurements of distance moved (red). Photo: Svalbardposten.

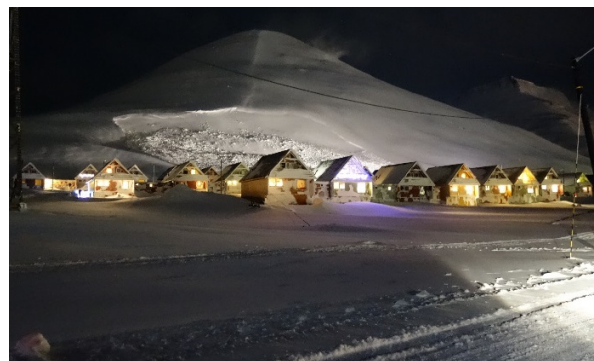
After midnight, some 14 hours after the accident, the weather changed again and it started snowing and blowing with new wind transport into the release areas. NGI and the local police (Sysselmannen) discussed the situation and decided to

Figure 6: New wind-loading of release area about 350 m. a.s.l. at Sukkertoppen. Photo: Kjetil Brattlien, NGI.

expand the evacuation zone. Another 59 persons were evacuated when the police went from house to house that night.

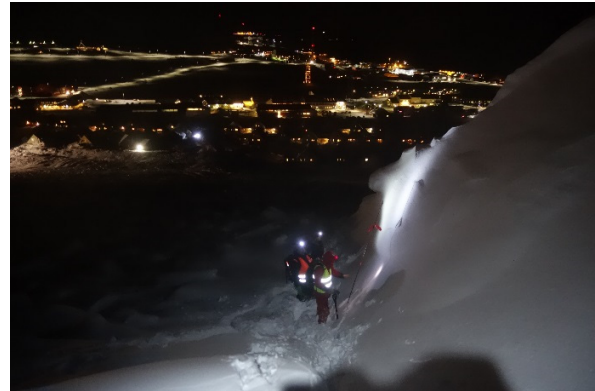
Figure 8: Erik Hestnes, NGI, investigating crown flank. Photo: Kjetil Brattlien, NGI.

The weather improved in the morning the day after the accident. NGI hiked up the avalanche debris about 24 hours after the accident. The avalanche was investigated and profiles were made in the release area (Fig. 8).

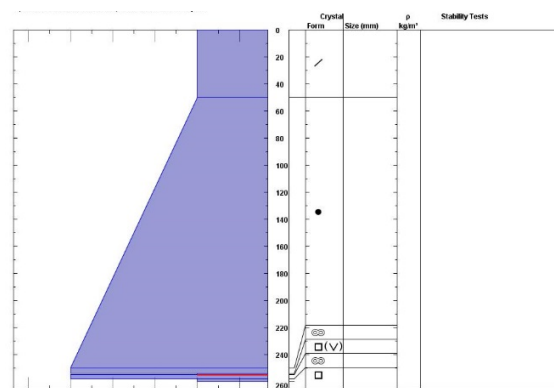
The avalanche released on a persistent weak layer of faceted crystals with 4 finger hardness (4F) near the ground. The crown was partly filled in with fresh snow, but the crown face indicated that the slab was about 2 m of rounded grains (RG) with 4 finger hardness (4F) in the top gradually increasing to knife hardness (K) above the weak layer (Fig. 9).

Figure 9: Snow profile at crown face.

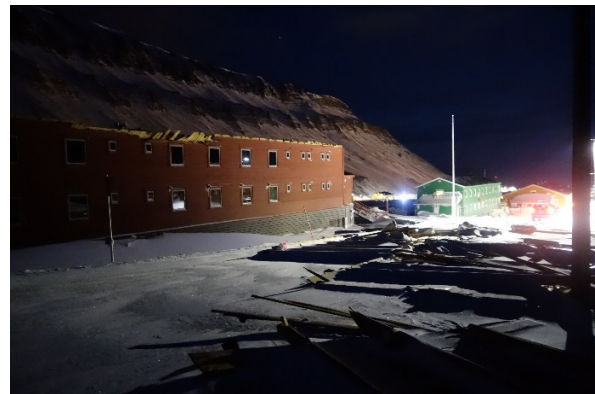
The fieldwork showed that many avalanches had released during the storm and the risk for new avalanches at these places where minimal. In Nybyen a big roof had blown off one of the houses, showing the extreme wind during the storm (Fig. 10)

Figure 10: Roof blown of house in Nybyen. Photo: Kjetil Brattlien, NGI.

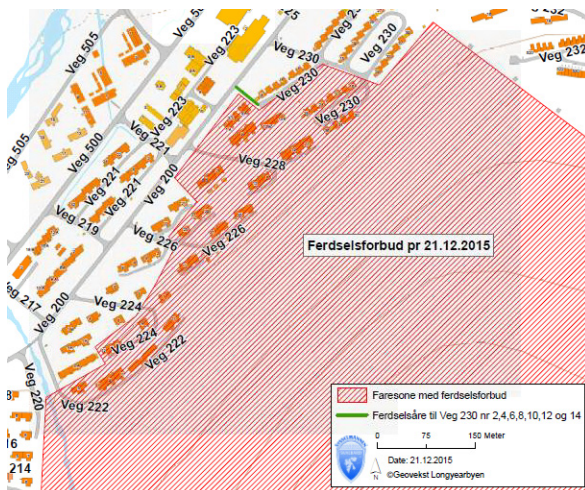
The weather situation improved gradually and NGI recommended repealing most of the evacuation 21<sup>st</sup> December (2 days after the accident). However, evacuation was still enforced for many houses under the Sukkertoppen Mountain closest to the accident site due to uncertain stability of the

snow in the 300 vertical meters with steep terrain above the houses (Fig. 11). The weather forecast predicted a new storm coming in and NGI recommended that the avalanche situation should be watched carefully.

Figure 11: Remaining evacuated areas after 21<sup>st</sup> December 2015.

NGI recommended to completely repeal evacuation of all areas 4<sup>th</sup> January 2016 given that avalanche forecasting continued until end of winter.
