Deliverable D1.4

Rockfall and landslide warning system on the Rauma Line

Project acronym:	GoSAFE RAIL
Starting date:	01/10/2016
Duration (in months):	36
Call (part) identifier:	H2020-S2R-OC-CCA-04-2015
Grant agreement no:	730817
Due date of deliverable:	April 2018
Actual submission date:	14-05-2018
Responsible/Author:	Yme Asgeir Kvistedal - YK
Dissemination level:	PU
Status:	Issued

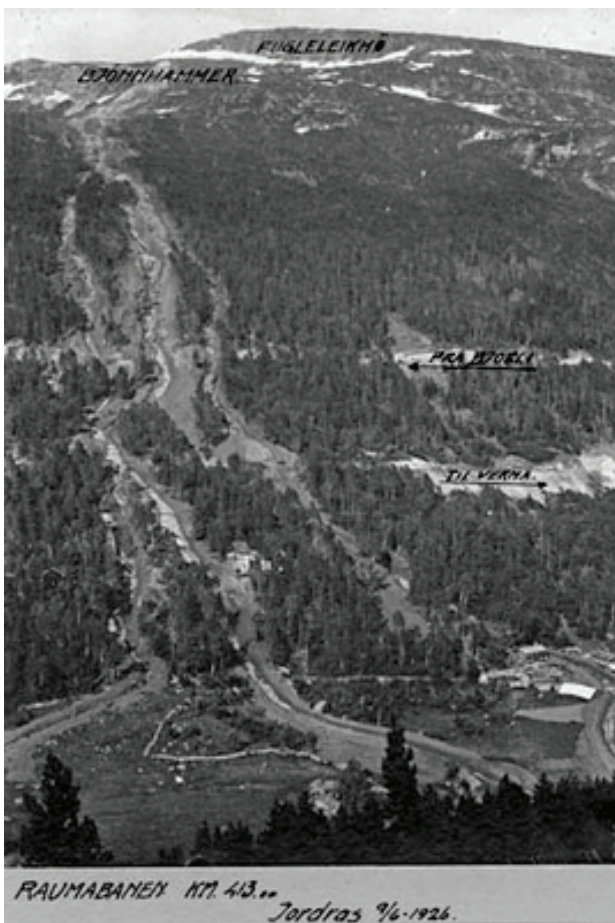
Figure 1: On the 9th of June 1926 a major landslide hit the Rauma line by Verma station. The landslide crossed the line twice, on both sides of the horseshoe turn in "Vendetunellen"

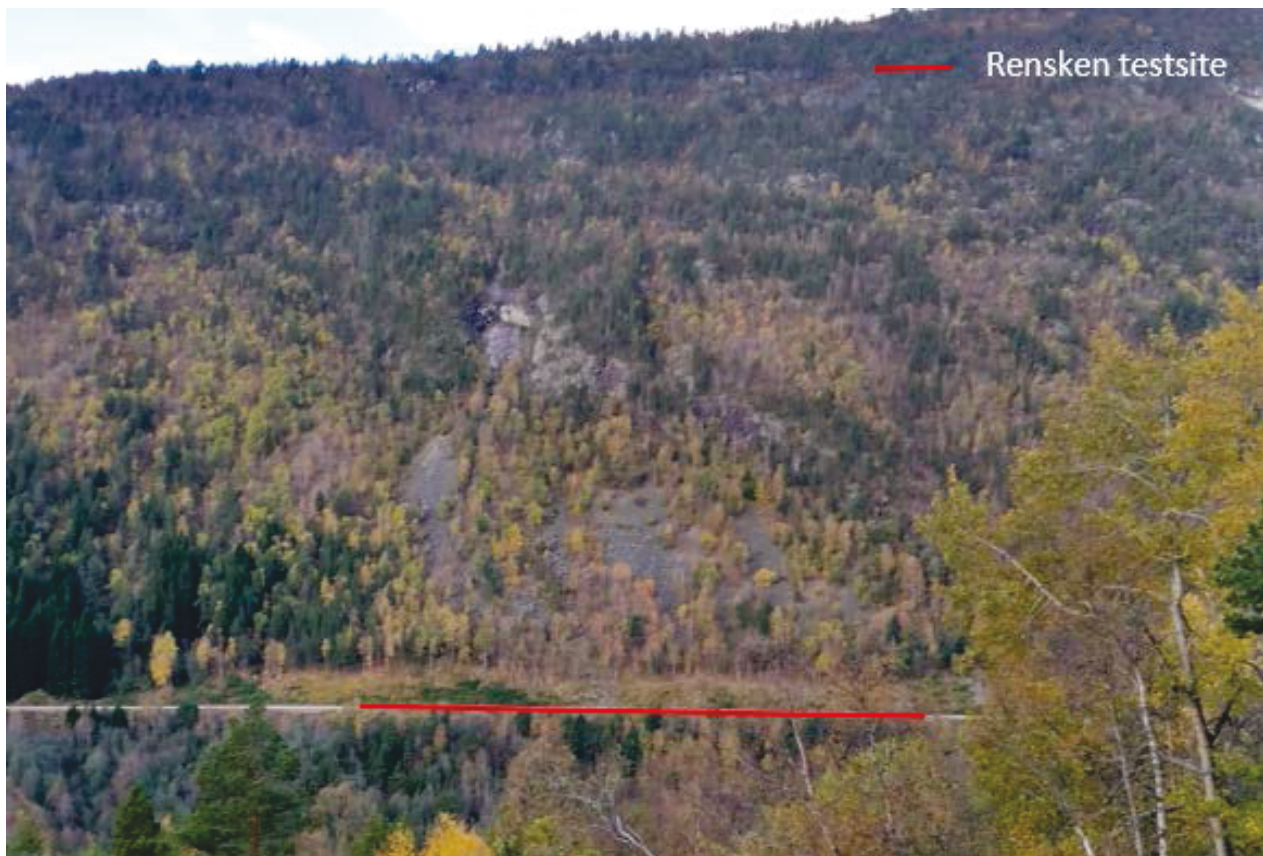
Figure 2: The GoSafeRail test site for rockfall and landslide detection cover a 330 meter long section of the Rauma line. The cliff directly above the line is named "Rensken", implying that considerable effort was made to clear the area of loose rocks when the line was built. Observations indicate that there are rockfalls annually on the site.

This report describes a wireless geophone-based rockfall and landslide detection system, developed as part of GoSafeRail. The prototype installation consist of 12 sensor units, mounted with 30 meter spacing, below a high-frequent rockfall site at the Rauma line in the north-west of Norway. Each sensor unit contains one geophone and magnetometer, a processing unit with radio transmitter and is self-contained with power from batteries and miniature solar cells. Pre-assembled in the laboratory, all sensor units were installed during only four hours in the field on the 28th of November 2017. Maintenance is equally simple, as a single unit can be replaced in a few minutes by local railway staff. The system can be extended for several kilometres and is only limited by bandwidth to a maximum of 1000 sensor units for a single gateway. The estimated cost per kilometre is small compared to all other mitigation measures and warning system technologies.

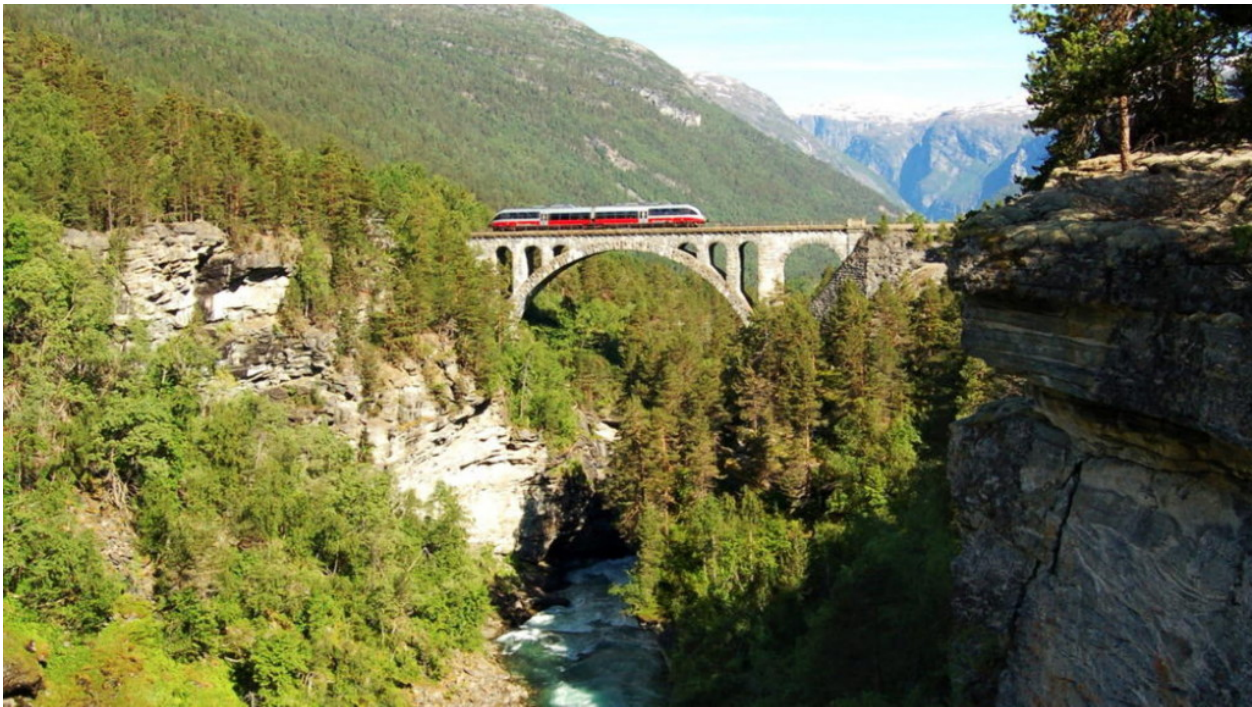
Figure 3: Kylling Bridge with a single type 93 passenger service between Dombås and Åndalsnes. The bridge is part of the second horseshoe turn at Verma.

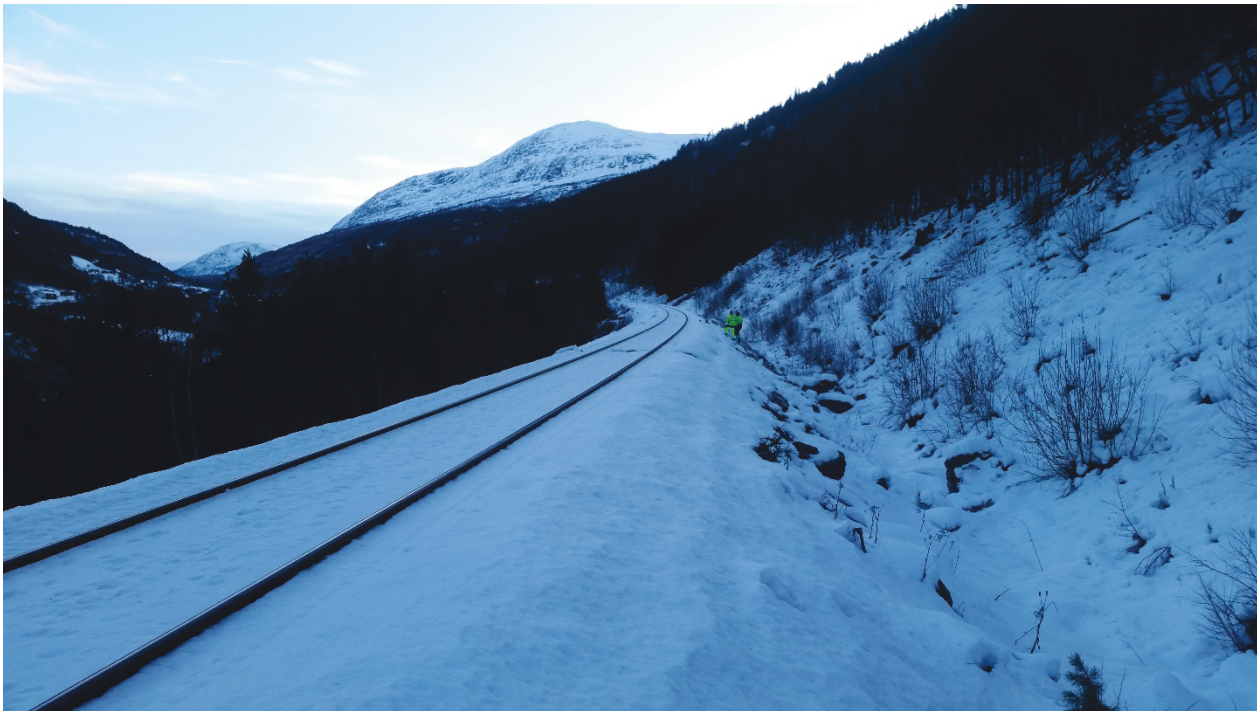
Figure 5: The line below Rensken. Several rocks and boulders can be observed partially covered by the snow beside the track. The photo was taken on the 27th of November 2017 during the installation of the sensor units.

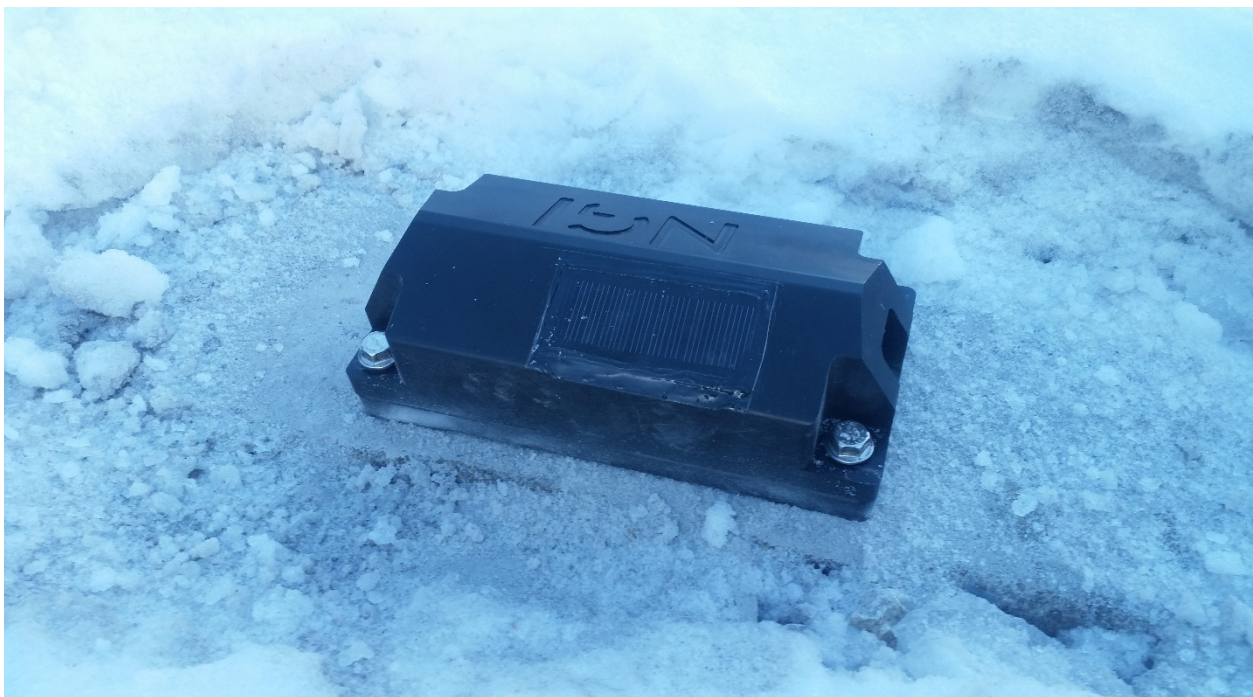
Figure 6: One of the sensor units installed on site. The enclosure encapsulates the sensors, data acquisition unit, radio module, antenna and battery. The only external components are the miniature solar panel visible on the lid, and a debug connector (not visible on the image). The sensor units are self-contained with no external cables.

Both sensors, data acquisition unit, radio antenna and battery are mounted inside a custom designed enclosure. The solar panel is mounted on top of the lid, and a debug connector is installed for easy maintenance and software upgrades. The geophone is glued to the inside of the enclosure baseplate, giving optimal mechanical coupling to the tracks, while all electronics are mounted with rubber gaskets minimizing strain from train-induced vibrations. The enclosures are constructed in a rugged plastic material (POM) and fastened directly to the sleepers with concrete-penetrating steel screws.

The sensor enclosures are installed mid-track. In order to avoid interference with snow moving and maintenance operations, the enclosures were designed to extrude as little as possible, while still giving room for a small vertical dipole antenna inside. The top of the enclosures extends 85 mm up from the sleepers, giving more than 100 mm headspace to the top of the rails. The footprint measures 80x220 mm.

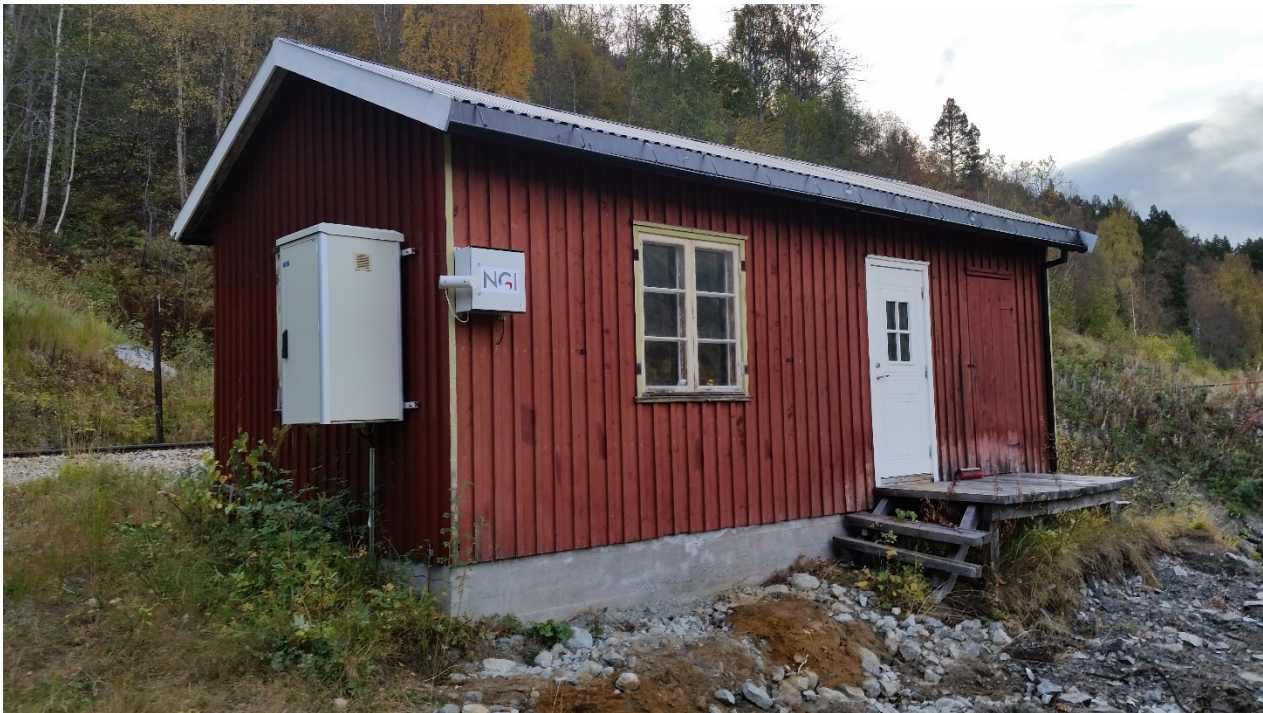
Figure 7: The cabinet containing the gateway is installed on the wall of a building by the entrance to "Vendetunellen". The gateway is the only system component requiring grid power, and this location was chosen as it is the only Railway owned installation within radio distance from the test site, with available power. The larger cabinet on the opposite wall is a GSM-R installation, enabling possible future integration of the system with existing railway telecommunication.

The gateway, containing the master radio and a 3G cellular modem, is the only part of the system requiring grid power. This is installed in a cabinet next to "Vendetunellen", on the opposite side of the valley. A stable 800 meter long radio-link, between the gateway and a dedicated relay radio trackside at Rensken, is achieved by using directional yagi antennas on both ends. The gateway is equipped with a small 24V UPS and an output relay for possible light signal warnings to the train operators.

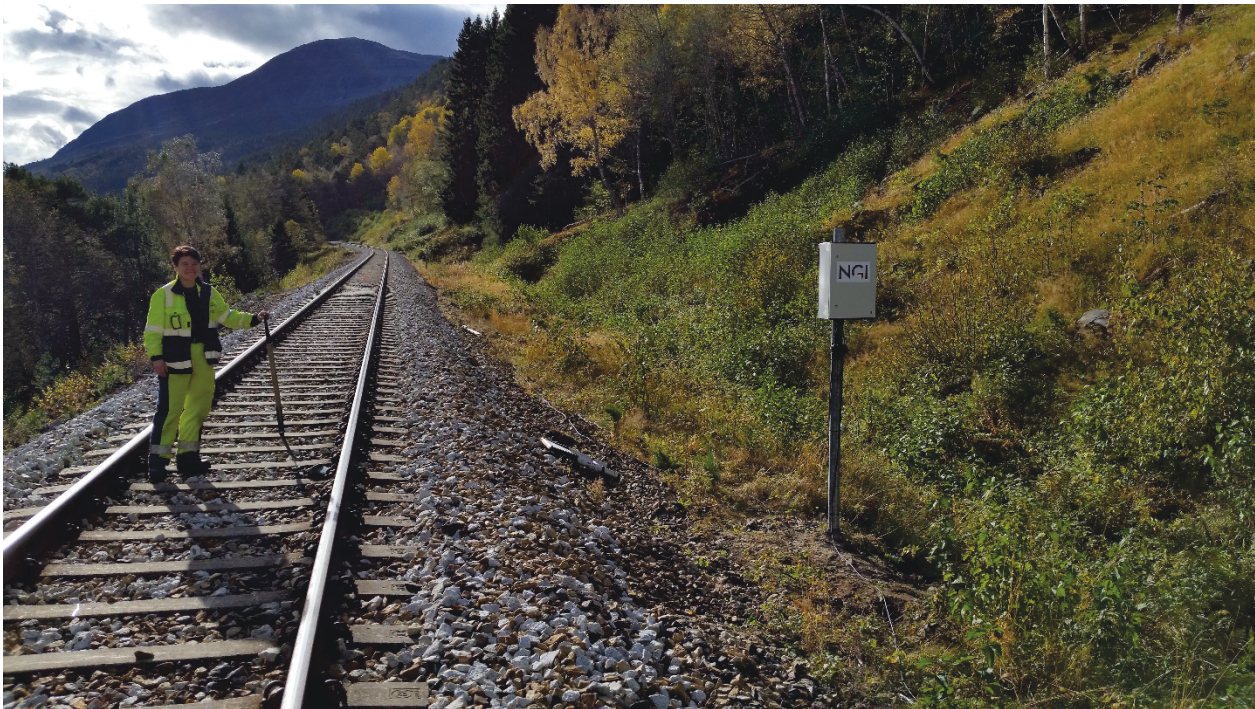
Figure 8: A second electronics cabinet is installed next to the line at the test site. This contains two relay radio units with directional yagi antennas. One antenna is directed towards the gateway on the opposite side of the valley, while the other is pointing towards the sensor units in the track. For optimal protection during snow moving, both antennas are mounted inside the enclosure.

The system is designed so that the sensor units will form a series of radio-links along the rail. In addition to producing its own data, the sensor units will forwards messages from neighbouring units, forming a chain of radio-links down the track. In theory this system could be extended over very long distances, but at some point there will be limitations due to bandwidth. During the 2018 winter all sensor units were fully submerged by snow and ice between the rails. The snow cover proved to limit the range of single radio-links to such an extent that four temporary radio units had to be install alongside the track. These radios serve as additional relay station, forwarding messages received directly from the sensor units.

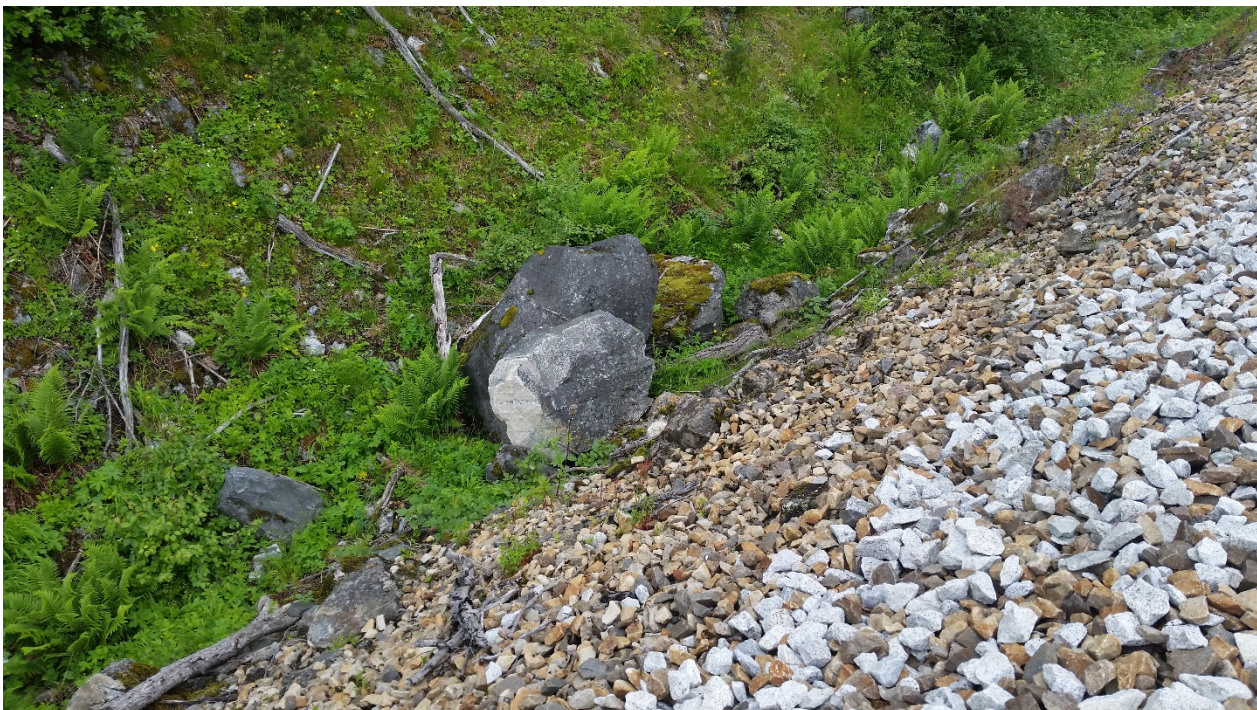
Figure 9: A single rockfall will generate a shockwave in the track, propagating in both directions from the point of impact. This acoustic signature is distinguishable from most other events, when the shockwave is strong enough to be detected by several sensors on both sides.

A single rockfall on the track will create vibrations with different acoustic signature than landslides and avalanches, and cannot be detected with the landslide algorithm above. In the extreme case a single rock could fall tens of meters through the air, hitting the track in a single impact, before bouncing further down the slope and into the river below. Such a high velocity impact will generate a shockwave in the track, progressing in both directions from the point of impact. The algorithm for detecting a rockfall is implemented with a criteria that the shockwave needs to be detected by

sensors on both sides of the impact, and that the measured amplitude must decrease with increasing distance between impact and sensor. In addition, none of the activated sensors are allowed to report higher standard deviation values during the first second prior to, or after, the impact. This algorithm has proven reliable in detecting shockwaves from sledgehammer tests (described below), as long as the impact is sufficiently strong to activate at least three sensor units. Potential criteria for minimum amplitude and number of sensor units detecting the shockwave, will likely need to be evaluated based on data from actual events.

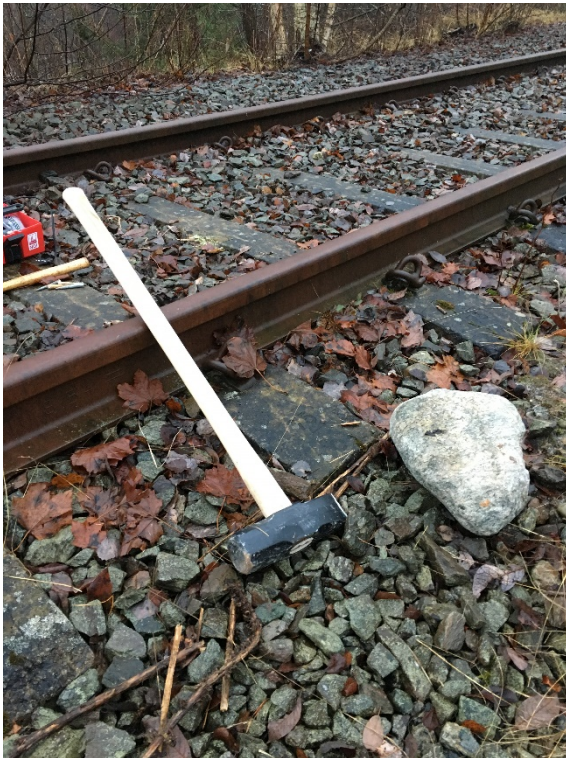
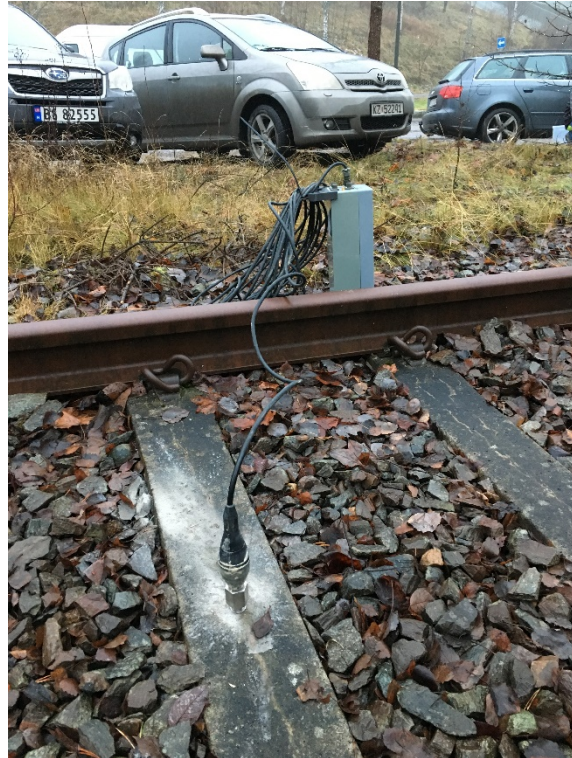
Figure 13: Simulated rock fall tests on an abandoned rail section. The geophones were mounted directly on the sleepers and a sledgehammer was used to generate shockwaves in the tracks.

In order to test detection of rockfalls a series of experiments were conducted on an abandoned track. This section was once part of the Main line northbound from Oslo, and is of similar quality to the Rauma line. In these tests four geophones were mounted directly on the sleepers using expansion bolts. Each of these geophones were hooked up to individual data acquisition units, similar to the ones installed on the Rauma line, and the data were acquired using a laptop and USB radio module. In order to generate the same type of shockwave expected from a rockfall, a sledgehammer and a 10 kg rock was used simulate a sequence of impacts to different components of the track (sleepers, rail, ballast). An example of data recorded during a single impact is shown in Figure 12. 26 individual tests were performed and the algorithm developed to detect rockfalls identified all of the events that were powerful enough to register on at least three sensors. Similar types of tests will be performed at the Rensken test site as soon as the snow and ice has melted.
