First-time landslides in Vashon advance glaciolacustrine deposits,
Puget Lowland, U.S.A.

Thomas C. Badger, Marco D'Ignazio

Abstract

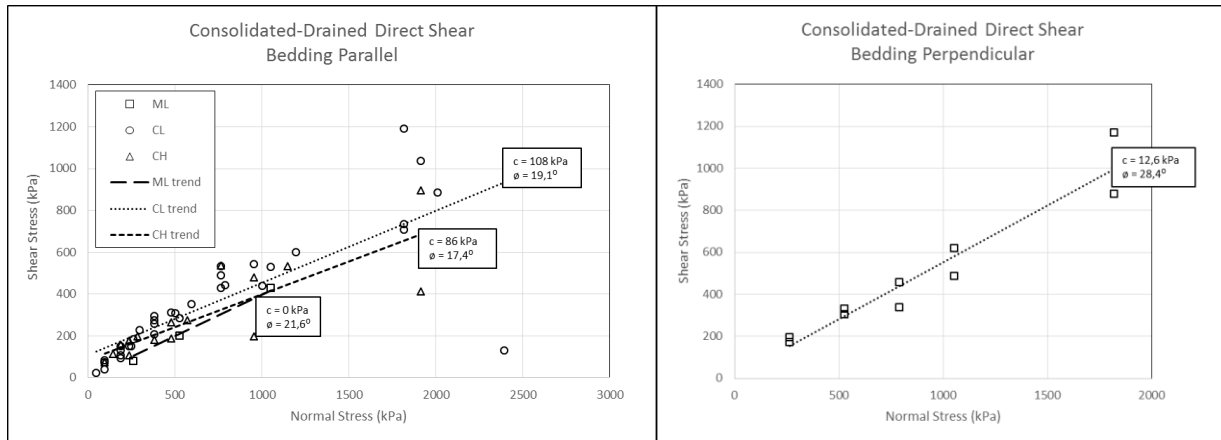
Figure 2. Peak drained strength envelopes from direct shear tests on samples sheared a) parallel to bedding and b) perpendicular to bedding.

Few published or public-domain geotechnical investigations exist that include shear-strength characterization of intact *Qglv* deposits through laboratory testing and/or back-analysis of failure. These include the landslides that occurred during construction of the Seattle Freeway in the 1960s (Palladino and Peck, 1972); the 1997 Woodway landslide (Landau, 1998; Arndt, 1999; Savage et al., 2000a,b); and the Oso landslide (Badger, 2016; Pyles et al., 2016; Cooper Testing Laboratory, 2016; GeoTesting Express, 2016; Stark et al., 2017). Anisotropic strengths were investigated for the Oso landslide using consolidated-drained direct shear testing (ASTM D3080) and shearing samples parallel to bedding (Badger, 2016; Cooper Testing Laboratory, 2016; GeoTesting Express, 2016) and perpendicular to bedding (Badger, 2016); failure envelopes are presented in Figures 2a and b, respectively. Typical stress-strain curves from the direct shear tests indicate brittle behavior with significant strain softening to plastic behavior and minor strain hardening; peak strength is commonly reached between 3 and 7% strain. Torsional ring shear tests were performed to assess strengths for fully-softened (ASTM D7608) and residual states (ASTM D6467) for the Oso landslide (Badger, 2016; Cooper Testing Laboratory, 2016; Stark et al., 2017). These data are summarized in Table 3.

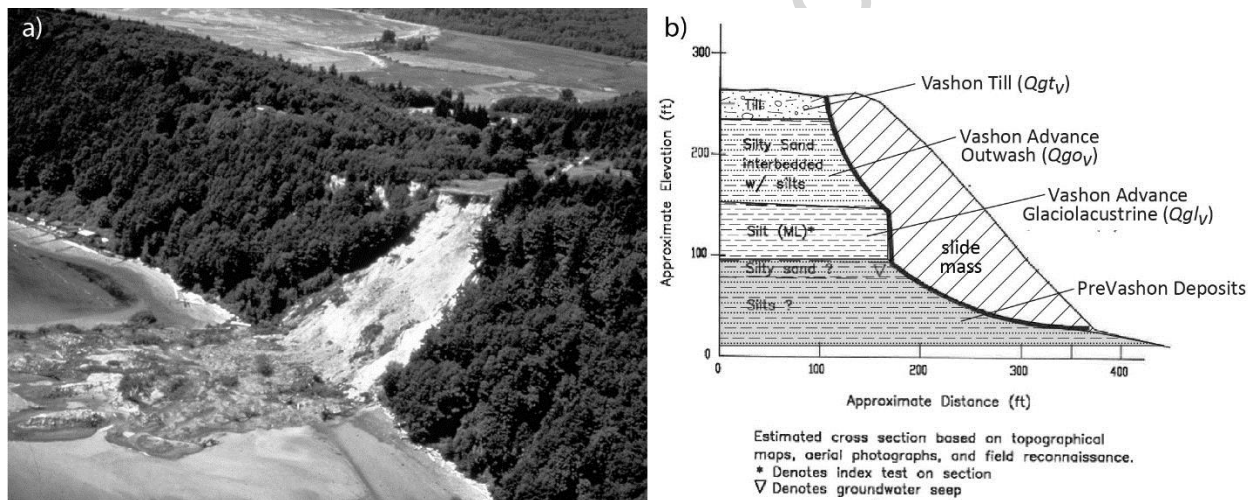
Figure 3. a) Photo of 1 July 1979 Possession Bay landslide (courtesy of D. Frank and H. Shipman). b) Measured geologic section (courtesy of Arndt, 1999), with interpreted geologic units based on regional mapping of Minard (1982).

In his evaluation of landslides occurring within similar intact sequences of Vashon glacial deposits as the Woodway landslide, Arndt (1999) reported on a large landslide in an 80-m-high marine bluff on the southeast end of Whidbey Island, south of the community of Glendale (Fig.

3a). The landslide, which exhibited considerable mobility, occurred on 1 July 1979 during the summer dry season and following four months of below-normal precipitation. Minard (1982) included the landslide in his regional geologic mapping, and identified the bluff sequence as Vashon till, advance outwash and transitional beds ($Qglv$ deposits) overlying PreVashon interglacial deposits (Whidbey Formation). Arndt's interpreted section of the landslide, prepared nearly 20 years after the event, is presented in Figure 3b; we attempted to assign Minard's geologic units to Arndt's section. The failure surface is depicted as shearing deeply through the Vashon sequence, possibly extending into the underlying PreVashon deposits. A slope inflection evident in the lower third of the landslide scar and the absence of a debris bulge or accumulation at the base of the slope suggest the failure surface is well above beach level. No borings or instrumentation data are available for this landslide to confirm stratigraphy and groundwater conditions behind the landslide, or the location of the basal failure surface. The reason for including this feature is to note that we consider it improbable that precipitation-induced pore pressures developed during the preceding four months to cause this movement.

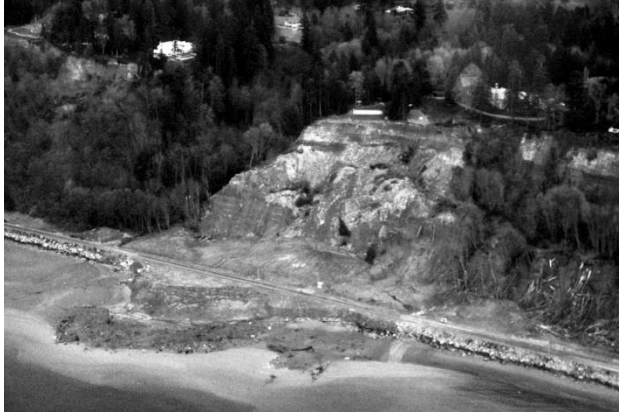
Figure 4. Photo of 15 January 1997 Woodway landslide (courtesy of H. Shipman).

On 15 January 1997, a rapid landslide initiated from a steep 75-m-high marine bluff located near the community of Woodway, about 25 km north of downtown Seattle (Fig.4). The landslide followed more than a year of above-normal precipitation; then several weeks prior to the event, a series of winter storms brought more with than 50 cm of snowfall that was followed by warm heavy rains (Gerstel et al., 1997). Estimated to involve 100,000 m³ of intact Vashon advance glacial deposits, it “...probably represent[ed] one of the larger coastal bluff landslides to have occurred in the last 30 years or so” (Landau Assoc., 1998).

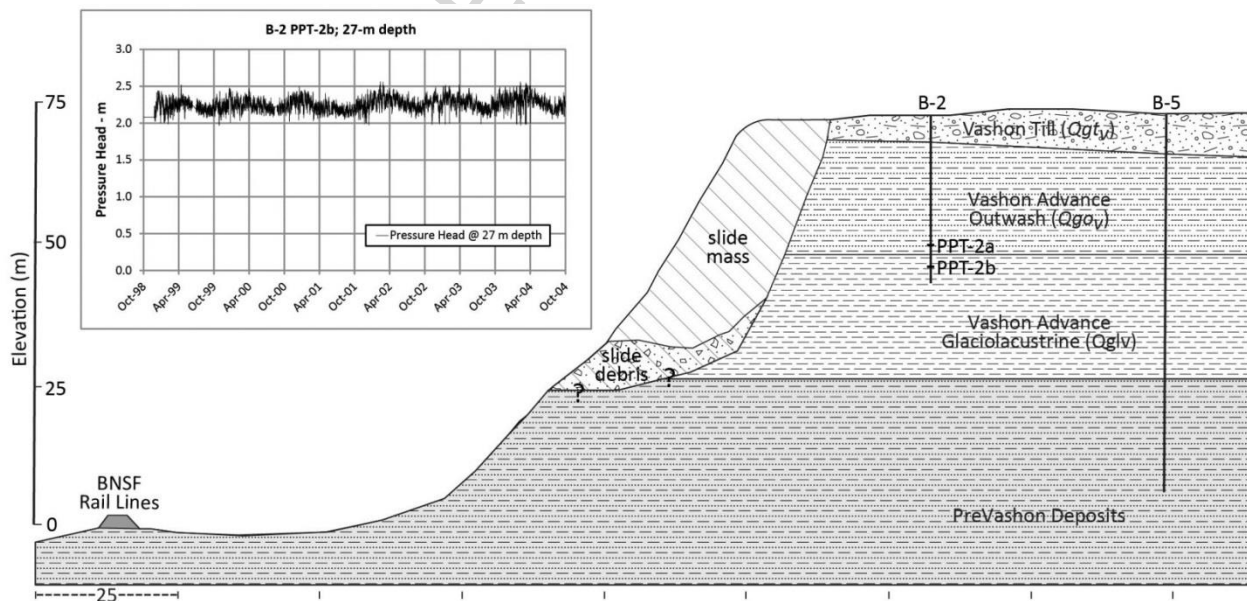
Figure 5. Geologic section of Woodway landslide (modified from Landau Assoc., 1998). Graph depicts pressure head on vibrating-wire piezometer PPT-2b at 27 m depth from boring B-2, located in the upper portion of the Vashon glaciolacustrine deposits for 1998 through 2003 water years. Unsaturated conditions were measured in the overlying outwash unit (PPT-2a) during this 6-yr period.

Landau performed a geotechnical investigation, including borings and piezometers, to characterize the stratigraphic and groundwater conditions in the bluff immediately behind the head scarp (Fig. 5). The landslide failed through a discontinuous 4-m cap of very dense diamict (till), about 25 m of advance outwash sand and interbedded silt, and ~20 m of fractured (fissured) advance glaciolacustrine silt and clay (*Qglv*). The surface rupture toe was interpreted to be near or just below the contact of the *Qglv* unit and PreVashon interglacial deposits (Whidbey Formation), consisting of very dense sand with interbedded hard sandy to clayey silt. Post-failure observations included many iron-stained fractures within landslide blocks of glaciolacustrine deposits and seepage within the back scarp from fractures within the advance glaciolacustrine deposits (Laprade et al., 1998). These observations suggest that groundwater flow and likely rapid recharge were dominated by fractures rather than interstitial pores. Landau inferred that above-normal precipitation preceding the failure, and resultant elevated pore pressures facilitated by the pre-existing tension cracks and fractures, were the primary controls on this failure.

One sanded-in-place, vibrating wire piezometer was installed in July 1997 near the top of the advance glaciolacustrine unit (PPT-2b), about 3 m below the contact with advance outwash. The piezometer (and other on-site instrumentation) was continuously monitored at 15-min intervals by the U.S. Geological Survey until 2005 (Fig. 5) (USGS, 2006). The presented data spans six water years beginning in October 1998 through September 2004. The on-site precipitation record is incomplete for this period and is not included, though typical seasonal quantities and patterns of dry summers and wet winters persisted during this monitoring period (Western Regional Climate Center). An annual fluctuation of about 0.3 m of pressure head was measured during this 6-yr period, with heads gradually increasing and peaking in late winter, then gradually dropping with the onset of the dry summer season. We recognize no indication in these data of response to significant storms during this period.

We applied the peak anisotropic strengths for the *Qglv* deposits derived from the Oso landslide investigation and adopted strengths used by Savage et al. (2000b) for the other units for the geologic section depicted in Figure 5. Using similar groundwater conditions as Savage et al. (2000b) resulted in a factor of safety of 1.08 for the observed configuration of the slide surface. Stability dropped precipitously with the hypothetical reduction in cohesion.

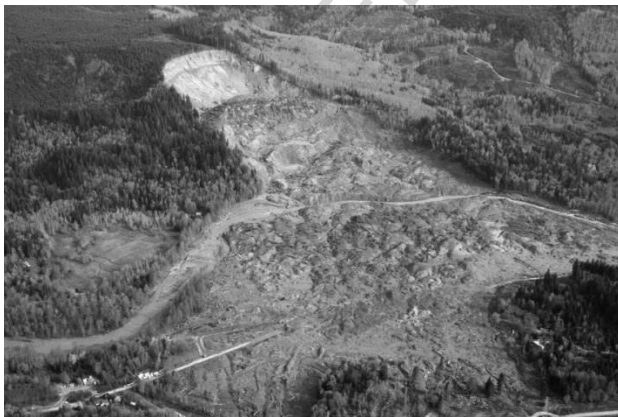
Figure 6. Photo of 22 March 2014 Oso landslide (courtesy of the Washington State Patrol).

Since at least the 1930s, landslide debris thickly mantling this valley slope in the North Fork Stillaguamish River valley experienced occasional wet-season remobilizations (usually called the Hazel slide, in pre-2014 literature; Shannon, 1952; Thorsen, 1970; Benda et al., 1988; Miller and Miller, 1999). The penultimate remobilization occurred in January 2006 and involved between 1 and 2 million m³ of landslide debris (Badger, 2015). Much of it fluidized and rapidly ran out nearly 250 m onto the valley floor, temporarily damming and diverting the river. That event was unnoticed by a nearby fisherman (Stillaguamish Tribe, 2006) and was unrecognizable in a review of the regional seismic network records (K. Allstadt, 2014 personal communication; Iverson et al., 2015). Initiating from this same slope, the catastrophic 2014 Oso landslide (Fig. 6) followed a multi-week period of heavy rains. This landslide originated within the 200-m-high glacial-fill terrace, retrogressing nearly 100 m into the intact sequence of glacial deposits composing the terrace. It evolved rapidly into a highly mobile debris avalanche-debris flow that reached the opposite valley wall more than a kilometer away in about a minute (Keaton et al., 2014; Iverson et al., 2015).

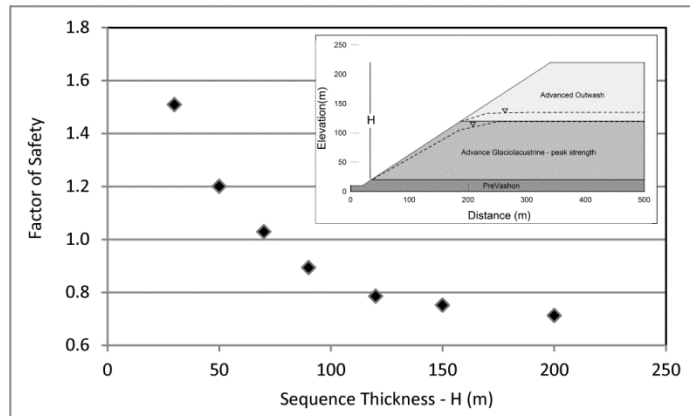
Figure 14. Relationship of slope height and factor of safety for a hypothetical two-unit section of outwash overlying mostly saturated, glaciolacustrine deposits using peak anisotropic strength.

cap this sequence. To examine the influence stress state has on stability we performed sensitivity analyses for a hypothetical sediment stack over a range of equal thicknesses of outwash and *Qglv* deposits at peak anisotropic strength. We assumed saturated conditions in the *Qglv* deposits with an overlying perched aquifer in the advance outwash deposits. We then calculated the lowest factor of safety for a slide mass with an aspect ratio (base width W / sequence thickness H) of ~ 0.4 to 0.6 , which is characteristic for all but one of the studied slide masses, BA6S. As would be expected, stability drops with increasing total thickness (slope height), but with greater sensitivity for sequences thinner than 100 meters (Fig. 14).

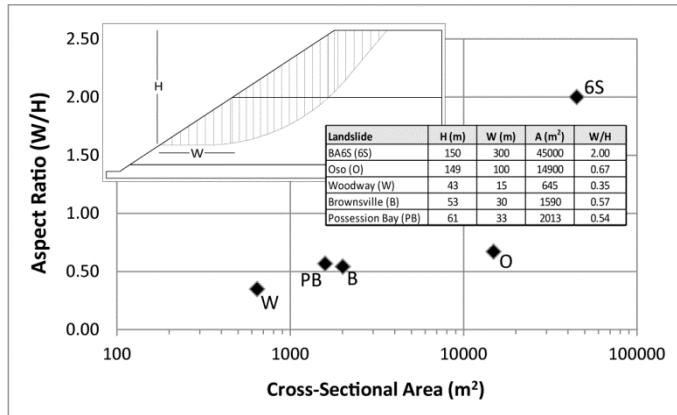
Figure 15. Relationship of aspect ratio (base width/height above failure surface) to cross-sectional area for the five studied landslides.

From the interpreted geologic sections through all of the studied landslides, slide masses have the appearance of being crudely shaped parallelograms. We measured the slide mass dimensions from the interpreted sections of Arndt (1999) for the Possession Bay and Brownsville landslides, Landau Assoc. (1998) for the Woodway landslide, and Badger (2015, 2016) for the Oso and BA6S landslides. Figure 15 plots the relationship of aspect ratio with cross-sectional area, as a 2-dimensional representation of landslide volume. The data suggest that increasing sequence thickness generates proportionally greater base widths, resulting in higher aspect ratios with larger cross sectional areas. Such a relationship might be induced by proportionally greater shear stresses and lower effective stress associated with increasing stratigraphic and saturation thickness. The BA6S landslide is an obvious outlier. Perhaps not coincidentally, back-analyses of this landslide were unable to simulate static instability within a reasonable range of fully softened or residual strengths under near-fully saturated conditions, suggesting an external load on stability might have been necessary to mobilize this landslide or that it developed as two or more smaller landslides occurring in quick succession.
