Norwegian GeoTest Sites (NGTS)

FIELD AND LABORATORY TEST RESULTS HALDEN

DOC.NO. 20160154-04-R

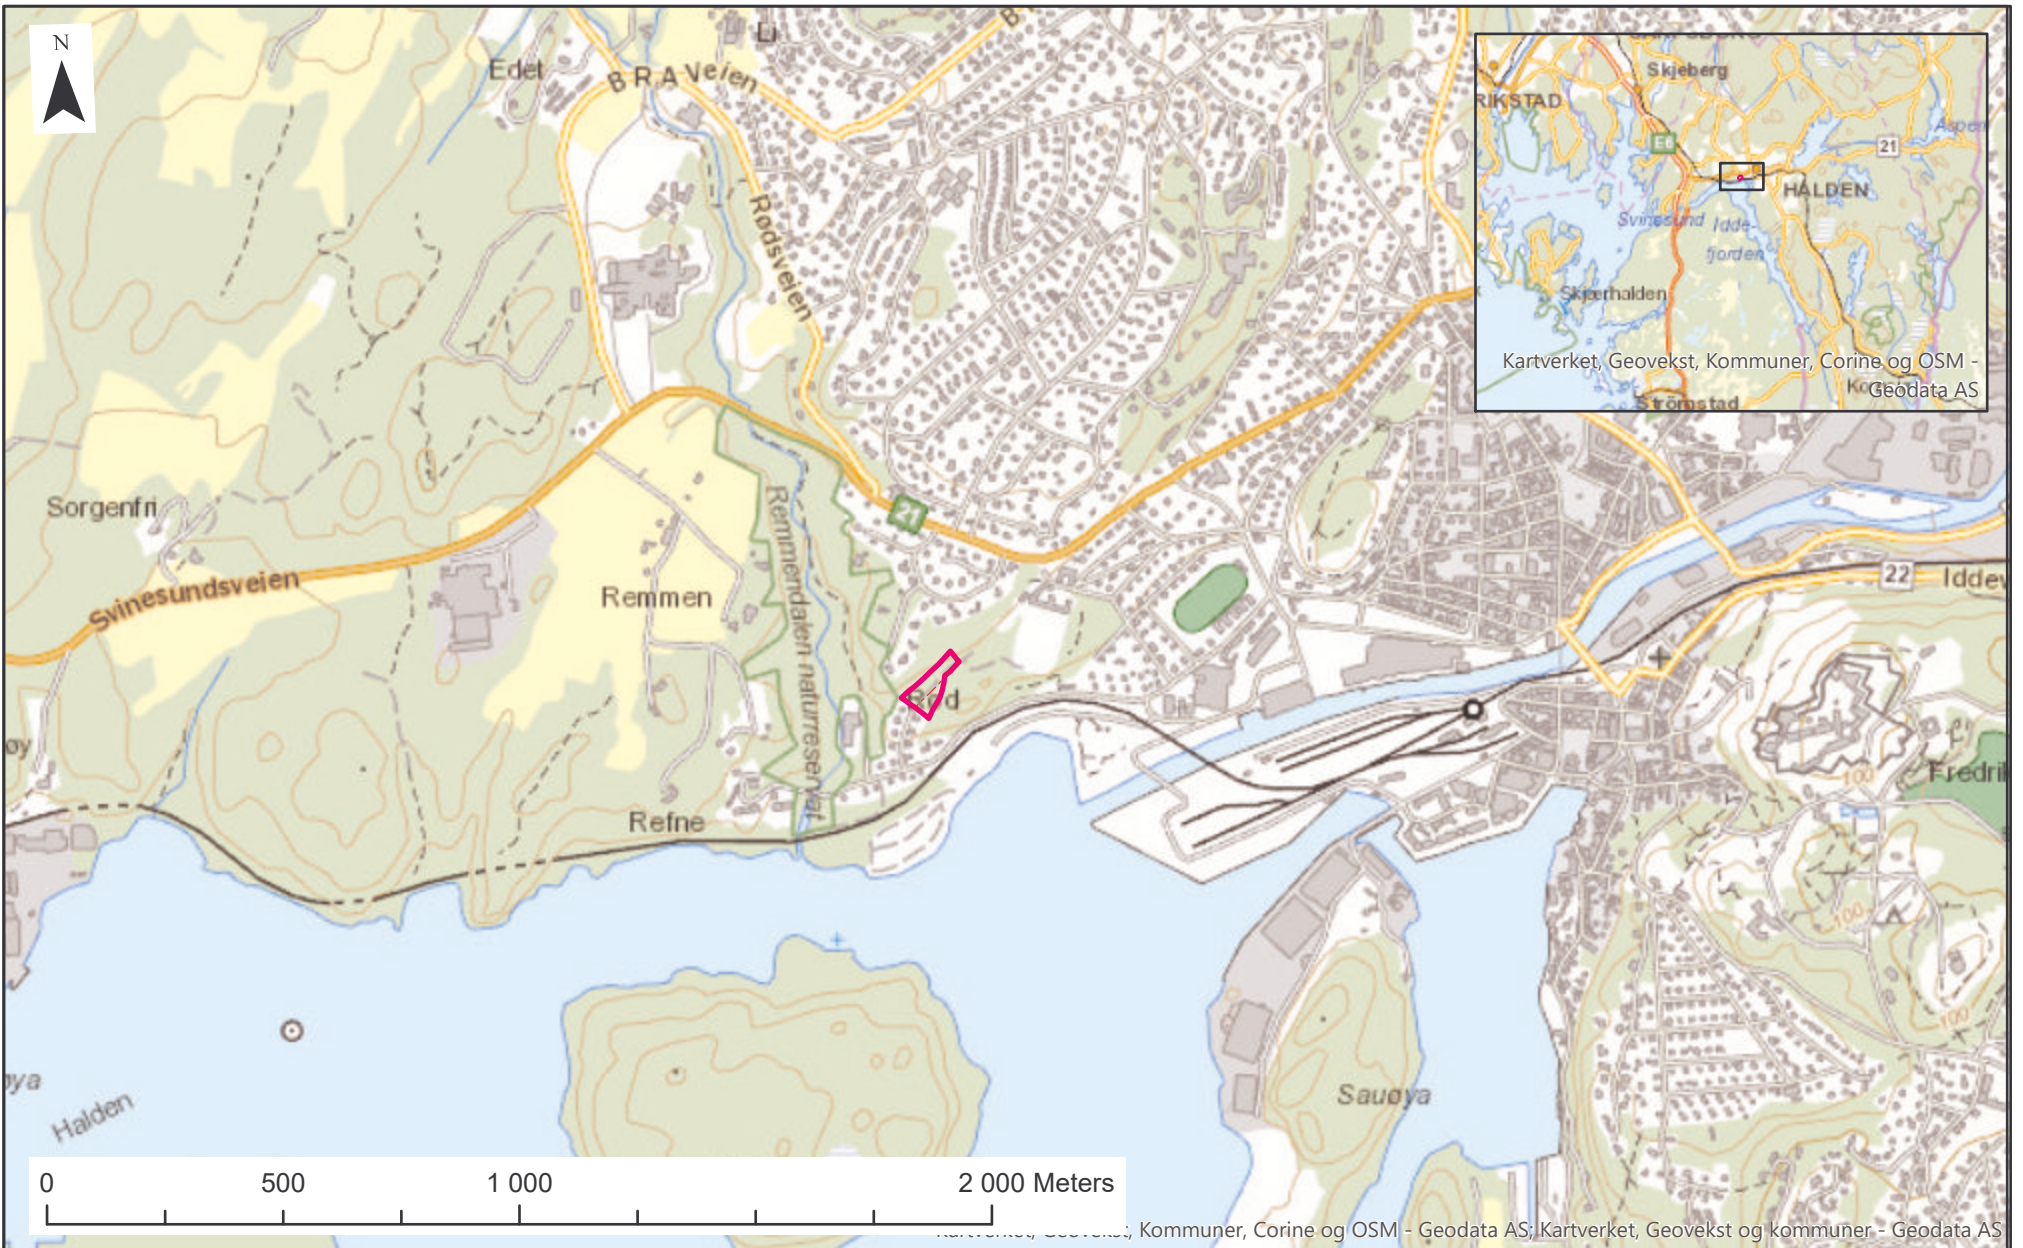
Site extent	Halden research site	Document No. 20160154-04-R	
	Site location	Figure No. 1.1	
	Spatial Reference: ETRS 1989 UTM Zone 32N	Date 2018-04-06	Drawn by HCS/RCa

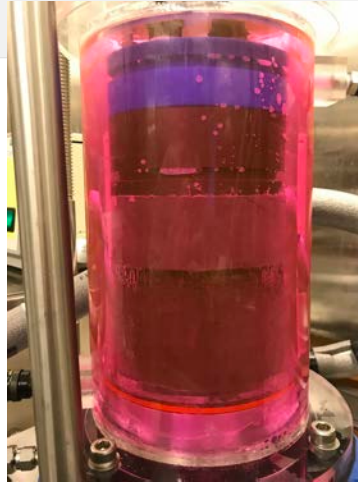
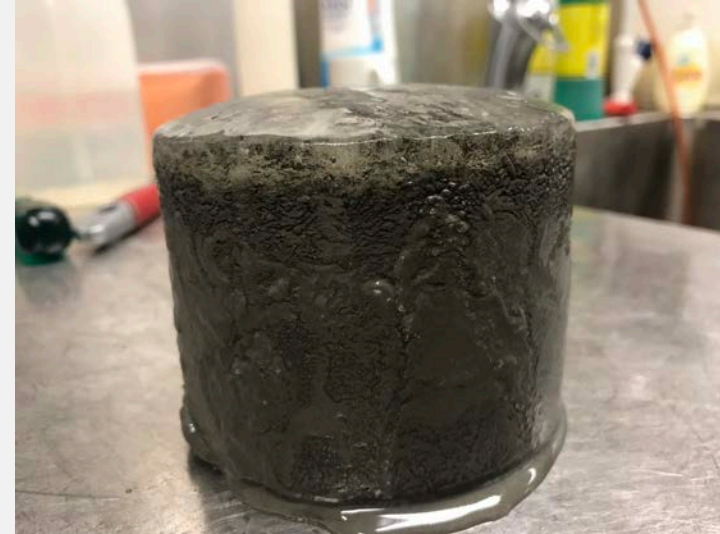
- Halden soil, Silt (SC)
- KICT and NGI test result comparison

Test Com.	No	Dry unit weight, (kN/m ³)	Height mm	Bottom °C	Top °C	Gradient °C/mm	Con. °C	Heave amount (mm)			Heave rate (mm/day)		
								total	Pore water	Water intake	ASTM (8hr)	KICT (14hr)	SP (hr)
KICT	K100-10	14.51	99.59	-9.1	2.7	0.118	3.0 °C	31.01	3.02	27.99	43.55	34.23	-
KICT	K100-20	14.72	98.15	-20.8	2.8	0.240		31.85	3.34	28.51	55.35	41.57	-
NGI	N100-10	13.55	105.26	-9.4	3.2	0.119		26.62	3.67	22.95	43.34	33.20	-
NGI	N100-20	13.43	107.60	-20.9	3.1	0.223		28.29	4.11	24.18	51.23	34.87	-
