# Norwegian GeoTest Sites (NGTS)

FIELD TEST RESULTS ØYSAND

DOC.NO. 20160154-08-R

Project title: Norwegian GeoTest Sites (NGTS)  
Document title: FACTUAL REPORT - ØYSAND RESEARCH SITE  
Document no.: 20160154-08-R  
Date: 2020-01-15  
Revision no. /rev. date: 0

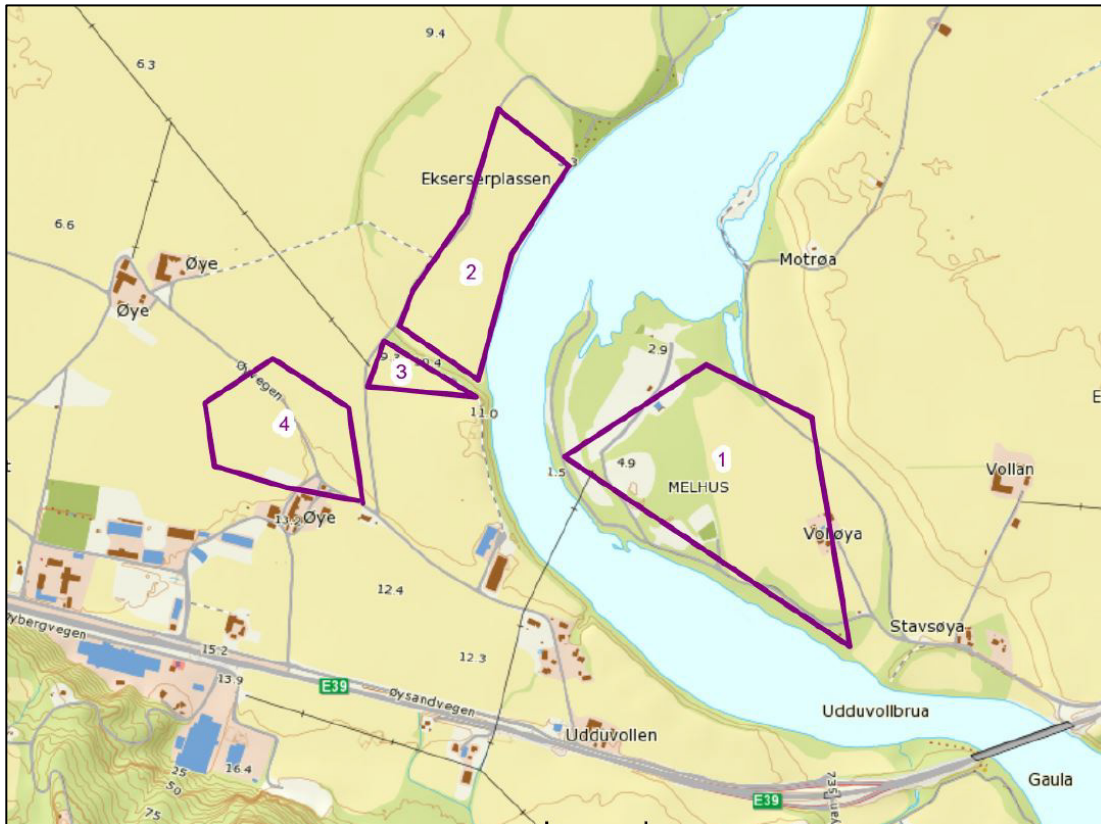
Figure 4. Map of region showing investigated areas (1 to 4) with total soundings. Area 2 corresponds to the selected test site at Øysand.

On the west bank north of the cliff (Area 2), a stiff layer is observed at depths of 1.5 to 3 m with a variable thickness in the range of 4 to 7 m. At locations OYSTS10, OYSTS11 and OYSTS12, hammering and flushing were required to penetrate through sections of this layer. At locations OYSTS08 and OYSTS09 this layer was mostly penetrable with little hammering, but application of forces in excess of 20 kN was required. At locations OYSTS10 and OYSTS12 similar stiff layers were also encountered at 23 to 25 m depths. Below this layer softer soils were encountered to at least 23 m depth.

On the west bank near the farm (Area 4), a stiff layer is observed at location OYSTS15 between 2 and 5 m depth and at location OYSTS16 at 1.5 to 2 m and at 4.5 to 5.5 m. Below these zones the soil resistance is less and fairly uniform down to 20 m.

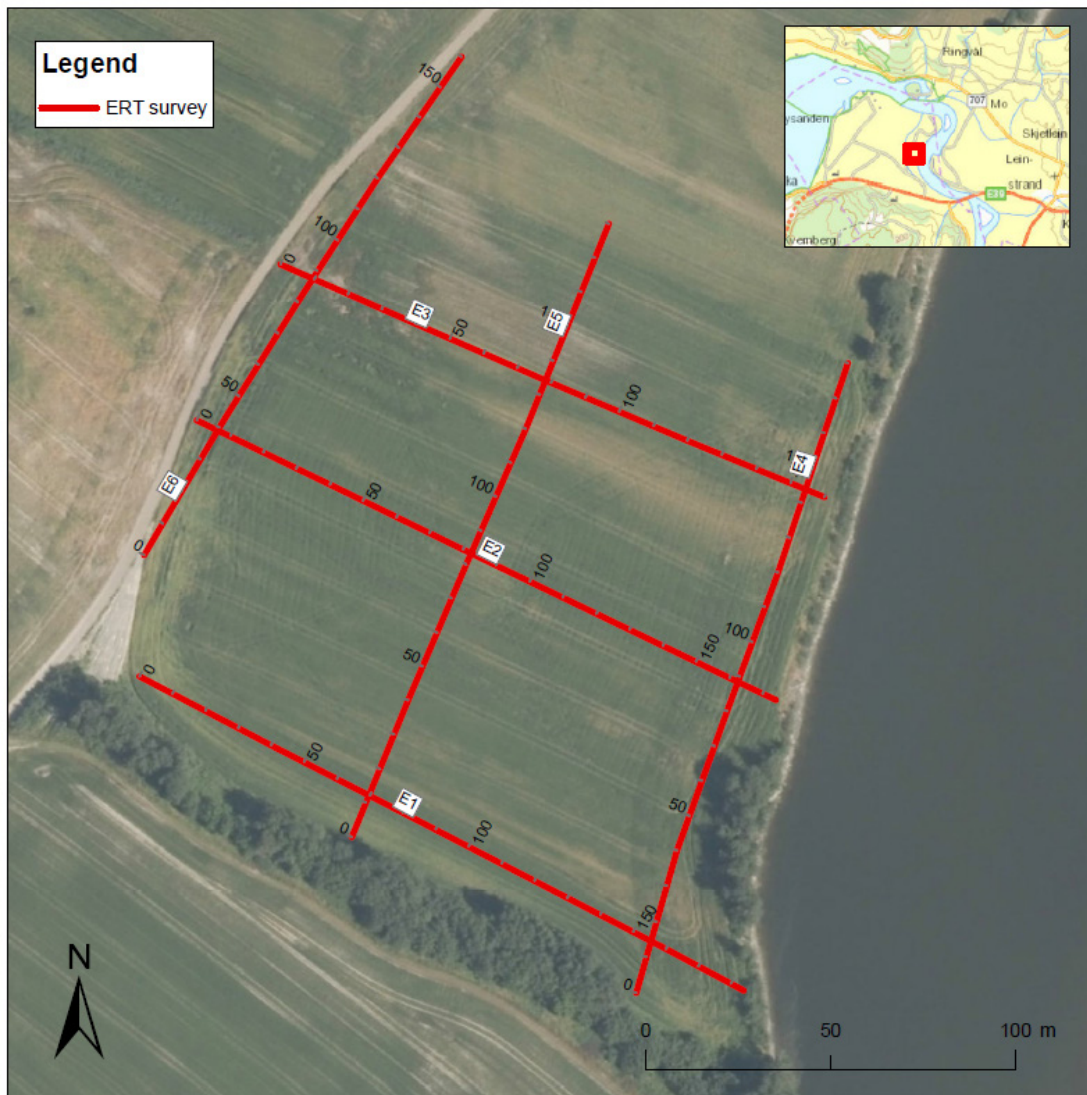
Figure D1 Overview map of the ERT survey

A total of six profiles of ERT were performed on 10-11-12 April 2017. Three parallel profiles were carried out in the West North West - East South East (WNN-ESE) direction and three parallel profiles were performed in the South West South - North East North (SSW-NNE) direction. Figure D1 shows a location plan with the start and end point of each resistivity profile. **The official names are OYSER01 instead of E1 etc.**

On all profiles, the top 1-3 meters are marked by a resistive ( $\rho > 1000 \Omega\text{m}$ ) dry crust layer. This top layer thickens towards the NE. The layer below the dry crust shows resistivity values typical of silt and sand (64-512  $\Omega\text{m}$ ). This layer does not seem to be uniform. Below 10-15 m depth, resistivities typical of clay (1-64  $\Omega\text{m}$ ) are observed.

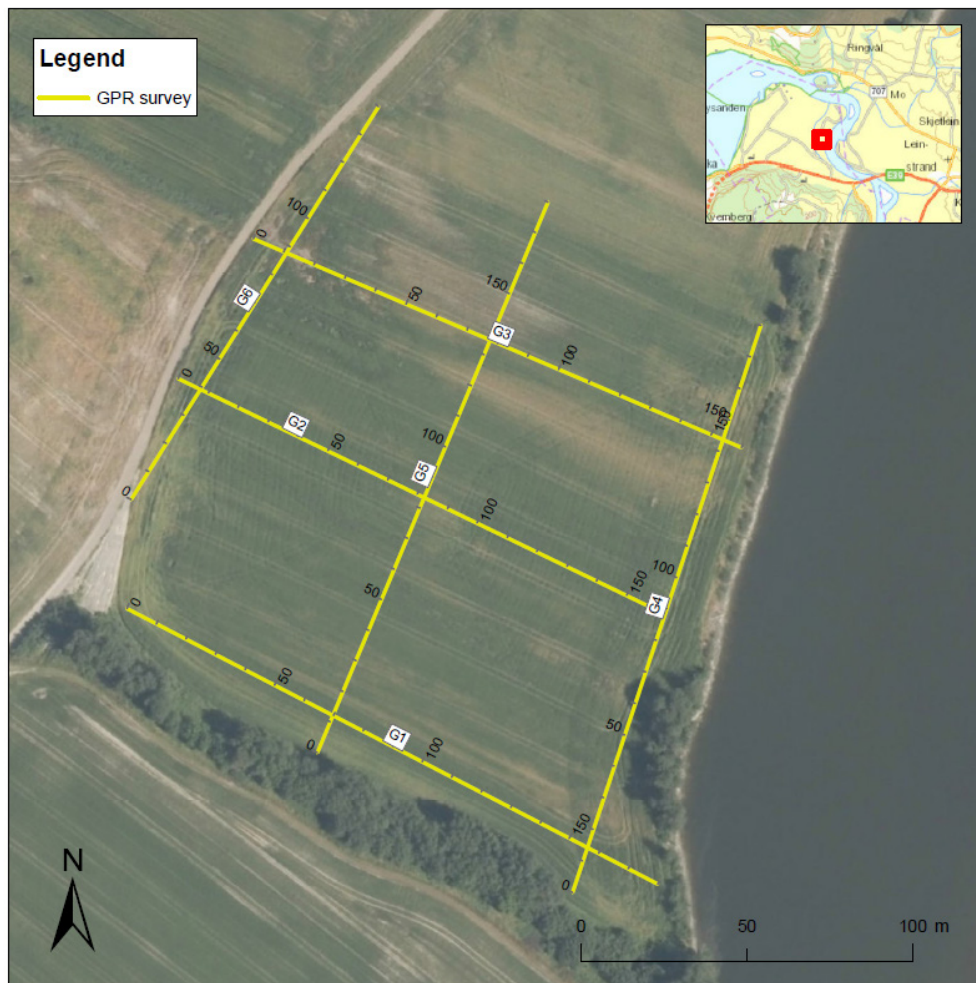
Figure E1 Overview map of the GPR survey

<b>East UTM32</b>	<b>North UTM32</b>
OYSG01 (G1) - 0m Start	562469,20	7022938,89
OYSG01 (G1) - 180m End	562635,99	7022871,2
OYSG02 (G2) - 0m Start	562478,13	7023009,27
OYSG02 (G2) - 161m End	562628,82	7022953,0
OYSG03 (G3) - 0m Start	562496,63	7023053,22
OYSG03 (G3) - 160m End	562648,91	7023004,37
OYSG04 (G4) - 0m Start	562610,67	7022866,30
OYSG04 (G4) - 180m End	562651,84	7023041,06
OYSG05 (G5) - 0m Start	562530,31	7022901,04
OYSG05 (G5) - 180m End	562584,00	7023072,56
OYSG06 (G6) - 0m Start	562467,36	7022971,54
OYSG06 (G6) - 140m End	562530,43	7023096,29

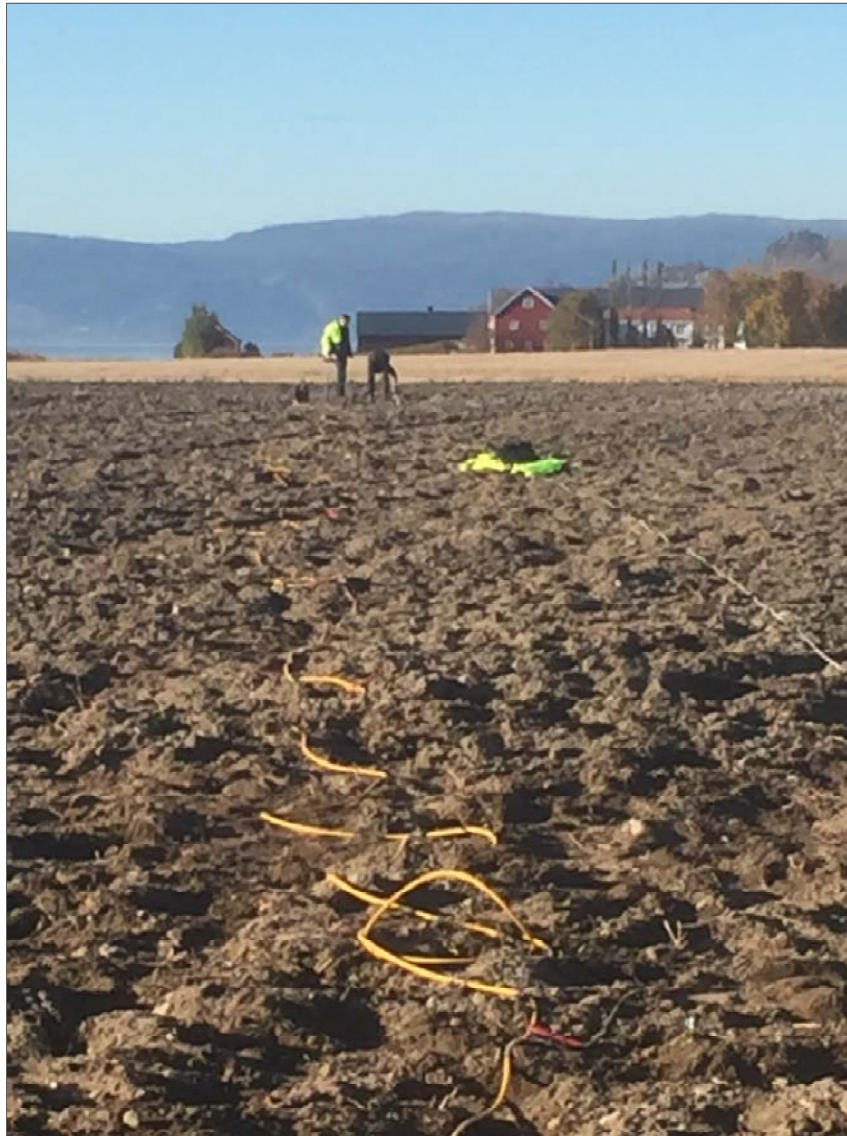
*Fig.2.2. Area 1 survey location, for Profiles M1, S1 and S2.*

The topography for the survey area is generally flat, with elevation ranging from 3-10 mOD. The survey was carried out upon crop fields (Figs.2.2 and 2.3).

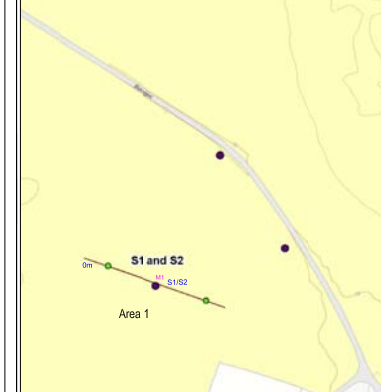
INDEX MAP: scale 1:5000@A4

- 429-576 m/s P-WAVE VELOCITY LAYER
- SOFT/LOOSE OVERBURDEN
- SOFT-FIRM/LOOSE-MEDIUM DENSE OVERBURDEN
- FIRM/MEDIUM DENSE OVERBURDEN
- STIFF-VERY STIFF/DENSE-VERY DENSE OVERBURDEN

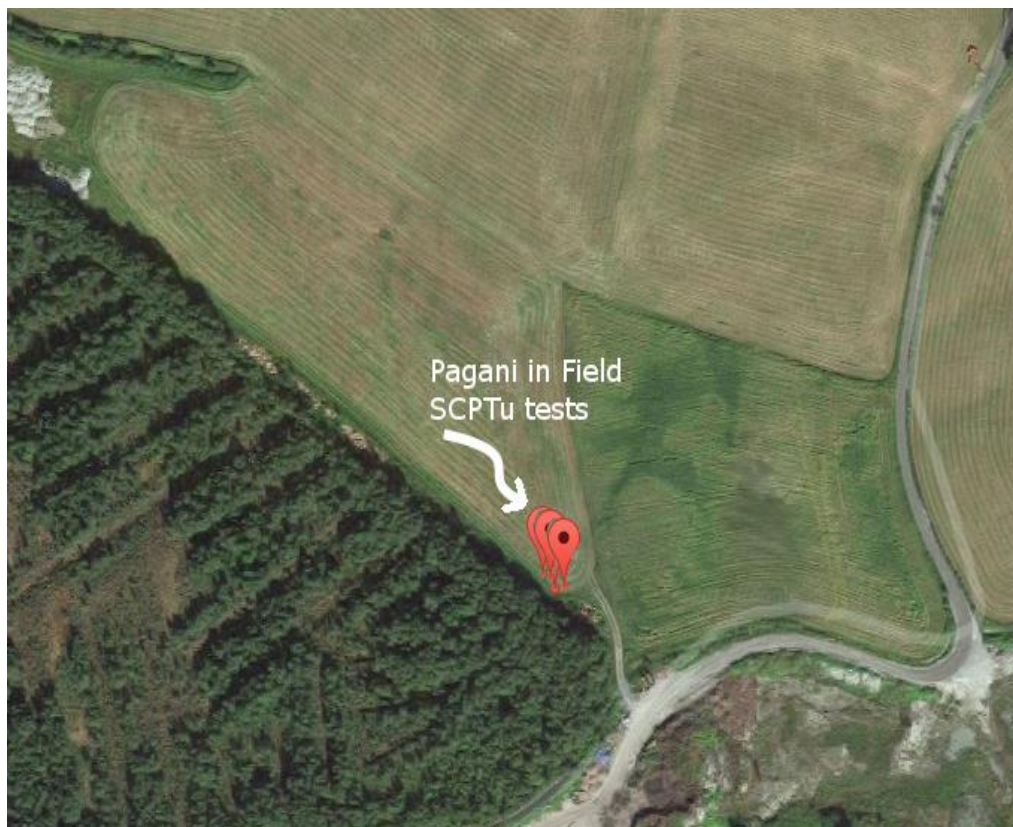
Fig.1: Test location at Tiller site

The third and fourth National GeoTest Site (NGTS) in Norway are located near Trondheim city. Pagani team started to perform the tests in Tiller first (September /25, 26/ 2017) (Fig.1). The information available from NGI were (further information from NGI where added during the tests):

- Soil type: Quick clay
- Testing depth: approximately 25-30 meters
- Number of tests: 4 tests (3 CPTu and 1 SCPTu )

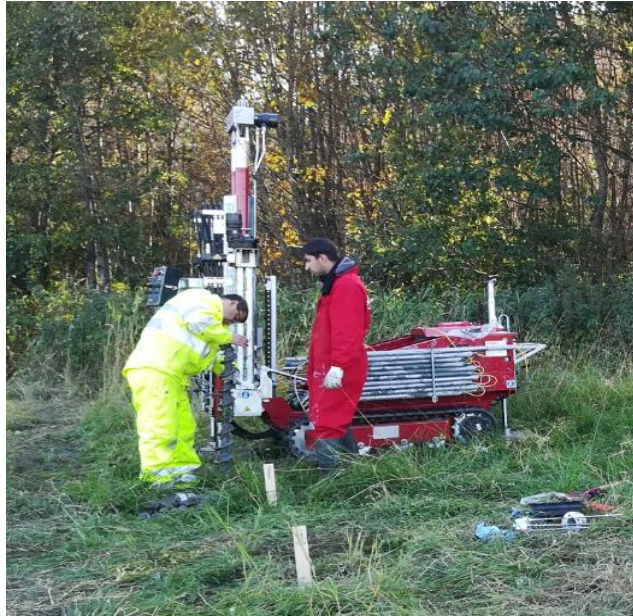
Fig.2: Operators at work

The Pagani rig anchored into the ground with helical augers of external diameter of 100mm, the anchoring depth was approximately 2.4 meters (Fig.2).

The Fig.2 shows Pagani team during an anchoring procedure with the helical augers

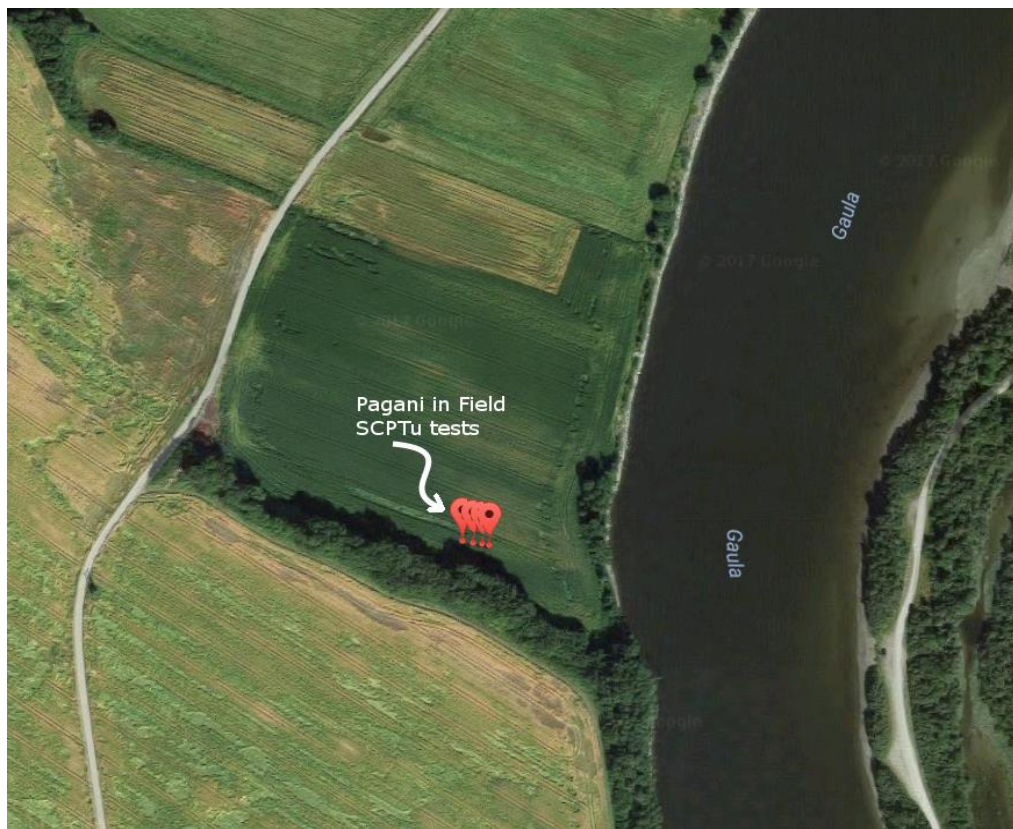
Fig.3: Test location at Øysand site

Pagani team started to perform the tests in Øysand (September /27, 28/ 2017) Fig.3. The information available from NGI were (further information from NGI where added during the tests):

- Soil type: Sand, gravel layer at 4/5 m below ground
- Testing depth: approximately 20-25 meters
- Number of tests: 4 tests (3 CPTu and 1 SCPTu )

The Pagani rig anchored into the ground with helical augers of external diameter of 220mm, the anchoring depth was approximately 2.4 meters (Fig.3).
