Technical Note

Design and performance of the Quxue asphalt-core rockfill dam [☆]

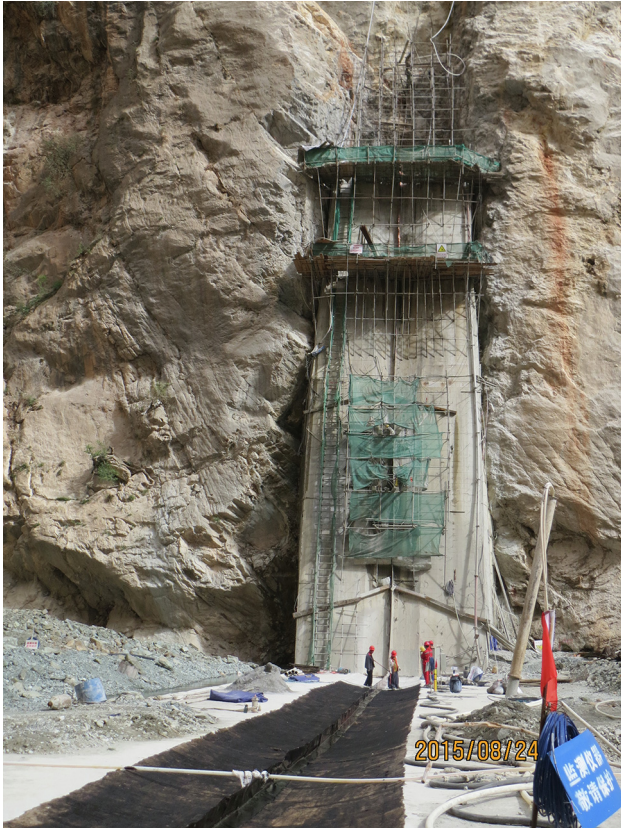
Fig. 2. View of the top of the foundation plinth and the plinth along the left abutment.

The concrete plinth along the abutments was placed on a clean and fresh surface of rock and was built in slabs with slab lengths of 7–10 m along the core centerline (Fig. 2). The construction joints between the slabs were sealed with rubber and copper water stops.

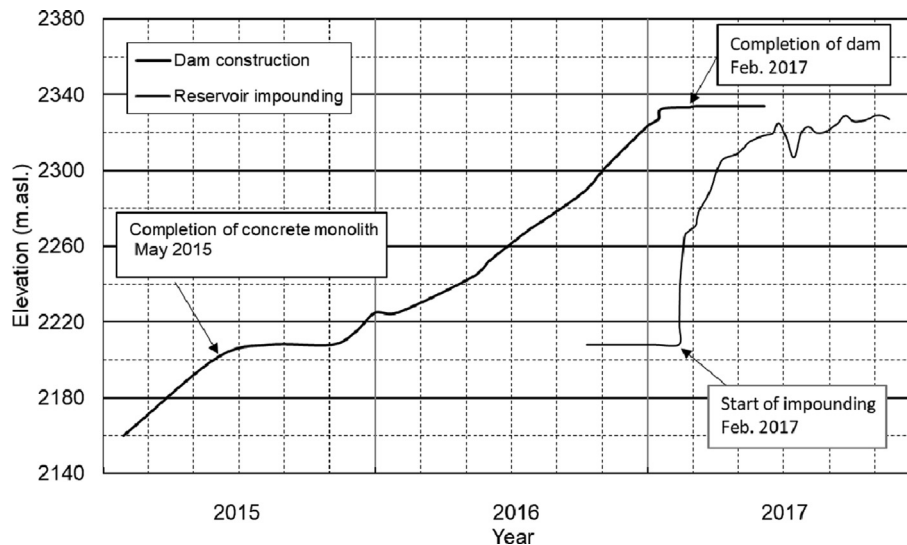
Fig. 4. Progress of dam construction and reservoir impounding.

completed 31 May 2015. Embankment fill construction started 13 April 2015, and the top of the asphalt core was reached 27 February 2017 at el.2333.35 m.asl. The design elevation for the top of core was el.2333.0 m.asl., but the core was built to el.2333.35 m.asl. to compensate for the estimated settlement after construction.

The reservoir impounding started on 12 February 2017 from el. 2208 m.asl., and on 17 June 2017 the water level reached el.2320 m.asl. which is 10 m below the NWL at el. 2330 m.asl. The water level at el. 2320 m.asl. was kept for the flood season from June to October. On 30 July 2017, the Quxue hydropower station started to generate electricity. In November 2017, the water level reached el. 2327 m.asl. only 3 m below the NWL. Fig. 4 shows the progress of dam construction, impounding and operation until November 2017.

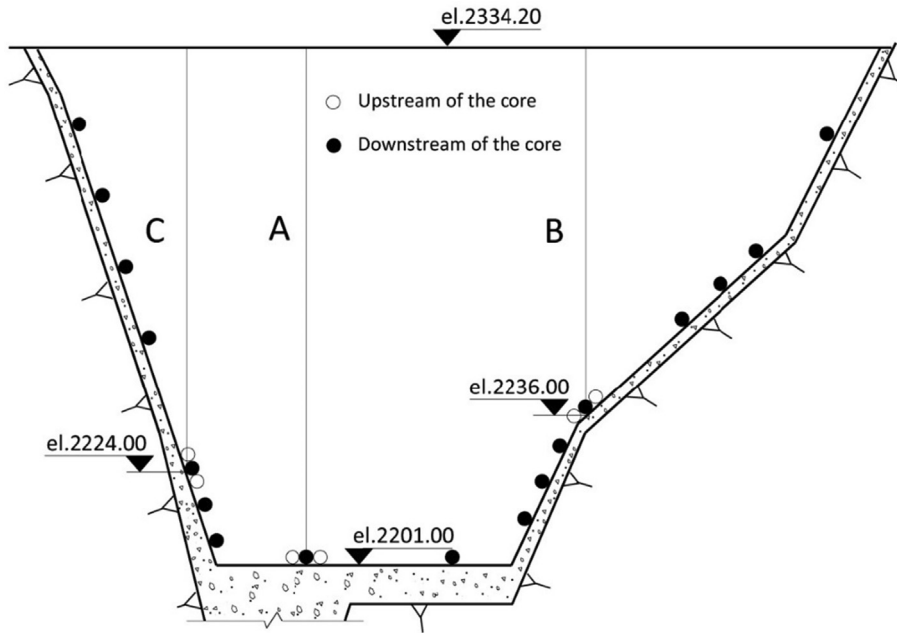
Twenty-five (25) piezometers were installed in the dam foundation and fourteen inside the dam. Fig. 13 shows the piezometers at the top of the concrete plinth and upstream and downstream of the asphalt core. The

Fig. 13. Piezometers at the top of the concrete plinth and upstream and downstream of the asphalt core.

piezometers on the concrete plinth were arranged along and parallel to the core center line. The piezometers located in the foundation in front of the grout curtain showed good correlation between the measured water pressures and the reservoir level during the impounding. The piezometers located under the plinth on the left bank showed pressure head increases of 0–20 m as a result of reservoir impounding while the piezometers located under the plinth on the right bank showed water pressures not significantly affected by the reservoir impounding. The piezometers located in the foundation in the left and right abutments and in cross-sections B and C behind the core wall, showed that the water pressures were not significantly affected by the impounding. The piezometers located in the foundation under the downstream shoulder along cross-section A (Fig. 6) showed a pressure head increase of about 6 m as a result of the impounding.
