Technical note

To: NVE
Attn.: Odd-Arne Jensen
Copy to:
Date: 2022-04-07
Revision no./Rev.date: 0 /
Document no.: 20200017-06-TN
Project: AARN - Applied Avalanche Research in Norway
Project manager: Christian Jaedicke
Prepared by: Peter Gauer, Henrik Langeland, Sean Salazar and Krister Kristensen
Reviewed by: Sean Salazar

WP 2 – Full-scale experiments at Ryggfonn Ryggfonn avalanche observations 2020/2021

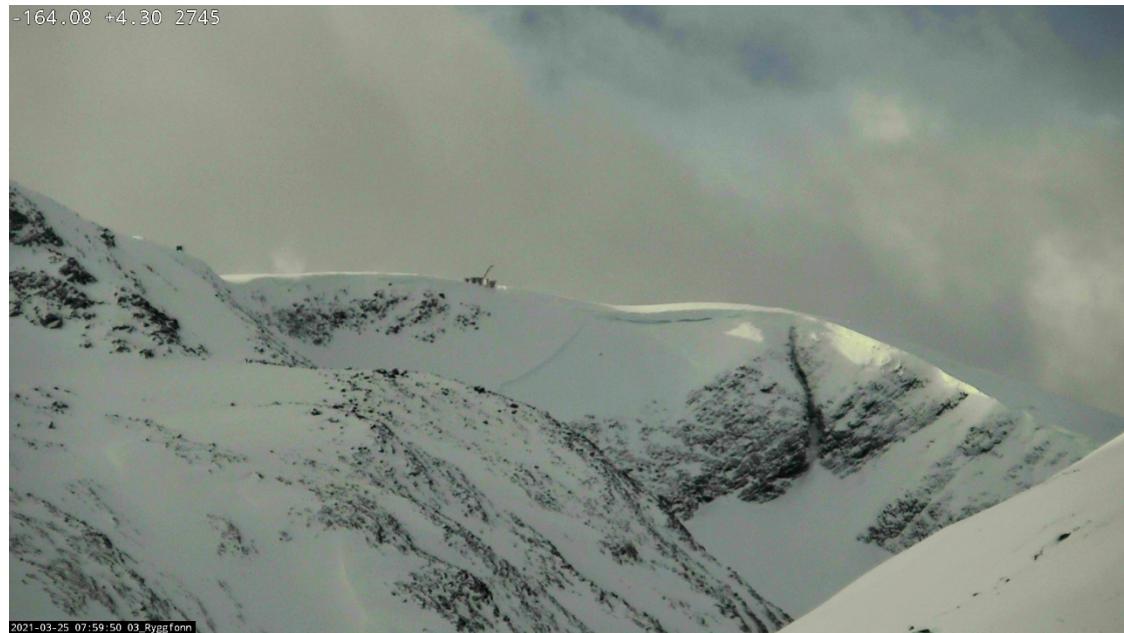
Figure 14 Release area after natural release on 2021-03-24 around 22:09 (photo 2021-03-25 07:59)

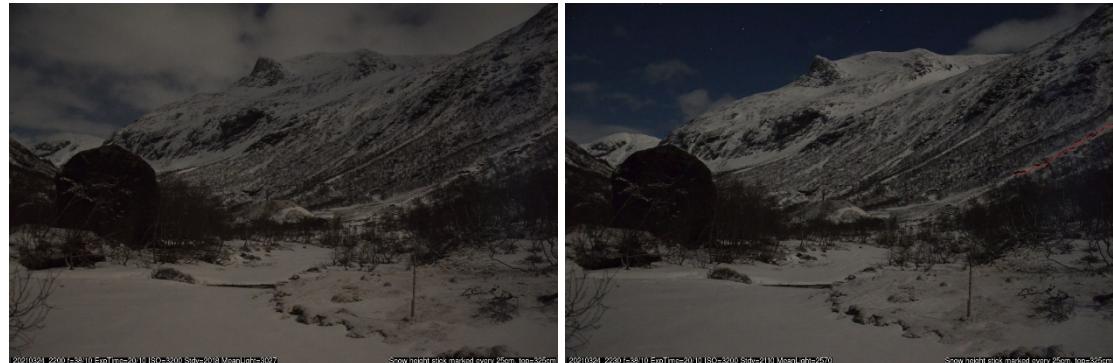
Figure 15 Image of the runout area before (2021-03-24 22:00) and after the release (2021-03-24 22:30). Deposits are indicated by the red line in the right photo.

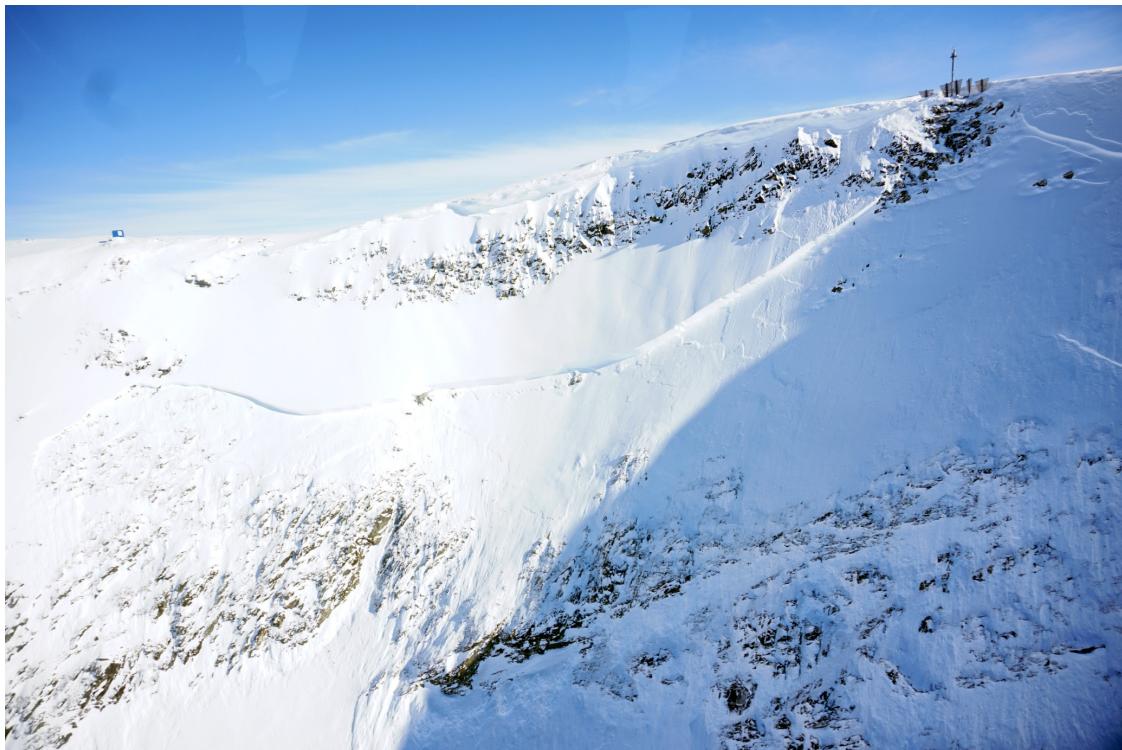
Figure 29 Release area after artificial release on 2021-04-11

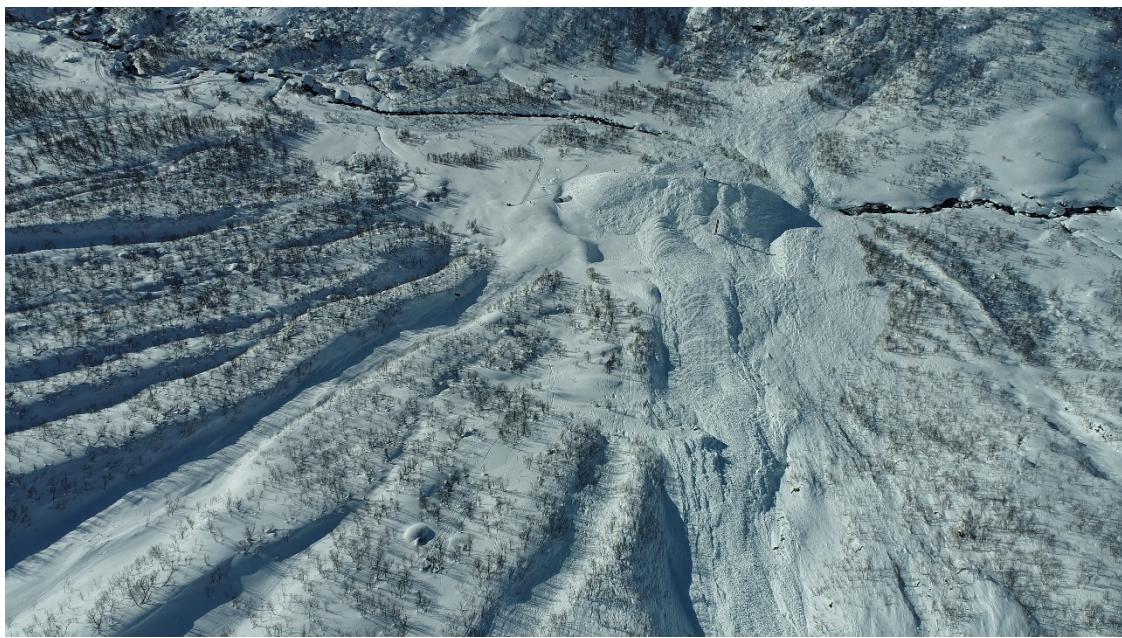
Figure 30 Deposition area after artificial release on 2021-04-11

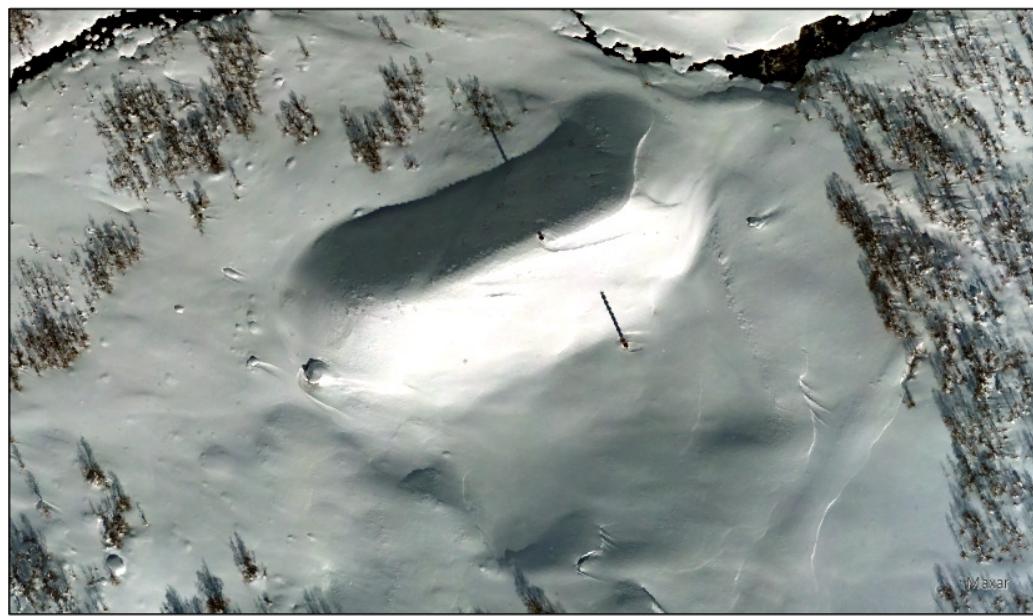
Figure 39 Drone image-derived orthomosaic of the retaining dam before (top) and after (bottom) the avalanche experiment on 11.04.2021.

approximately 16,500 m³ was estimated from the difference between the pair of independently georeferenced snow surface models (before, after the event, as depicted in Figure 36, Figure 37, Figure 38) while orthomosaics provided high-resolution overviews of the avalanche path (Figure 39, Figure 40).

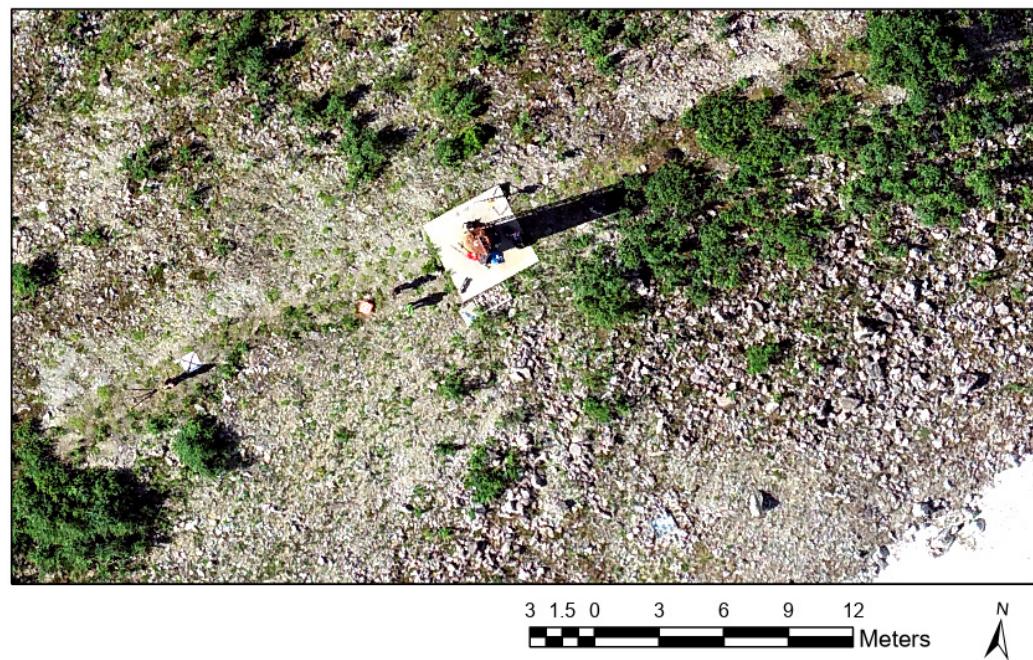
Figure 42 Drone image-derived orthomosaic close-up of the instrumented mast (M3) on the retaining after the avalanche experiment on 11.04.2021 (top) and in summer on 08.07.2021 (bottom).
