Avalanches in Longyearbyen Svalbard 2015 and 2017

ARNI JONSSON, CHRISTIAN JAEDICKE

Abstract:
Longyearbyen, the administrative centre of the Svalbard archipelago, is facing most types of natural hazards under a changing Arctic climate. The first indication in meteorological data of a change in climate was a heavy rainfall midwinter 1995/96, years before global warming of the Arctic was documented.

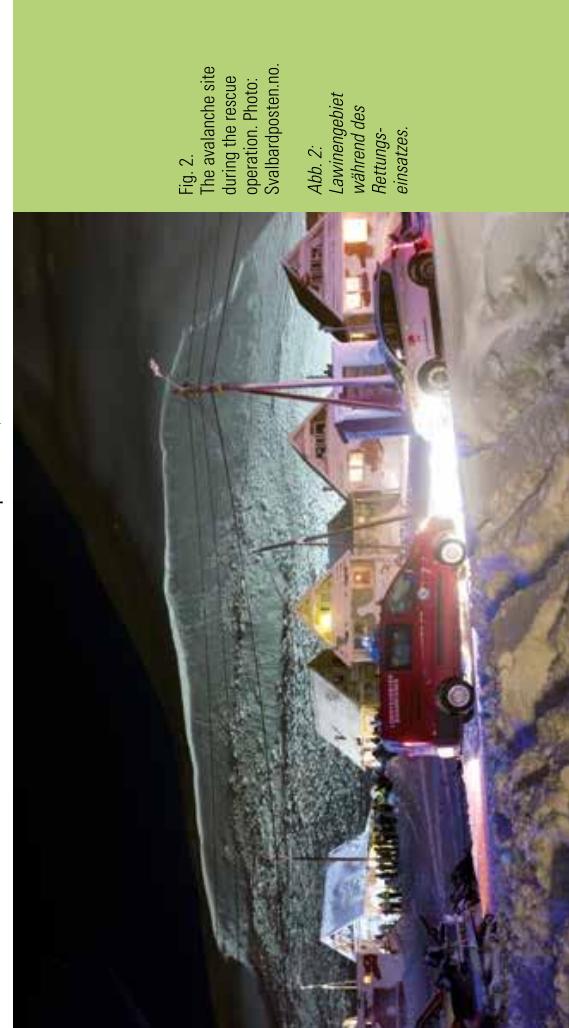
Fig. 2
The avalanche site during the rescue operation. Photo: Svalbardposten.no
Abb. 2:
Lawinenbedarf während des Rettungseinsatzes.

The avalanche hit eleven of the landmark "spisshus" (pointed-gable houses) from the 1970s and stopped against a few larger two-story houses to the southwest without damaging them. The four spisshus in the uppermost row were displaced by up to 80 m. In total, 19 persons were inside the houses during the event. Eight of them had to be hospitalized, an adult and a toddler died. Inhabit-

Due to permafrost, most buildings in Svalbard are built on posts and horizontal wooden beams (the foundation). The "spisshus" are built of rigid segments and connected to the foundation with thin metal stripes. When the avalanche hit the buildings, it was relatively easy task for the fatalities.

avalanche to rip apart the metal stripes and displace the buildings.

The buildings suffered various degree of damage during the displacement. Table 1 gives an indication on the displacement, rotation and fatalities. It also gives "serviceability" of the building i.e. how well a building serves as a shelter for the residents when it is hit by rapid mass flows/ movements (e.g. snow avalanches, slushflow/debrisflow, rockfall etc.). Our evaluation on "serviceability" is based on field a report which is short and incomplete. "Serviceability" is graded into five grades S1 to S5 or percentile where low percentile denotes "bad serviceability".

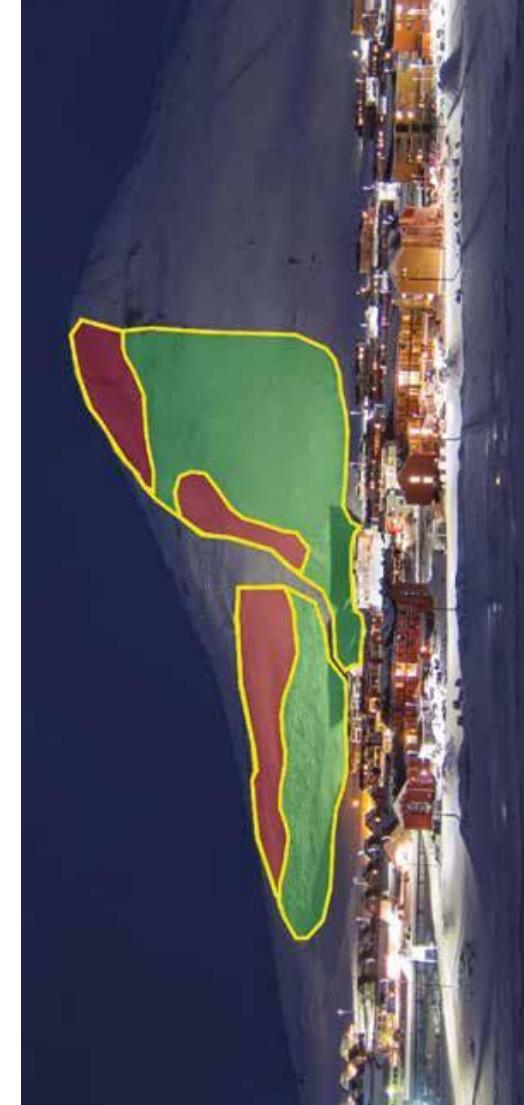
Fig. 3: Avalanche registered on Feb. 21st 2017. The red areas are estimated to be the release areas and the green is registered path and run-out zone. The area on the left is almost the same area as avalanched in Dec. 2015. Photo taken Feb. 22nd 2017 by Amt Remnan at the Governor's office adapted from (NVE, 2017)).

Fig. 3: Dokumentiertes Lawinenereignis vom 21. Februar 2017. Die roten Flächen stellen die angenommenen Abrutschgebiete dar, die grünen Flächen den Lawinenpfad und die Auslaufzonen. Die linke Fläche ist fast identisch zu der aus dem Jahr 2015. At the Governor's office adapted from (NVE, 2017)).

It is assumed that the initial release of the avalanche on the right in Figure 3 was at the top and depression to the left (red area). The time of release of the avalanche to the left (release area) is not known. An avalanche release from the top of Sukkertoppen (e: Sugartop) (approx. 370 m above sea level) has been noted earlier by local observers but the avalanches stopped on a small shelf high up in the mountainside. Also in the lower elevations in the mountainside several smaller avalanches have been registered. Apparently, the avalanche in February 2017 was the first to reach all the way from top to bottom in this slope after the area was inhabited. However, some reports have indicated that a release from the mountaintop is possible.
