Back-calculation of pillar foundation for Skjeggestad Bridge

Back-calculation of pillar foundation for Skjeggstad Bridge

Abstract. In 2015, a landslide incapacitated the expressway E18 in southern Norway because one of the large foundation pillars of the southern lane of Skjeggstad Bridge near Mofjellbekken failed. This accident immobilised throughway traffic between Oslo and southern Norway for 17 months until the bridge became fully operational again. This paper focuses on the adjacent bridge pillar of the northern lane which experienced substantial displacements during the landslide. The paper presents the back-calculated reserve capacity of the pile foundation immediately after the landslide occurred. This was essential to establish the impact of the slide on the foundation capacity and evaluate the safety of the northern lane for traffic. The paper is a companion of the paper presenting the two- and three-dimensional analyses of the landslide that occurred in Mofjellbekken. The software Trimble NovaPoint Geosuite was used for an integrated design approach examining the soil layering, selecting the soil parameters and doing capacity calculations on the pile foundation (and ca

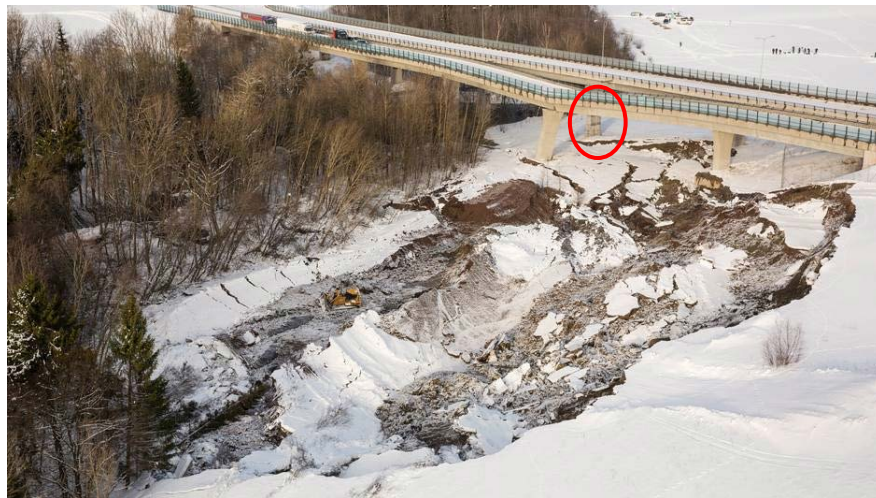
The landslide occurred on February 2, 2015 and damaged the Mofjellbekken Bridge (also called Skjeggstad Bridge). Fortunately, the traffic was stopped immediately, and no lives were lost. Figure 1 shows the extent of the 10 000 m³ landslide [5] and its effect on the bridge. The southern bridge got heavily damaged and had to be demolished and rebuilt. This paper focuses on the northern bridge and especially the bridge pillar at Axis 4 (red circle in Fig. 1), which was exposed to horizontal displacement, of 3-6 cm towards the south and 2-4 cm towards the west, as measured after the landslide. Based on an evaluation of the reserve capacity of the piles, the pillar was reinforced with jet grouted columns in 2015-2016 as permanent rehabilitation [7].

Figure 1. Quick clay landslide that caused failure of the Skjeggstad Bridge pillar. The investigated pillar, Axis 4 bridge, lies slightly outside the failure footprint and is circled in the figure (Photo: SVV 2015)

The Norwegian Water Resources and Energy Directorate (NVE) established an independent commission to investigate the cause of the landslide. Possible triggering actions investigated were erosion in the stream, rainfall events, traffic vibrations and the placement of new fill material on the slope. The inquiry concluded that the fill material placed at the slope crest caused the landslide [5].

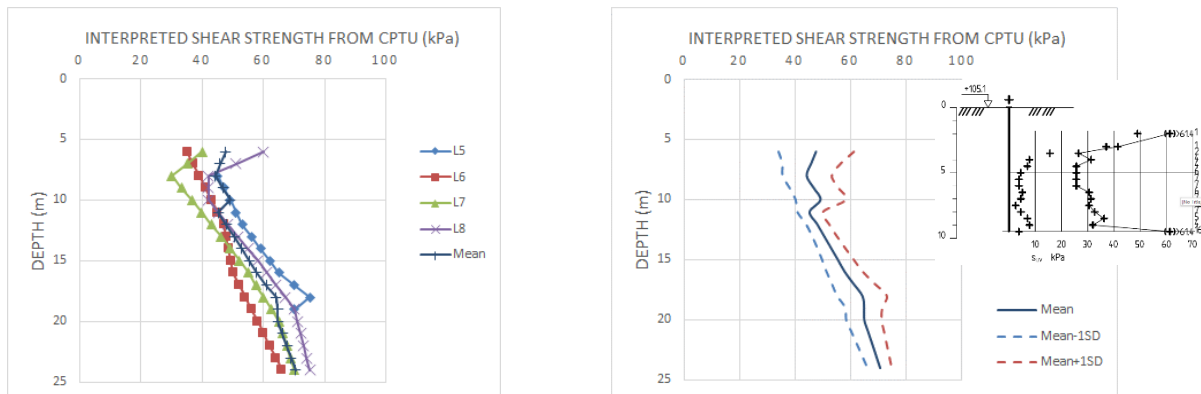
Figure 3 presents the results of the undrained shear strength interpreted from the piezocone tests (CPTU), using a cone factor N_{kt} between 10 and 14. The undrained shear strength interpreted corresponds to the triaxial compression strength (s_{uTC}). The figure on the right also shows the results of one *in situ* vane shear (VS) test run before construction of the bridge, but only in the top 10 m of the deposit (small inset

in right of Fig. 3). A statistical analysis of the CPTU results was carried out in the SDI (right figure) showing mean \pm one standard deviation. The coefficient of variation (COV, equal to the ratio of one standard deviation to the mean) was 15% below 7 m but could be as high as 30 % above 7 m. More discussion on the variation of the undrained shear strength across the site can be found in the companion paper [1]. For the present paper, the mean shear strength was adopted as a representative profile.

Figure 3. Active undrained shear strength at Bridge Pillar 4 from CPTU (left: 5 CPTU tests, right: mean \pm one standard deviation (SD); inset: result of one vane shear (VS) test close to Pillar 4)

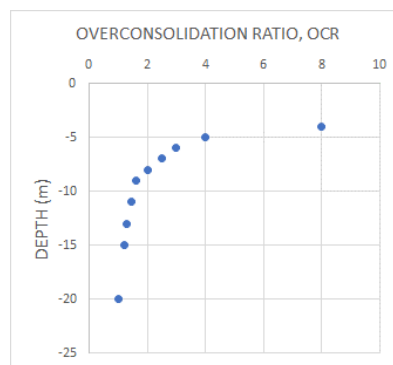
There were very few oedometer tests to estimate the preconsolidation stress and overconsolidation ratio (OCR). As a result, the OCR was established from the undrained shear strength in triaxial compression normalized with the effective overburden stress. This is evaluated in light of values for both Norwegian clays and clays in the literature [9]. The inferred OCR is therefore only approximate. Nonetheless, it was possible to obtain a reasonably looking approximate OCR profile with depth, as shown in Figure 4.

Figure 4. Approximate overconsolidation ratio inferred based on undrained shear strengths normalised with in situ overburden stress at location close to Pillar 4

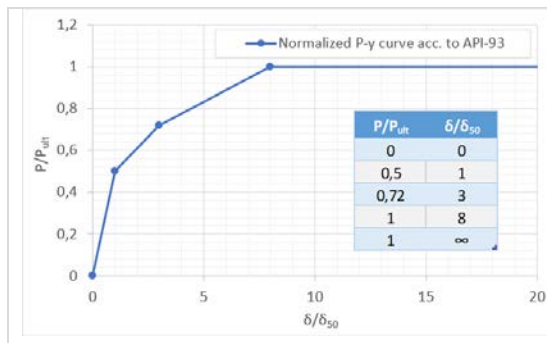
The API-93 method is based on Matlock [12] and is valid for small diameter (D) piles ($D < 2.5$ m). The approach is considered common practice and used for both onshore and offshore pile design. Figure 5 shows the normalized API-93 curve.

The static lateral resistance P_{ult} is given by $N_{ru} \cdot s_u$, where the lateral bearing factor, N_{ru} , depends on whether the failure of the surrounding soil is shallow or deep. API-93 suggests N_{ru} -values between 3 and 9. Shallow failure (a wedge mechanism) occurs when the effective overburden stress, p'_o , is small. The transition between shallow and deep failure is estimated through calculation of a transition depth, X_r , which is a function of s_u , γ' , diameter D and the constant J , with J varying between 0.25 and 0.50.

Figure 5. Normalized static P - y curve according to API-93 approach

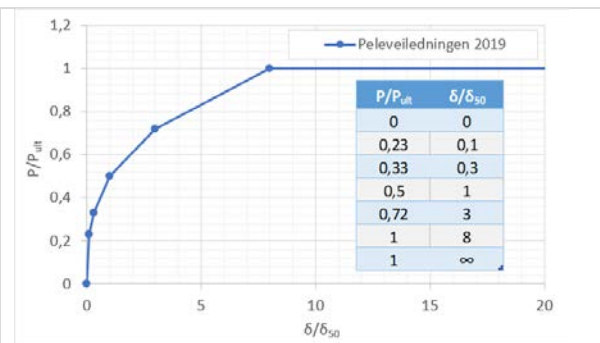
Peleveiledningen 2019 is a Norwegian guideline considered as best practice for pile design. The P - y curve formulation for clay is based on the same principals as given in API-93, except for two additional stress ratio points at levels ($P/P_{ult} = 0.23$ and 0.33) (Fig. 6). This curve is the same as suggested in the newer revisions of API and ISO-19901-4:2016 [13]. In terms of static lateral resistance, the P_{ult} suggested by Peleveiledningen 2019 is slightly higher than that from the API-93 method. The lateral bearing factor, N_{ru} , varies between 5 and 10 depending on the failure mechanism, where deep failure starts at a depth of $8D$ (i.e. 8 pile diameters).

Figure 6. Normalized P - y curve according to Peleveiledningen 2019

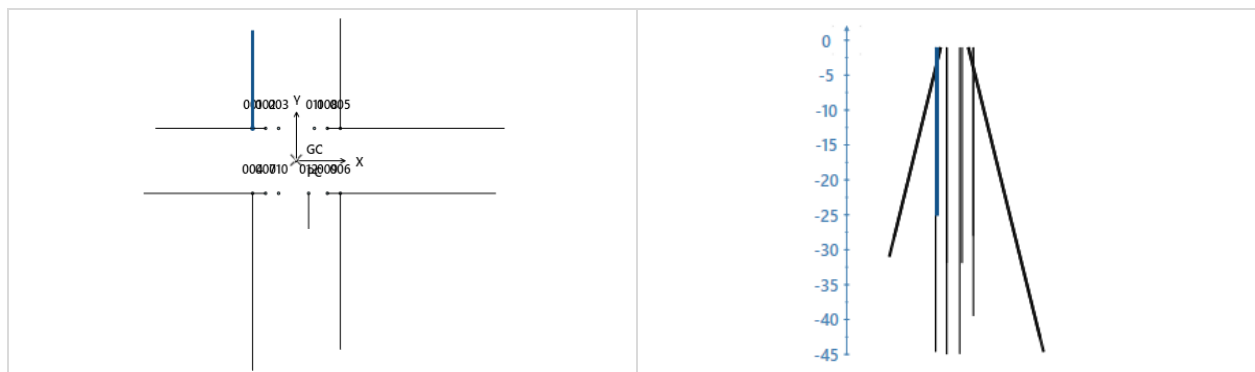
The Trimble NovaPoint GeoSuite Toolbox [2] assembles a series of computer programs especially developed for geotechnical design, including stability, settlement, bearing capacity, pile and excavation calculations. The module for pile calculations, GS PileGroup, was used for this study for simulating the interaction between piles in the pile group with the surrounding soil by means of different P - y models. The API-93 approach is a standard model in GS PileGroup, while the Peleveiledningen needs to be manually inserted at this time. The pile group in axis 4 was modelled 'as-built' with both vertical and inclined piles (Fig. 7).

Figure 7. Illustration of pile group in GS PileGroup (Left: plan view, Right: depth profile view)

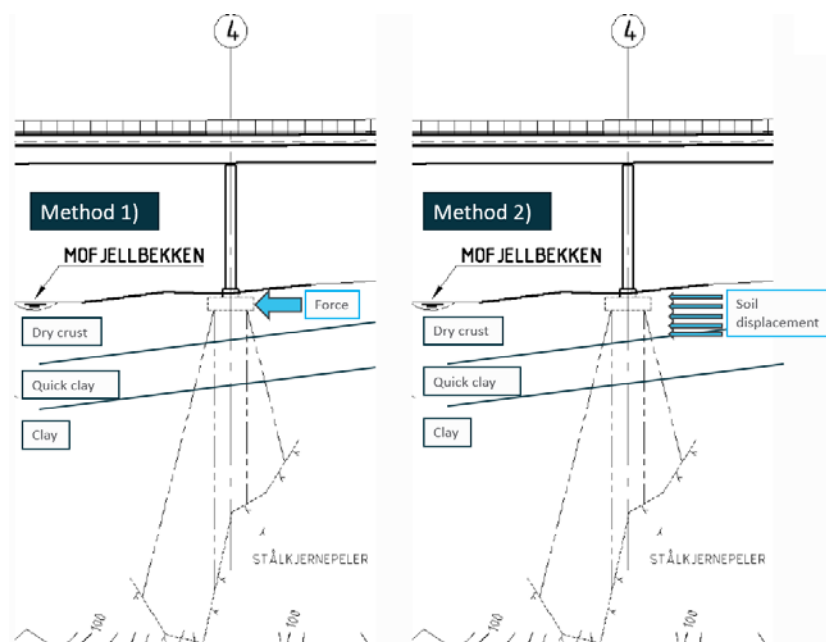
After the landslide, the top of the pillar foundation was observed to have been displaced horizontally 3-6 cm towards the south and 2-4 cm towards the west. For the back calculations, a lateral 5 cm displacement at the pile top was used. The pillar foundation was outside the landslide front, an important assumption deduced from this fact was that the landslide caused soil movement around the pillar foundation in axis 4 only in the top 5 m thick dry crust, down to the transition between the dry crust and the quick clay. If the soil movement occurred in the quick clay layer, the pillar foundation in Axis 4 would have been exposed to significant movements. To identify the effect of the soil movement on the pile cross-sectional capacity (Axis 4 pillar foundation), two methods were used (Fig. 8) with the following procedure (for both methods, the analysis included dead weight of the bridge):

- 1) Apply horizontal force at pile top resulting in 5 cm displacement at the pile top. This is referred to as "Applied force" method.
- 2) Apply soil displacement in dry crust, resulting in 5 cm displacement at pile top/dry crust. This is referred to as the "Applied soil displacement" method.

Figure 8. Illustration of bridge pillar, foundation system and analyses methods: left: Applied force method; right: Applied soil displacement method.

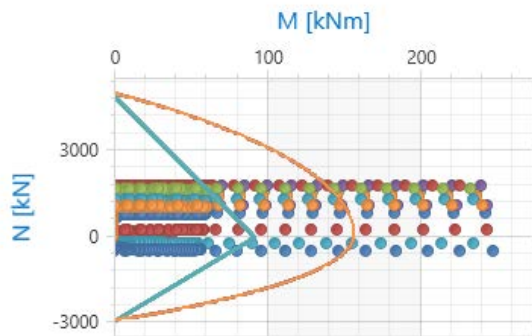
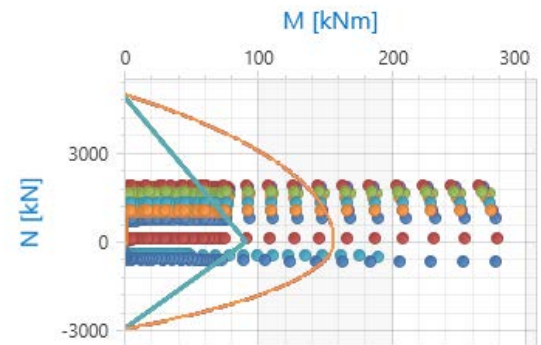
The results of the GS PileGroup calculations are presented in three figures: (1) pile group utilisation with the API-93 and Peleveiledningen (2019) guidelines, with $\varepsilon_{50}=0.02$ (Fig. 10); (2) displacement of

Figure 10. Utilization of pile group with API-93 and Peleveiledningen 2019, $\epsilon_{50}=0.02$: Outer yield curve represents the plastic capacity, linear curve represents the elastic capacity of pile cross-section, are the utilization of each pile node from pile top to toe. Each pile in GS PileGroup have different colours.

The back-analyses of the pile group under the pillar Axis 4 of the northern Skjeggstad Bridge showed a significant difference in pile cross-section utilization depending on the method investigated. A higher utilization was achieved for the case where the 5 cm displacement of the bridge pillar was modelled by applying a shear force at pile top ("Applied force" method), compared to the case where the 5 cm foundation displacement was achieved by applying soil displacement in the dry crust soil layer ("Applied soil displacement" method). Applying a shear force on the pile top creates higher concentrated bending stresses in the uppermost part of the pile, due to the dry crust supporting the piles with rather high stiffness with the Winkler springs. This results in higher pile cross-section utilization and thus forms a more conservative estimate of the pile group utilization directly after the landslide.

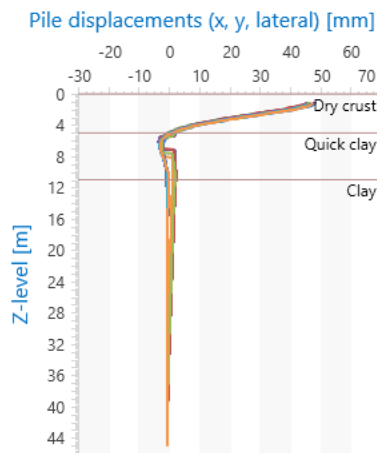
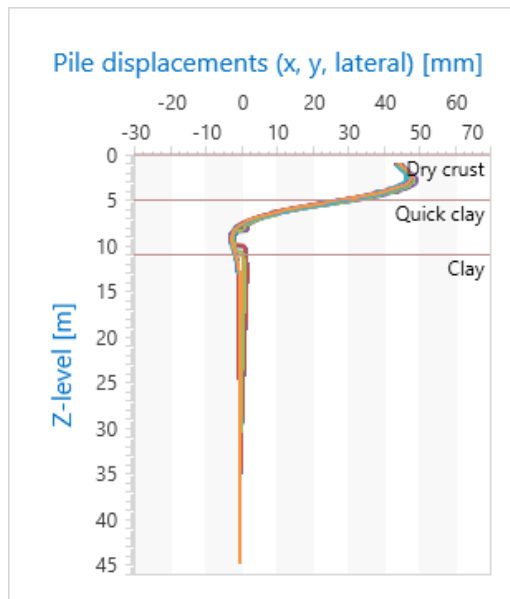
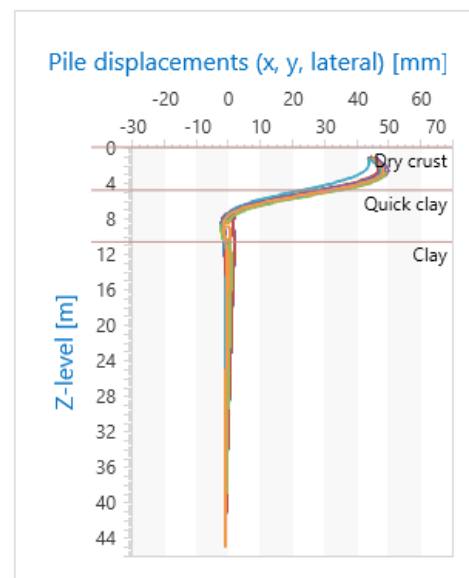
pile group with API-93 and Peleveiledningen (2019) guidelines, with $\epsilon_{50}=0.02$ (Fig. 11); and (3) pile group utilisation with the API-93 guideline, using $\epsilon_{50}=0.02$ and $\epsilon_{50}=0.006$ (Fig. 12). The two methods, the 'Applied force' and the 'Applied soil displacement method', are compared. The results suggest that horizontal forces of 3500 kN and 3880 kN are required to reach 5 cm displacement with the *p-y* curves from the API-93 and the Peleveiledningen 2019 approaches respectively. The required force to reach 5 cm displacement when using API-93 with $\epsilon_{50}=0.006$, was 4303 kN.

Figure 11. Displacement of pile group with API-93 and Peleveiledningen 2019, $\varepsilon_{50}=0.02$. The displacement of each pile is shown with different colours, as presented in GS PileGroup.

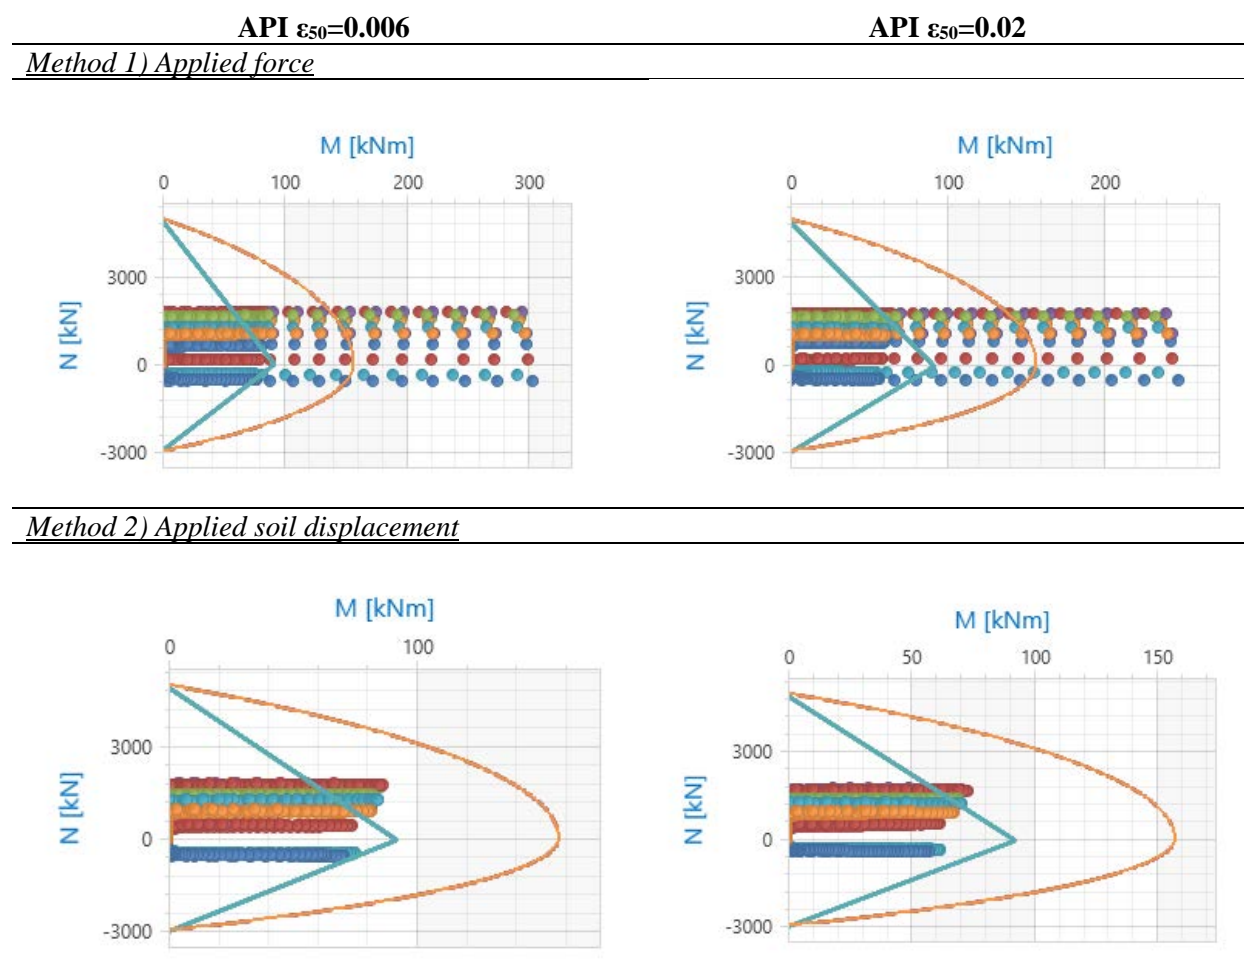
Figure 12. Utilization of pile group for API-93 using $\epsilon_{50}=0.02$. and $\epsilon_{50}=0.006$. The dots represent utilization of each pile node from pile top to toe.

The analyses also show that where soil displacement is considered as an action on the pile group, a stiffer Winkler spring gives higher pile cross-section utilization. Displacing a stiffer soil causes larger stresses in the pile compared to a softer soil. Since Peleveiledningen 2019 suggests stiffer springs at lower stress levels and slightly higher lateral bearing factor N_{ru} as compared to API, Peleveiledningen 2019 is believed to represent a more conservative model for the evaluation of reserve capacity after the landslide event.
