VULNERABILITY OF HOUSES AND PERSONS UNDER AVALANCHE IMPACT – THE AVALANCHE AT LONGYEARBYEN ON 2015-12-19

Dieter Issler*, Árni Jónsson, Peter Gauer, and Ulrik Domaas

Norwegian Geotechnical Institute, Oslo, Norway

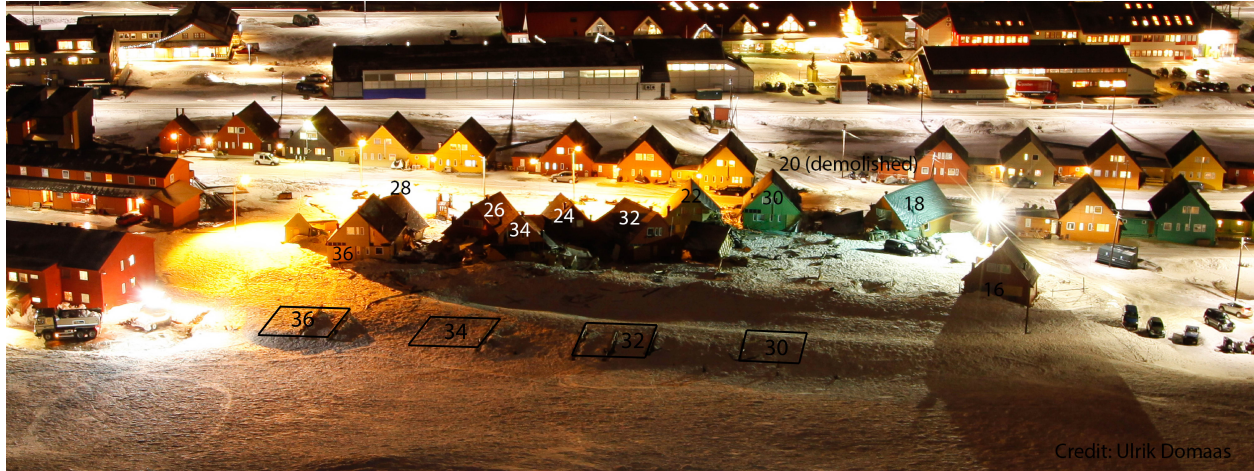
Fig. 2: Overview of the destroyed houses from the release area. The house numbers are the same as those used in Tbl. 2. For the four houses in the upper row, their original locations are shown as rectangles.

The avalanche hit eleven of the landmark “*spisshus*” (pointed-gable houses) from the 1970s and stopped against a few larger two-story houses to the southwest without damaging them. The four *spisshus* in the uppermost row were displaced by up to 80 m (Fig. 2), and all eleven had to be dismantled afterwards. In total, 19 persons were inside the houses during the event. Eight of them had to be hospitalized, an adult and a toddler died. Inhabitants of similarly exposed houses in Longyearbyen were subsequently evacuated.

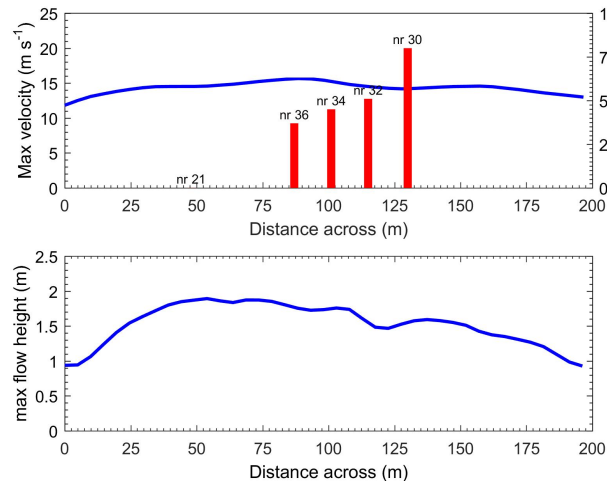
Fig. 4: Profiles of maximum velocity and flow height along the blue line in Fig. 3, from SW to NE.

Note that the cross-sectional profile along the upper side of the top row of houses (Fig. 4) indicates high values of velocity and flow depth at the location of house no. 21. However, no damage to this building is reported, and images show a moderate avalanche deposit against the house wall, contradicting the simulation result. We do not presently understand the reason for this discrepancy. As we will discuss in Sec. 4, the low degree of structural damage to, and short displacement of, house no. 16 indicates a similar effect along the north-western edge of the path.

Given the limited length of this avalanche, the calibration of RAMMS recommended by SLF is expected to also model the avalanche velocities reasonably. The simulated speed at the top row of houses is $12\text{--}15\text{ m s}^{-1}$, which appears plausible (Fig. 4). Unfortunately, there are no measurements of the deposit depth distribution, but again, at 1.5–2 m the simulated values are close to what we estimated from the available photos and the impressions gathered by one of us (U.D.) during field work two weeks after the disaster.

Another important question concerns the spatial variability of the flow depth and pressure. Figure 4 shows a cross-sectional profile of the maximum flow-depth and velocity across the width of the avalanche at the location of the upper row of houses. Superposing the rafting distance of the houses at their respective locations, one sees that

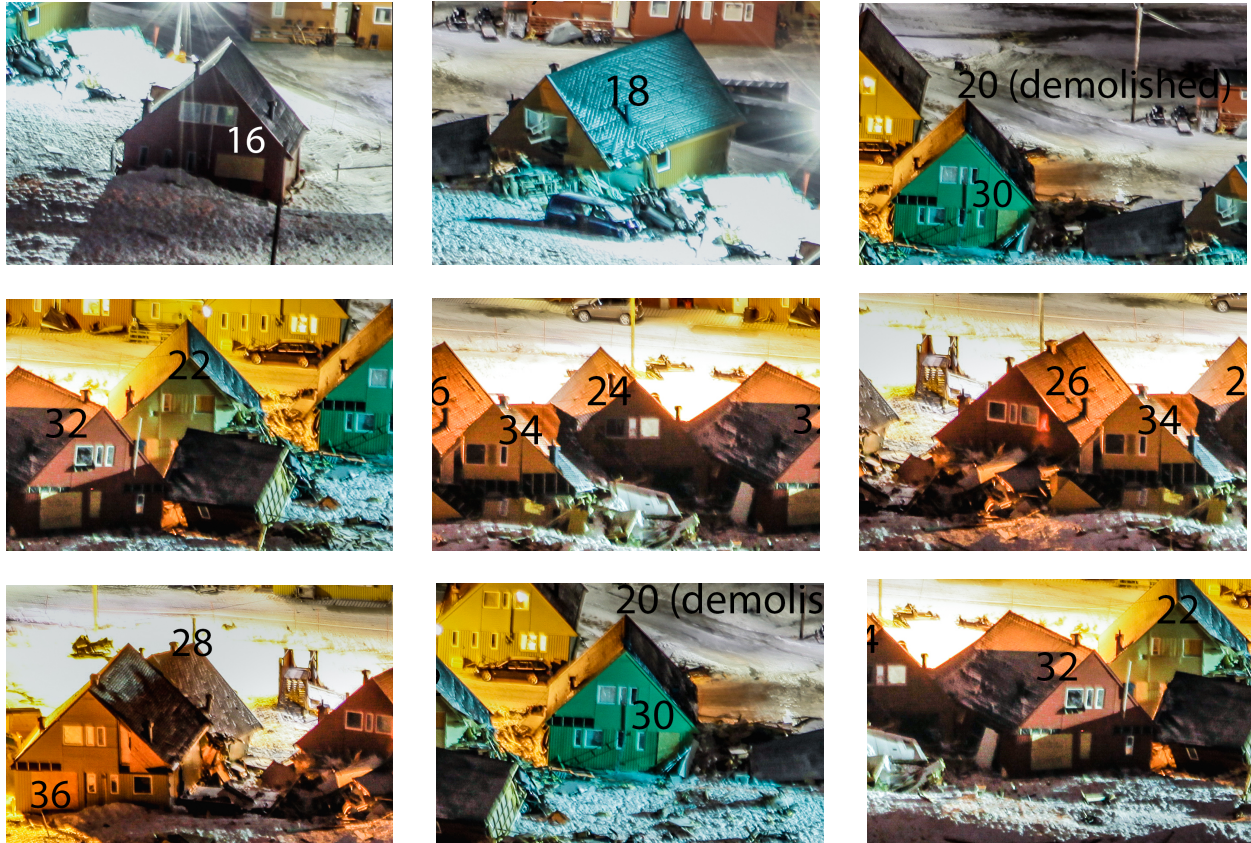
Fig. 5: Detailed views of the damaged houses (extracted from Fig. 2). The numbers correspond to those in Tbl. 2 and Fig. 2.

We have scant information on the structure of the connecting one-story structures between houses. Based on images, particularly the left-most of the middle row of Fig. 5, we conjecture that they were built upon a floor plate of some stiffness and that the roof also had a certain degree of stiffness. It is unclear whether all these connecting structures had side walls of their own and how strongly they were connected to the adjacent houses. The strength of these structures is probably somewhat inferior to that of a typical Norwegian wood-frame home. The avalanche impact completely destroyed most of the connecting structures between houses. Several of those in the upper row were torn to pieces and scattered over a considerable area, while those in the lower row were partly torn apart by their adjacent houses moving in different directions or by impact with a house from the upper row.

House no. 20 in the lower row was sheltered from direct avalanche impact, but hit essentially square on by no. 30. The damage was slight, apparently because the impact force could be transferred to the stiff floor and roof plates and the longitudinal walls. The house was nevertheless promptly dismantled because it came to rest on the access street to the third row of houses. House no. 28 received more damage because it was hit by no. 36 at an angle. Similarly, nos. 24 and 26 suffered considerable damage because their upper sides were hit by the corners of nos. 32 and 34.

The elevated position of the houses and their weak fixation to the foundation caused the avalanche to partly push, partly lift the houses from their foundations, sweeping them up to 80 m downstream. In particular, there was virtually no pile-up of avalanche debris behind houses no. 30, 32 and 36 (Fig. 5)—they seem to have been rafted along. Interestingly, these three houses show similar dam-

age to the outer hull at the sides of the lower gable area. This rafting generally reduced the structural damage in the upper row, but houses in the lower row were damaged more severely by collisions between houses than by the avalanche itself.

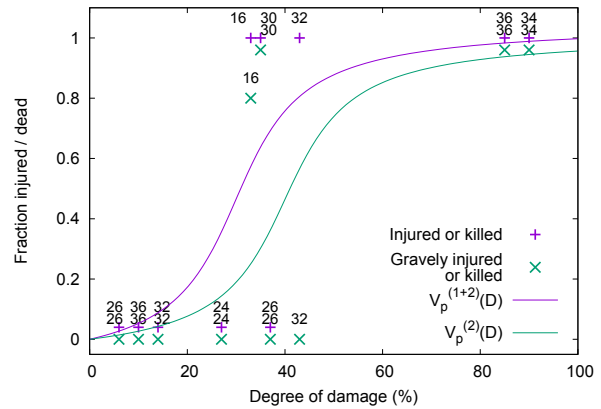
Fig. 6: Vulnerability as a function of the degree of (structural) damage: Fraction of moderately or severely/lethally injured persons in the 2015 Longyearbyen avalanche. The data is not differentiated according to age.

The basis data for plotting the vulnerability of persons in buildings against the degree of damage is given in Tbl. 2. In creating Fig. 6, we combined adults and children due to the small number of data points. On the other hand, we distinguished between people on the first floor of the house proper and the annex because the degree of damage is 90–100% for the latter, but rarely more than 50% for the former. The adult and child who lost their lives both were in an annex. In order to make the plot easier to comprehend, we plotted the *sum* of moderately, gravely and mortally injured people instead

of the moderately injured ones only; in this way, the curve is always coincident with or above the one for gravely or mortally injured victims, and the difference between the curves corresponds to the fraction of moderately injured persons. Moreover, we slightly changed the degree of damage and the number of affected persons in order to resolve overlaps of data points in the plot.

In buildings that are not occupied by a large number of persons, the fraction of injured persons has a strong tendency to be either 0 or 1. This is exemplified by our data set (Fig. 6): Except in one case (house no. 16), either all persons present on

Our data set is too tenuous and incomplete for firm conclusions about the shape of the vulnerability curves $V_p^{(2)}(D)$ for grave or lethal injuries and $V_p^{(1+2)}(D)$ for moderate to lethal injuries. We nevertheless venture to show such curves in Fig. 6, but we caution that they were adjusted manually to guide the reader's eye and not determined by a comprehensive statistical analysis, for which well-established methods exist, see e.g. (Porter, 2016) for a pedagogical introduction.

Our data set is by far too small to allow firm conclusions on the form of the vulnerability functions, but the trends found appear reasonable, as exemplified by Fig. 6. As further events like the 1995 avalanche catastrophes of Suðavík and Flateyri in Iceland are analyzed in this way, the criteria and percentages given in Tbl. 1 will certainly need adjustment. But if the loss of protective capacity of the building indeed proves to be a useful independent variable for the vulnerability curves for people, it will be interesting to compare (i) the curves for snow avalanches against different building types, and (ii) the curves obtained from different natural
