SLUSHFLOW FORMATION, FLOW REGIMES AND CONSEQUENCES (Short version)

Erik Hestnes, Steinar Bakkehøi and Krister Kristensen
Norwegian Geotechnical Institute, Oslo, Norway

Keywords: Slushflow, snowpack, water level, formation, flow regimes, runout, hazard assessment

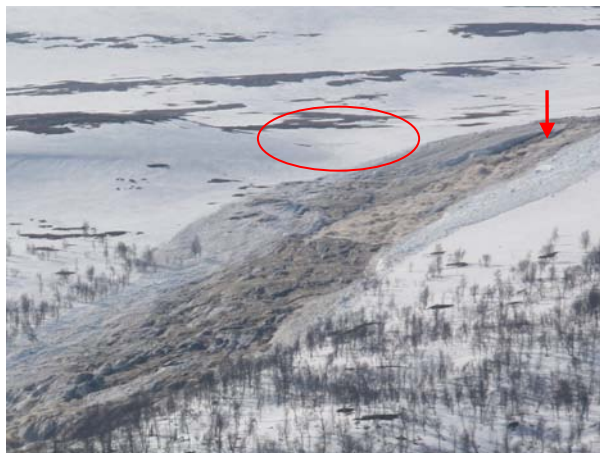
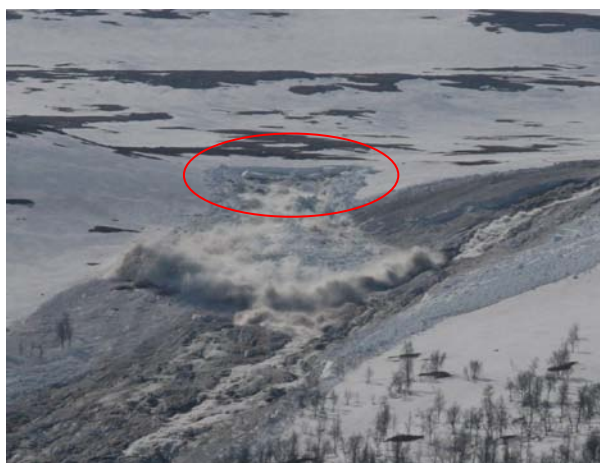
Fig. 2 Skarmodalen, Hattfjelldal. Three successive slushflows were released in the same basin. Top picture: The first on May 15 22:30, crown at arrow. The second released further to the right on May 16 08:41. Bottom picture: The third on May 16 09:27. A highly turbulent flow is documented both in the second and third flow, and a time-series of 22 pictures of the third slushflow exists. The top picture shows clean white snow within the track of the second slushflow, and no sign of a potential starting zone where the third flow was released. (Photo L. Fontain, Skarmodalen)

discussed in the literature are summarized. Among this are time-series of slushflows in motion and water level fluctuation in snowpack on uneven sloping ground (Figs. 2-3).

The water level in the snowpack rose above snow-height along drainages and on level ground, and was even seen on open sloping terrain (Figs. 3-4). Slushflows occurred in numbers, sizes and locations never observed before. Recurring events in the same path were common, and slushflows in motion were documented by unique time series (Fig. 2) (Hestnes 2010a-b; Jónsson 2010).

Slushflows in fully turbulent flow with saltation layer and air-borne part were documented by photo-series (Figs. 2, 9) (Hestnes 2010b, Pers. com.).

Distinct crown surfaces were formed when water-pressure suddenly released slushflows on slopes and fractured deep accumulations of snow located across their paths (Figs. 2, 10).

Most slushflows were full-depth only in the central part and flowed atop the adjacent snow surface along their flanks and in the runout zones. Clean white deposits were normal far outside areas of dirty deposits, i.e. far beyond future traceable slushflow deposits (Figs. 2, 4, 10) (Hestnes 2010 a-b; Jónsson 2010).

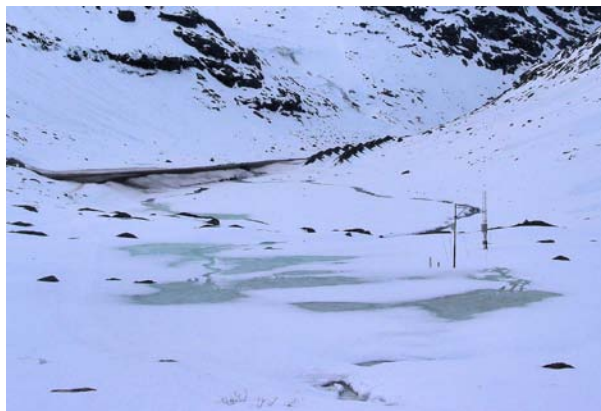
Fig. 3. A picture from a time-series of water level fluctuation in snowpack on uneven sloping ground. Snow-height variation 1.5-3 m. NGI field station May 16 20:24, 2010. (Photo K. Kristensen, NGI)

The unique time-series of water level fluctuation in the snowpack on uneven sloping ground has verified that shifting wind-loading, snowpack properties and local terrain and drainage conditions, are important factors determining the strength and stability of a water-saturated snow cover (Fig. 3).

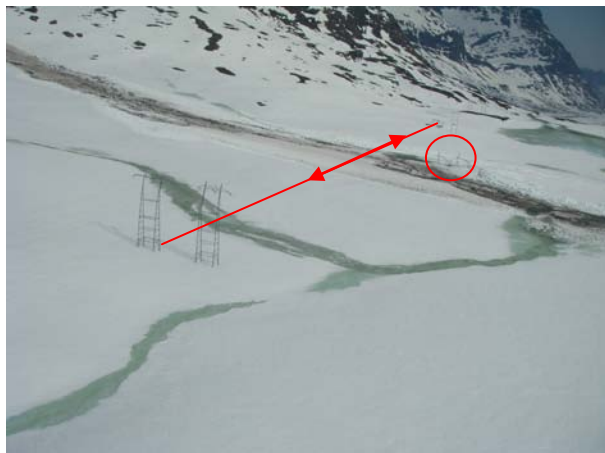
Fig. 4 Melhusskaret, Bardu. The twin 132 kV-lines are hit twice and moved 30-40 m by slushflow. Repair had to be postponed due to the high water level and critical stability of the snowpack. Both access route and working locations were unsafe. The slushflow path was 200 metres wide where the lines were broken. Only the central part of the path has dark and dirty snow with traces of mineralogical material. (Photo Statnett, Bjerkvik)

The power supply to the north-easternmost parts became vulnerable when the power-lines through one of the two corridors going north were broken by slushflows. Maintenance of the twin-lines had to be postponed until access route and working locations were safe (Fig. 4). Districts lost their electricity because local lines were cut off (Hestnes 2010a).

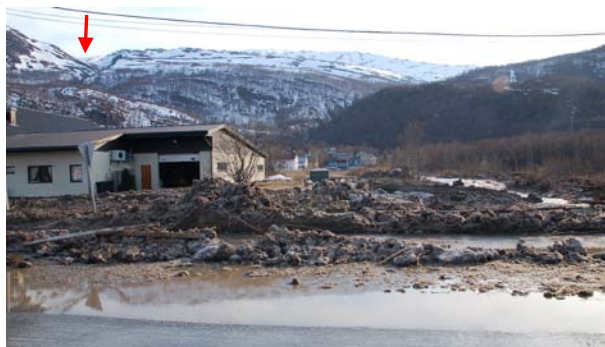
Fig. 5 Sørkjosen, Nordreisa, May 16, 2010. Slushflows released far up in the mountains flowed through the village along two streams and closed the main road E6 (foreground). 7-8 houses were evacuated. (Photo W. Bjerkmo, Sørkjosen)

Towns, villages and farms were affected by slushflows and floods. However, due to limited amounts of snow if any in the inhabited areas, the consequences were much less than expected, even though material damage and hampering of traffic were widespread. Evacuations were effected where slushflows threatened human activity (Fig. 5).

Potential hazard often build up in locations and at elevations not observable from the areas at risk. Elevation differences of hundreds of metres without snow and many kilometres in distance may separate starting zones and slushflow prone areas (Figs. 5-6).

Lack of visible signs where people live or travel can be fatal. Lack of records of rare events and often disregard for existing knowledge, is a general problem both in planning and safety work (Figs. 5-6, 8).

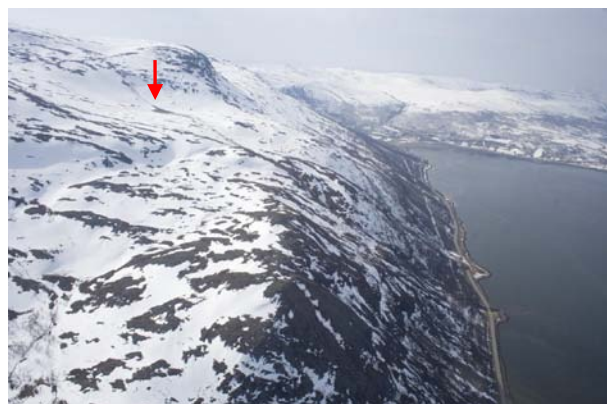
Fig. 6 Langfjorden, Alta. The E6 by the fiord was closed by slushflows from the plateau above at different locations. It is 800 km detour via Finland when this part is close. (Photo Á. Jónsson, NGI)

inspected and repaired (Fig. 6) (Jónsson 2010; Newspapers 2010).

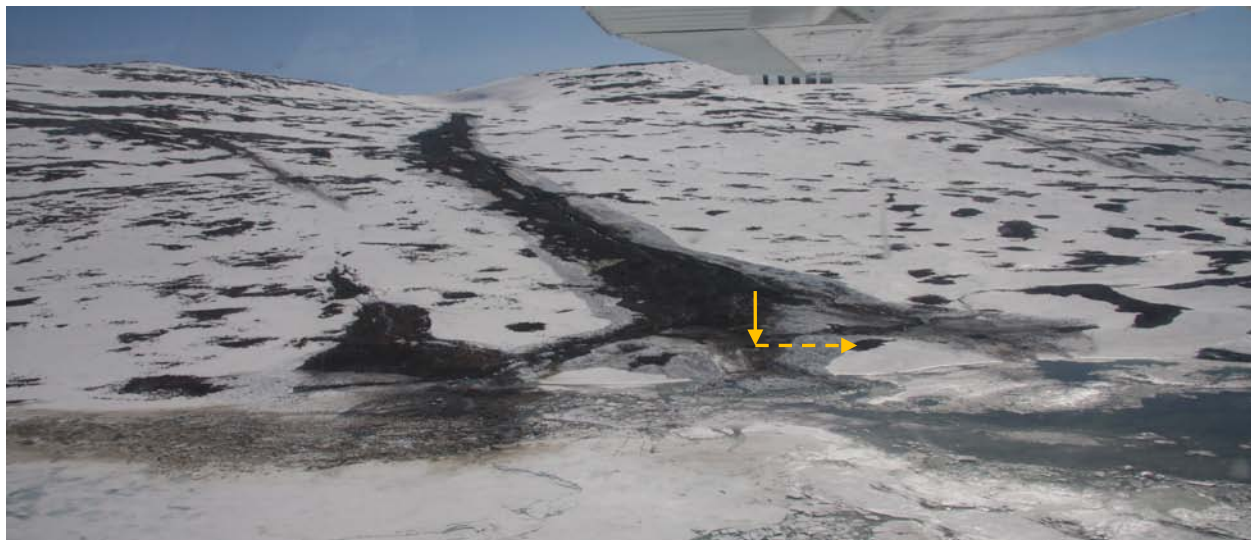
Fig. 7 Ranseren, Børgefjell National Park. Approximate location of campsite and the lucky choice of escape route. The slushflow reached the lake on both side of their stand by the fence. .Photo taken two weeks later by G. Prytz, Skarmodalen.

Other backcountry travellers survived in miraculous ways, among them three family members on a fishing-trip. Just when they were about to enter their tent for the second night, they heard a rumbling noise. They knew what it meant and run towards a slightly elevated spot some 30 metres away. They were stuck by a fence when the slushflow split and went on both sides, masses stopping less than 10 metres from their position (Fig. 7) (Pers. com.).

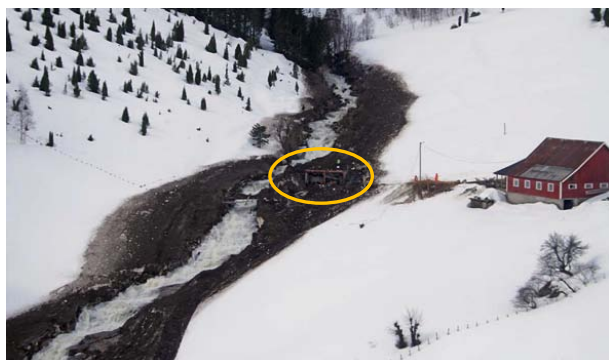
Fig. 8 Flesjaelvi, Balestrand March 21, 2011. A couple lost their lives when a house was hit by a slushflow. The house (circle) had been built without the compulsory hazard evaluation required by the Norwegian Building Code. (Photo U. Domaas, NGI)

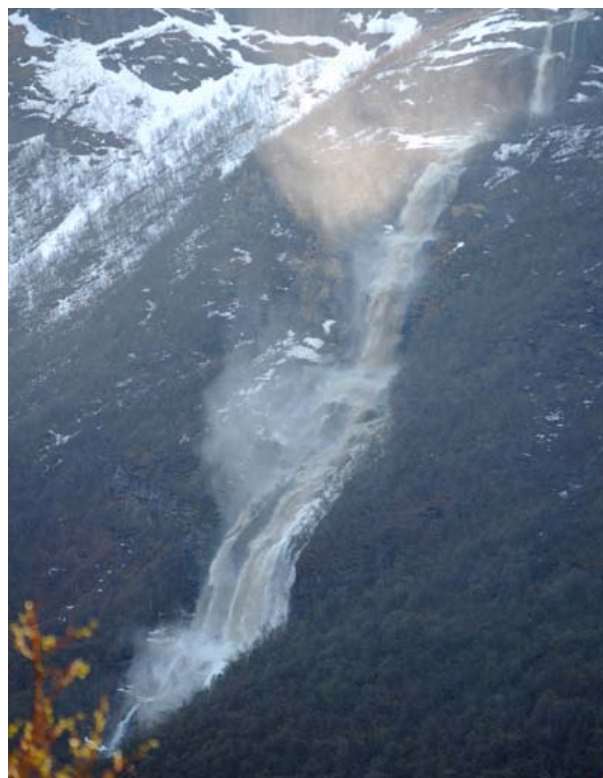
Fig. 9 Okselva, Kåfjord May 16, 2010. "The stream comes often in spring with a big crashing noise and rumble", i.e. slushflow. (Photo P. Lyngstad, Birtavarre)

Slushflows reaching below the snowline were normally black from entrained material, and sometimes the original snow might be gone. These circumstances often cause misinterpretation of the genetic origin of deposits. Worth mentioning in this context is the fact that many catastrophic floods in tributary drainages in valleys of Norway have originated from huge slushflows released in the catchment areas (cf. Fig. 9).

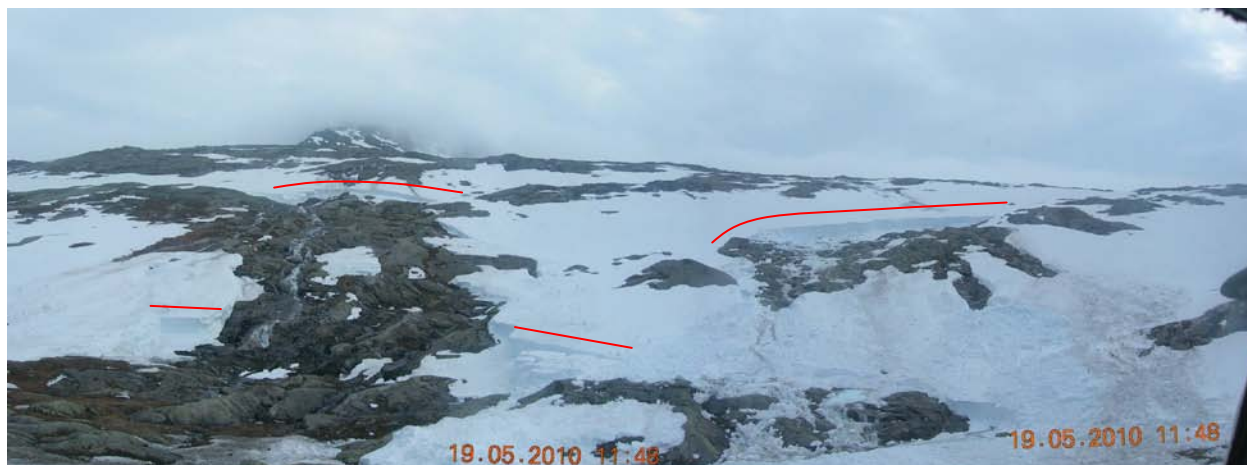
Fig. 10 Jamtfjellet, Grane. Remarkable crown surfaces across deep snowfields on relatively steep and open slopes were a common feature caused by sudden release due to high water-pressure. There were no indications of where and when such releases would occur. There was normally drainage somewhere under the snow, but the extensive water-supply by melting was probably of vital importance. Slushflows in motion also caused lateral fractures in deep accumulations. These fractures caused quite unforeseen widening of flow-paths on open slopes. (Photo E. Hestnes, NGI)
