To: NVE
Attn.: Odd-Arne Jensen
Copy to:
Date: 2021-03-22
Revision no./Rev.date: 0 /
Document no.: 20200017-05-TN
Project: AARN - Applied Avalanche Research in Norway
Project manager: Christian Jaedicke
Prepared by: Peter Gauer, Henrik Langeland
Reviewed by: Henrik Langeland

WP 2 – Full-scale experiments at Ryggfonn Ryggfonn avalanche observations 2019/2020

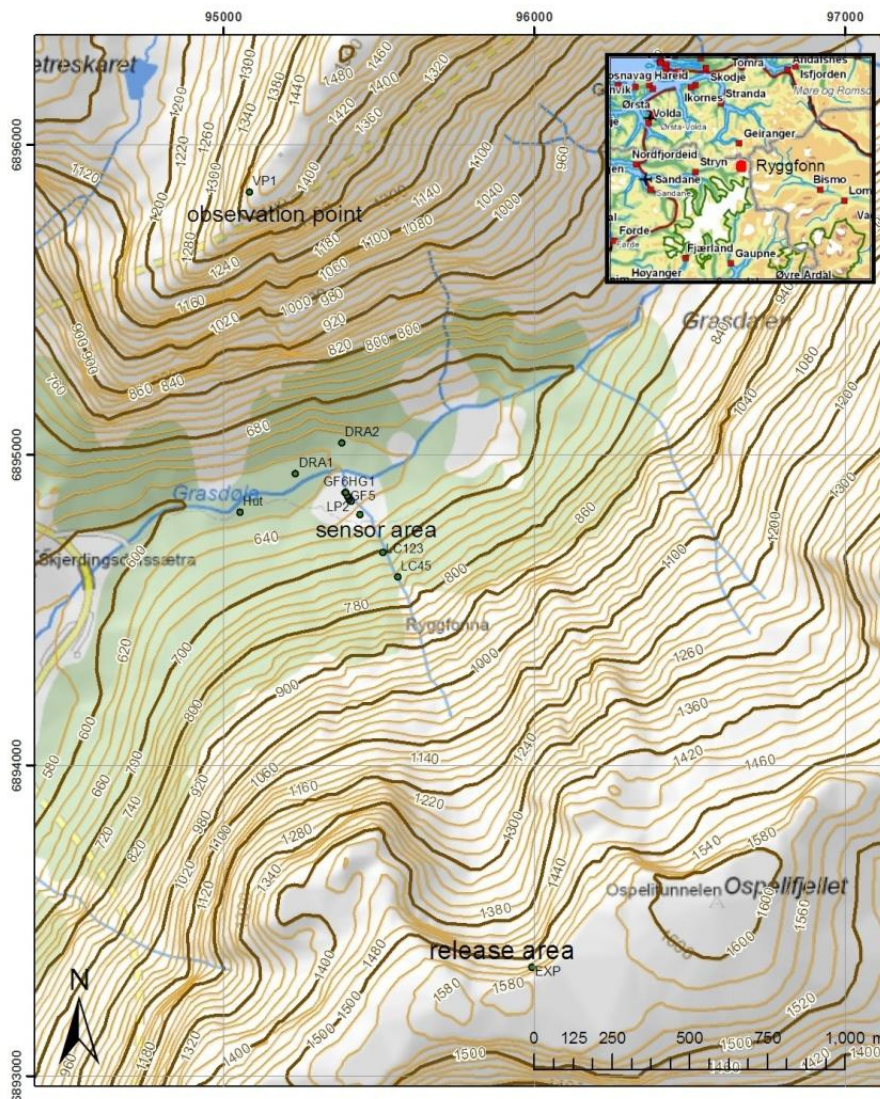
Figure 1 Map of the Ryggfonn test-site.

NGI's operating the avalanche test site at Ryggfonn near Stryn since early 1980s (Gauer et .et. al. 2010; Gauer & Kristensen, 2016, and refences therein). The facilities at Ryggfonn consist of the main and secondary avalanche tracks with a vertical drop of 950 m, a catchment dam at the base, and several instrumentation installations for monitoring avalanche dynamics. The current facility is one of only two in the world of this scale, and the catchment dam is a unique feature making this location the only place in the world where the efficiency of avalanche mitigation can be studied in full-scale.

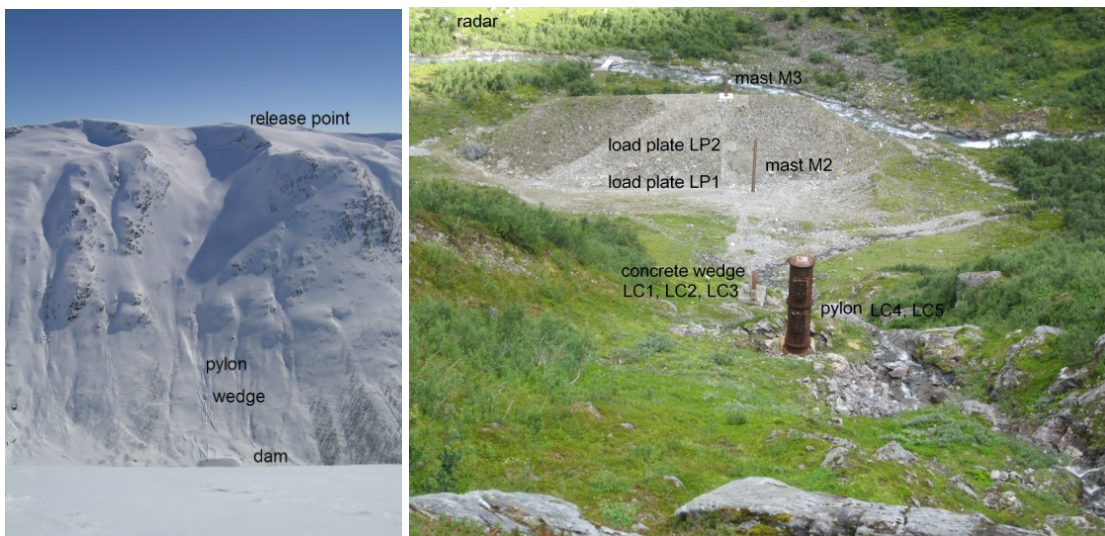
Figure 2 Existing NGI facility at Ryggfonn: (left) Avalanche track from the release area down to the retaining dam; (right) Example of sensor installations and full-scale pylon in the lower part of the avalanche track.

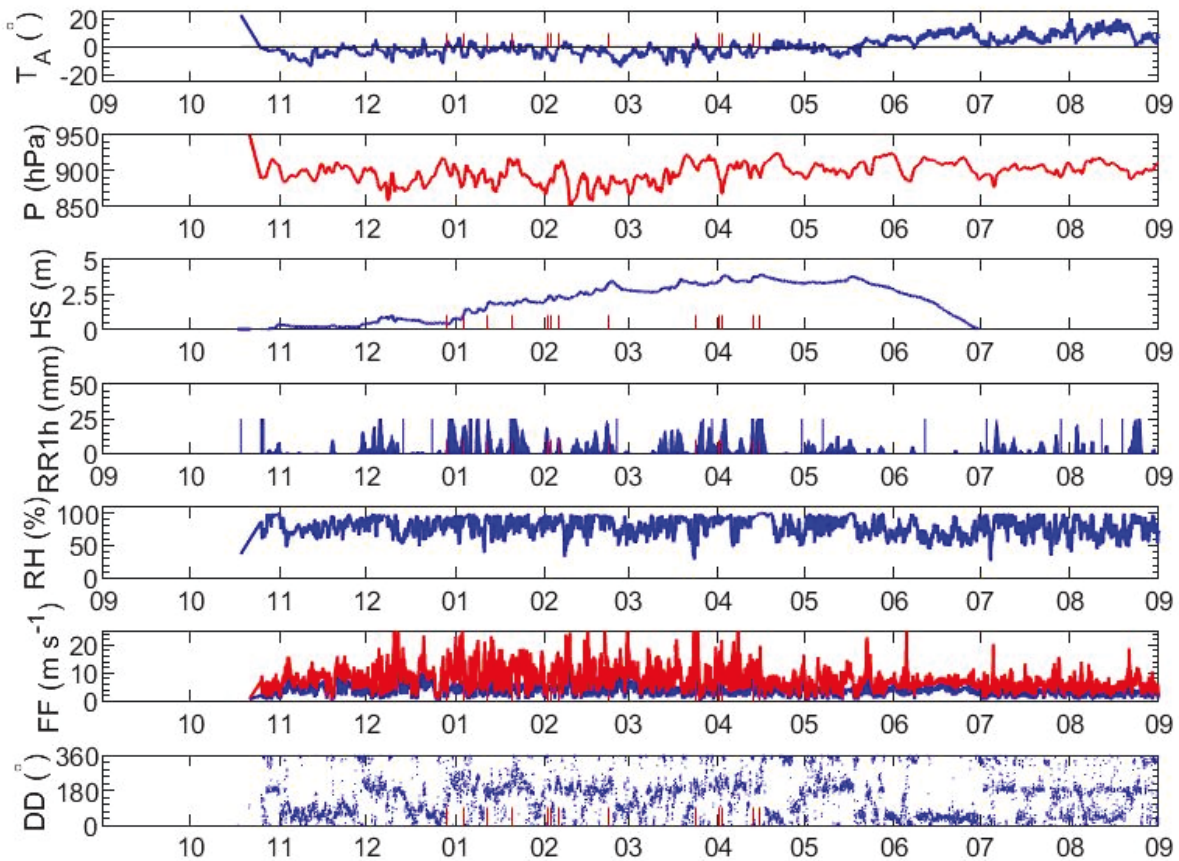
Figure 3 Overview of the major meteorological parameters (hourly data) during the season 2019/2020. The red stems in some of the plots indicate the date of the know avalanche event at Ryggfonn.

Figure 3 display an overview of major meteorological parameters throughout the season 2019/2020, with markers each month.

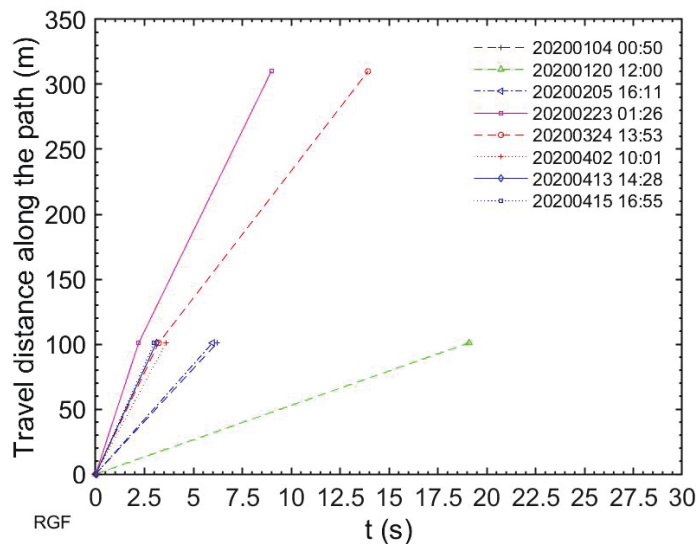
Figure 4 Timing of the avalanche. $T=0$ at the pylon, T_1 at concrete wedge, and T_2 at Mast #2(LC45, and LC123in Figure 1 and Figure 2).

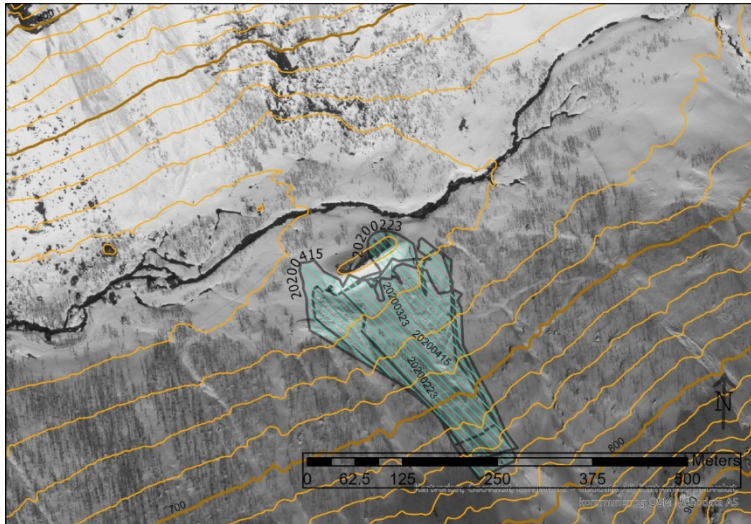
Figure 5 Deposition area of three natural avalanche events in 2020 based on brief field surveys; dates of the events are indicated.

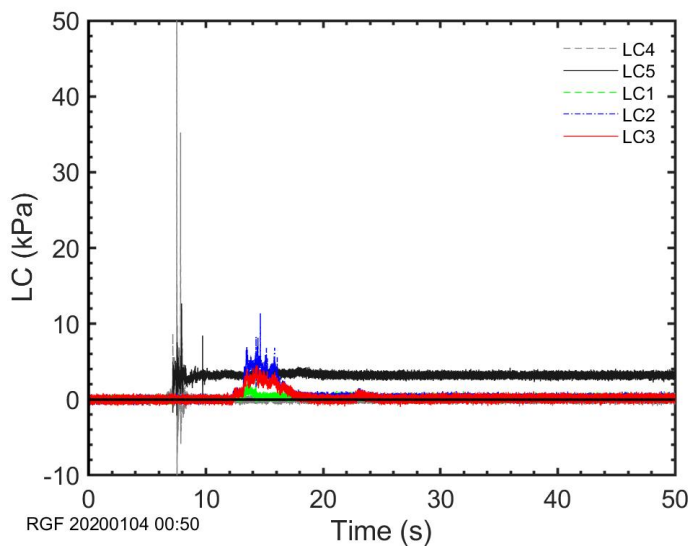
2020-01-04T00:50

Figure 6 Load cell measurement: pressure vs. time at the position of the tower (LC45) and the concrete wedge (LC123).

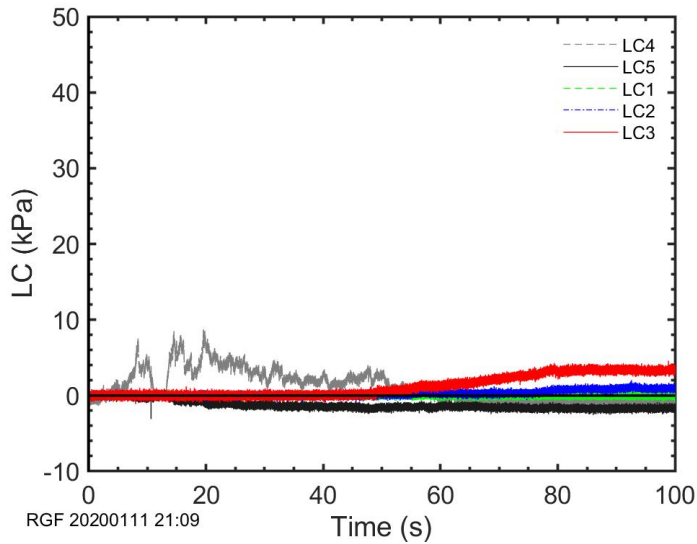
2020-01-11T21:09

Figure 7 Load cell measurement: pressure vs. time at the position of the tower (LC45) and the concrete wedge (LC123).

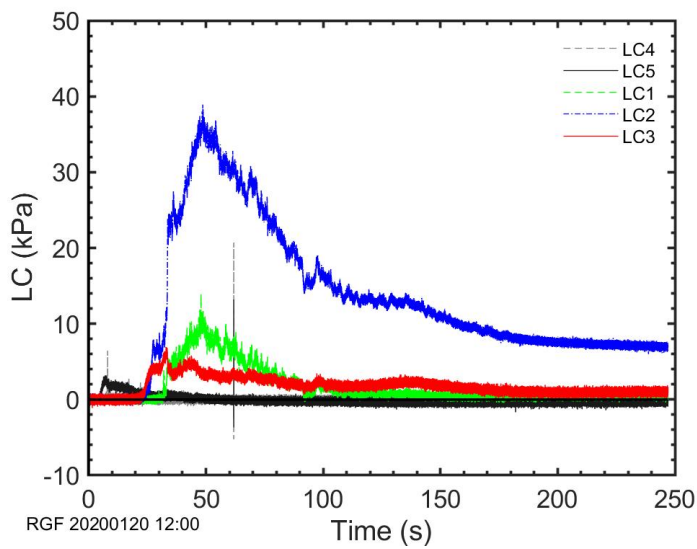
2020-01-20T12:00

Figure 8 Load cell measurement: pressure vs. time at the position of the tower (LC45) and the concrete wedge (LC123).

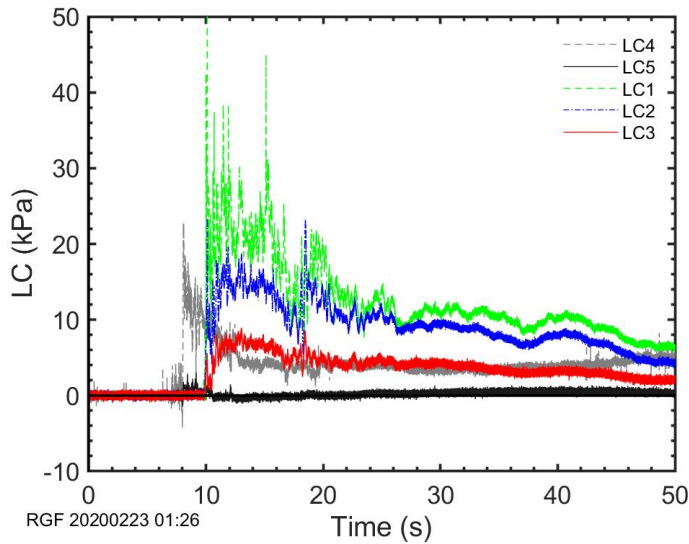
2020-02-02T07:23

Figure 9 Load cell measurement: pressure vs. time at the position of the tower (LC45) and the concrete wedge (LC123).

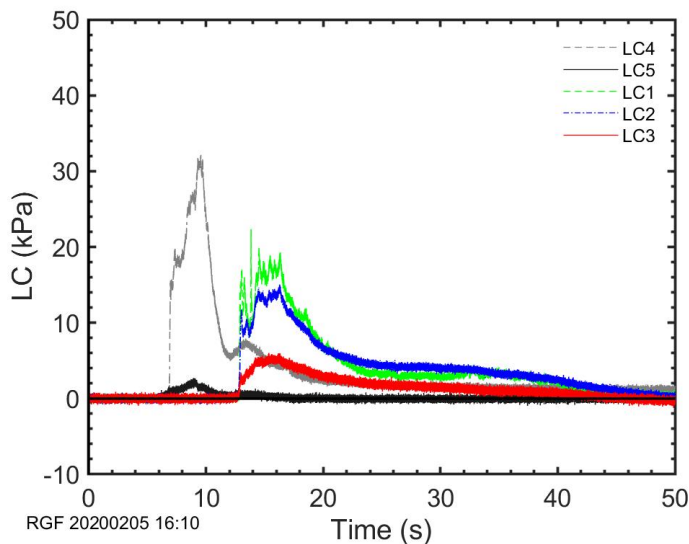
2020-02-05T16:10

Figure 10 Load cell measurement: pressure vs. time at the position of the tower (LC45) and the concrete wedge (LC123).

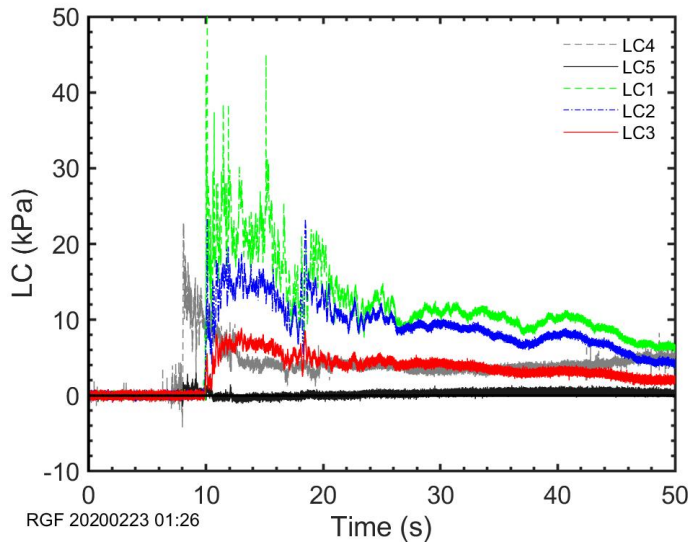
2020-02-23T01:26

Figure 11 Load cell measurement: pressure vs. time at the position of the tower (LC45) and the concrete wedge (LC123).

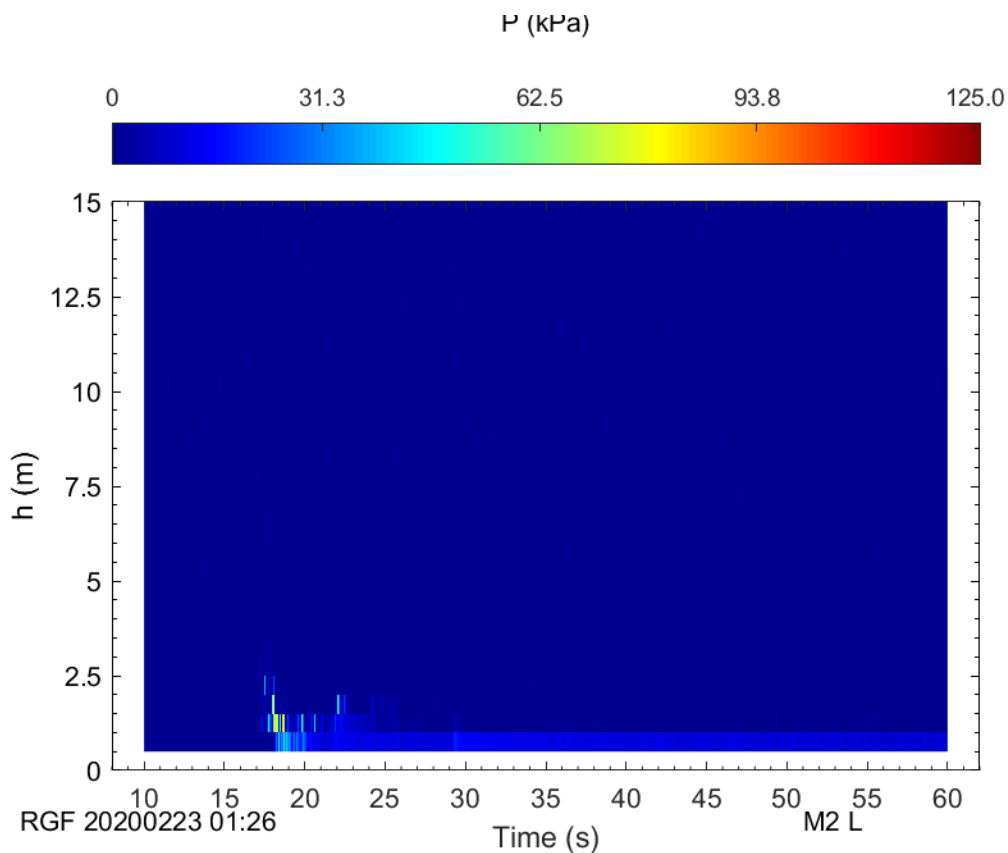
Figure 12 Load cell measurement: pressure vs. time at the position of Mast M2.

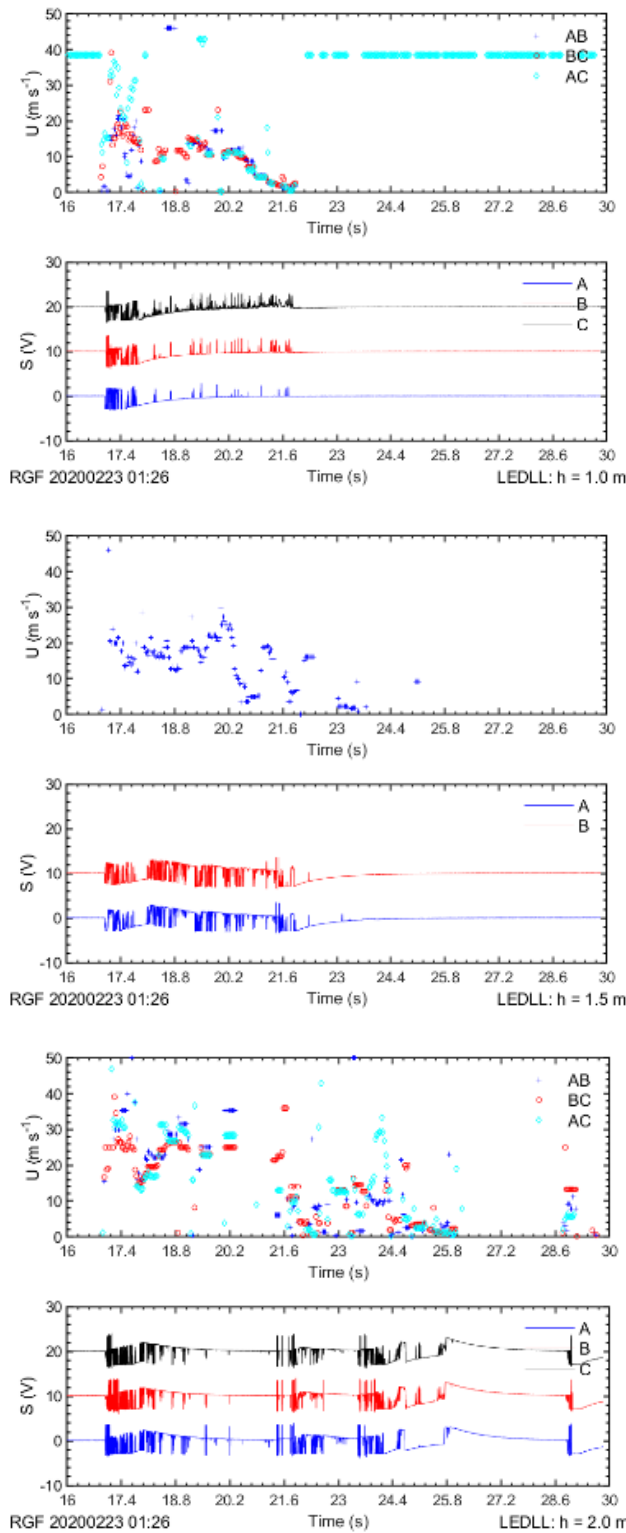
Figure 13 Preliminary velocity (U) estimates based on cross-correlated LED-data at 1.0, 1.5, and 2.0 m above ground. In addition, the raw data of the led-sensors are plotted.

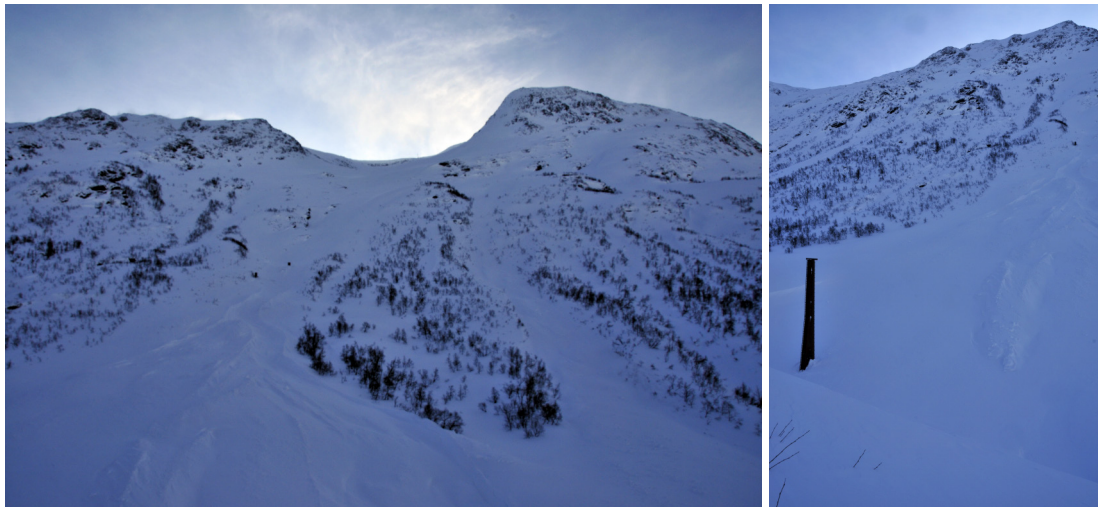
Figure 14 Track of the 2020-02-23T01:16 event; photo taken on afternoon of 2020-02-26 (photos Henrik Langeland).

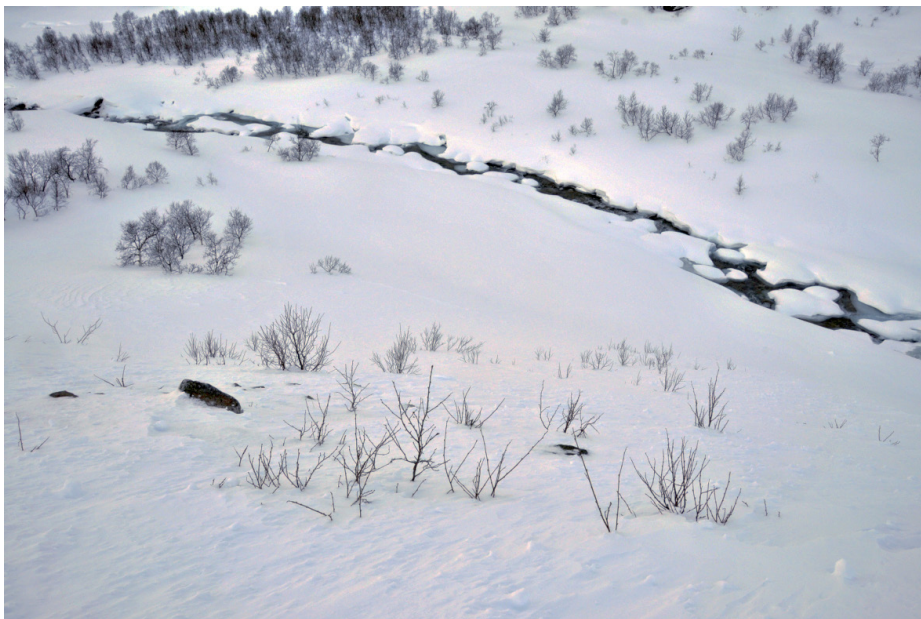
Figure 15 Back side of the dam after the 2020-02-23T01:16 event (photo Henrik Langeland 2020-02-26).

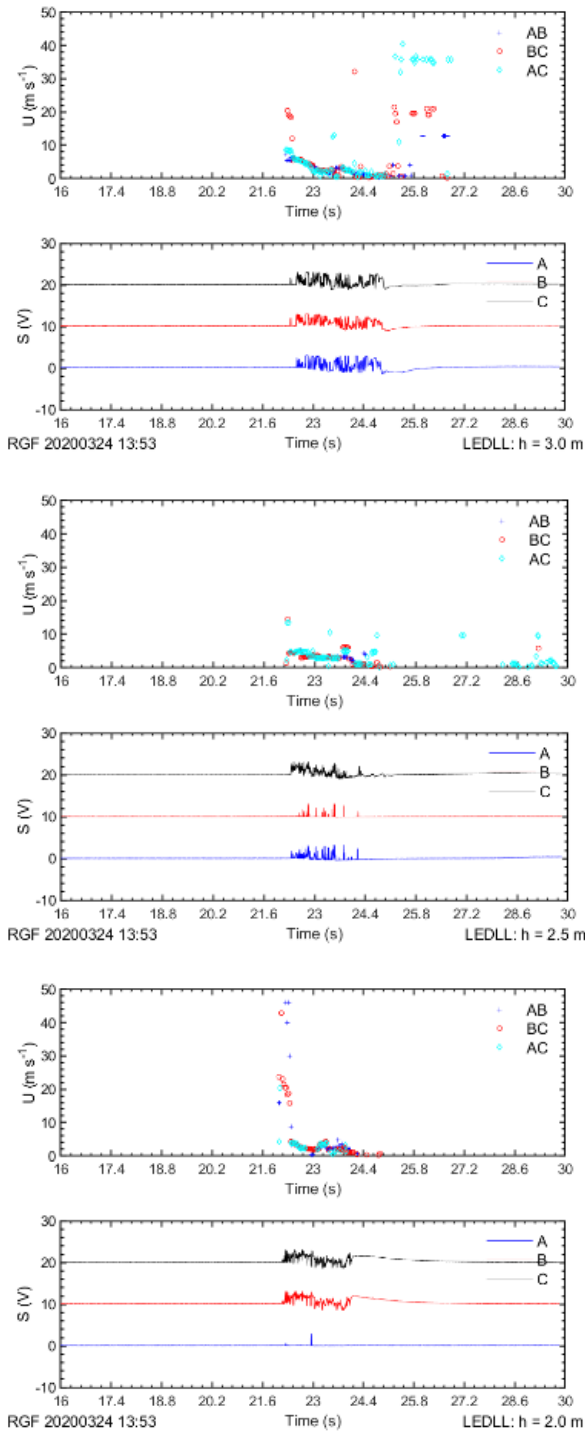
2020-03-24T13:53

Figure 16 Preliminary velocity (U) estimates based on cross-correlated LED-data at 2.0, 2.5, and 3.0 m above ground. In addition, the raw data of the led-sensors are plotted.

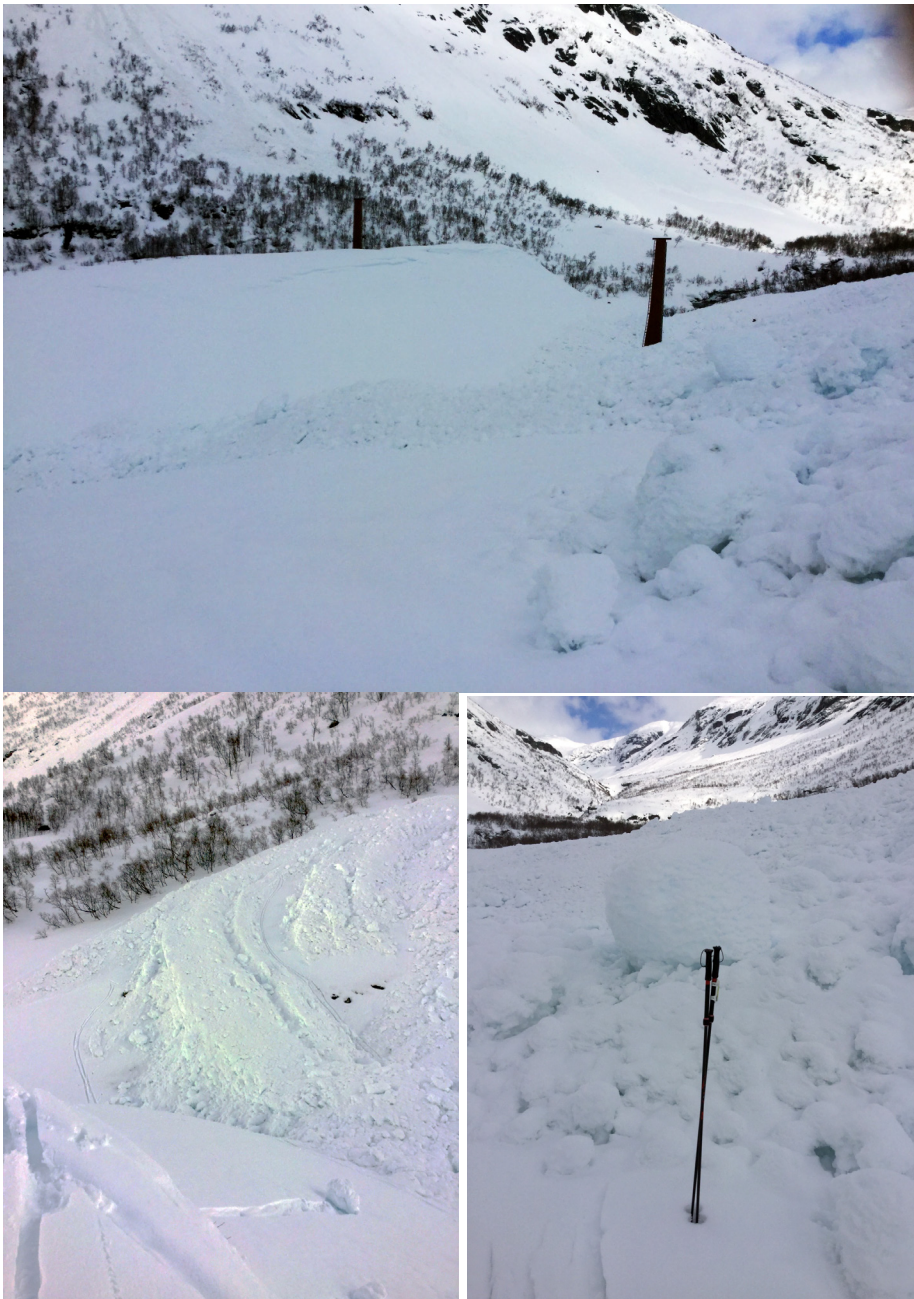
Figure 17 Deposition area of the 2020-03-24T13:53 event; photo taken on afternoon of 2020-03-26 (photos Henrik Langeland).

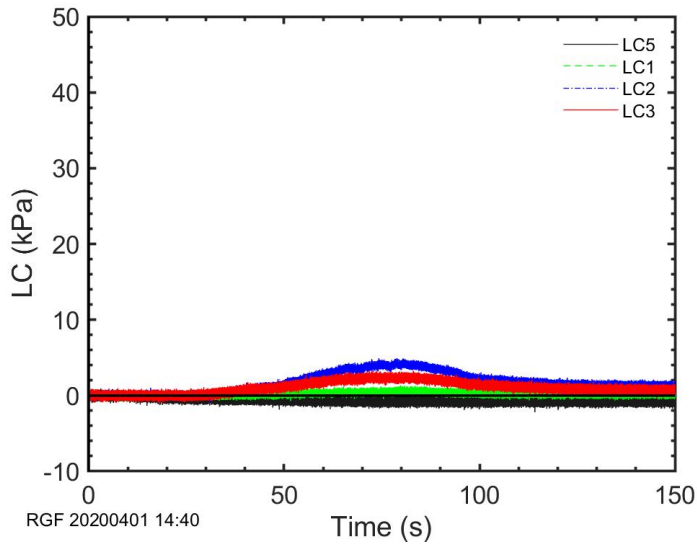
2020-04-01T14:40

Figure 18 Load cell measurement: pressure vs. time at the position of the tower (LC45) and the concrete wedge (LC123).

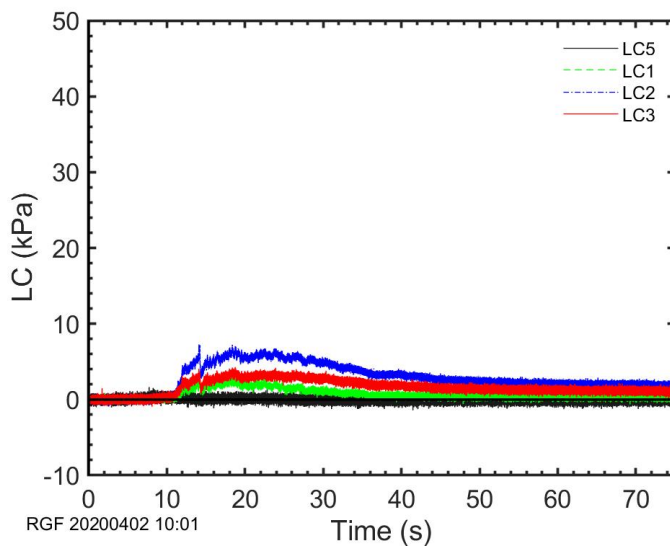
2020-04-02T10:01

Figure 19 Load cell measurement: pressure vs. time at the position of the tower (LC45) and the concrete wedge (LC123).

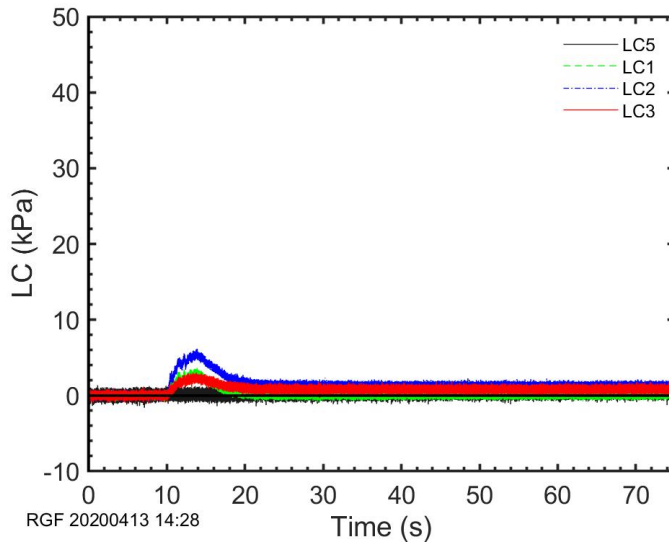
2020-04-13T14:28

Figure 20 Load cell measurement: pressure vs. time at the position of the tower (LC45) and the concrete wedge (LC123).

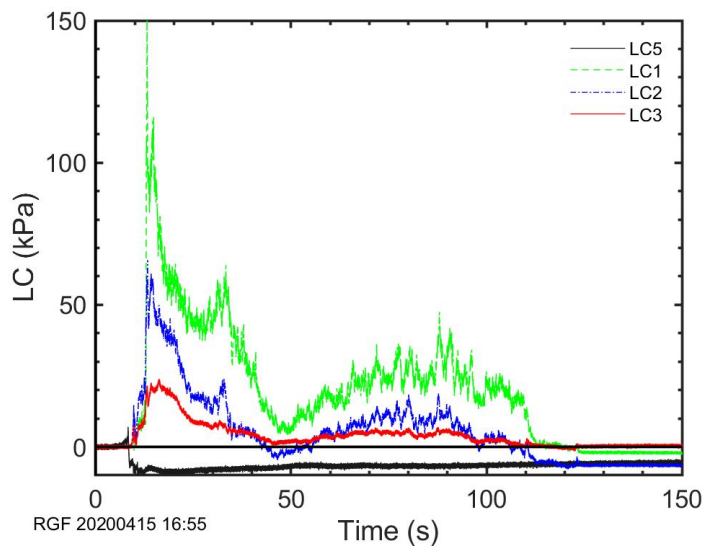
2020-04-15T16:55

Figure 21 Load cell measurement: pressure vs. time at the position of the tower (LC45) and the concrete wedge (LC123).

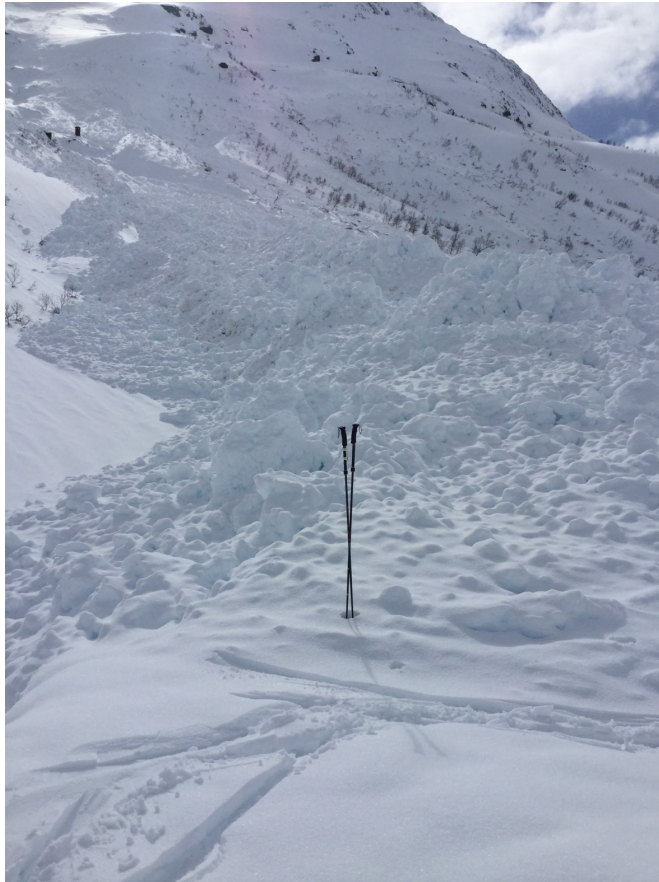
Figure 22 Deposition area of the 2020-04-15T16:55 event; photo taken on morning of 2020-04-18 (photos Henrik Langeland).
