# Drainage Åknes

DATA REPORT CORE LOGGING KH-02-2018

DOC.NO. 20180662-04-R

REV.NO. 1 / 2019-02-04

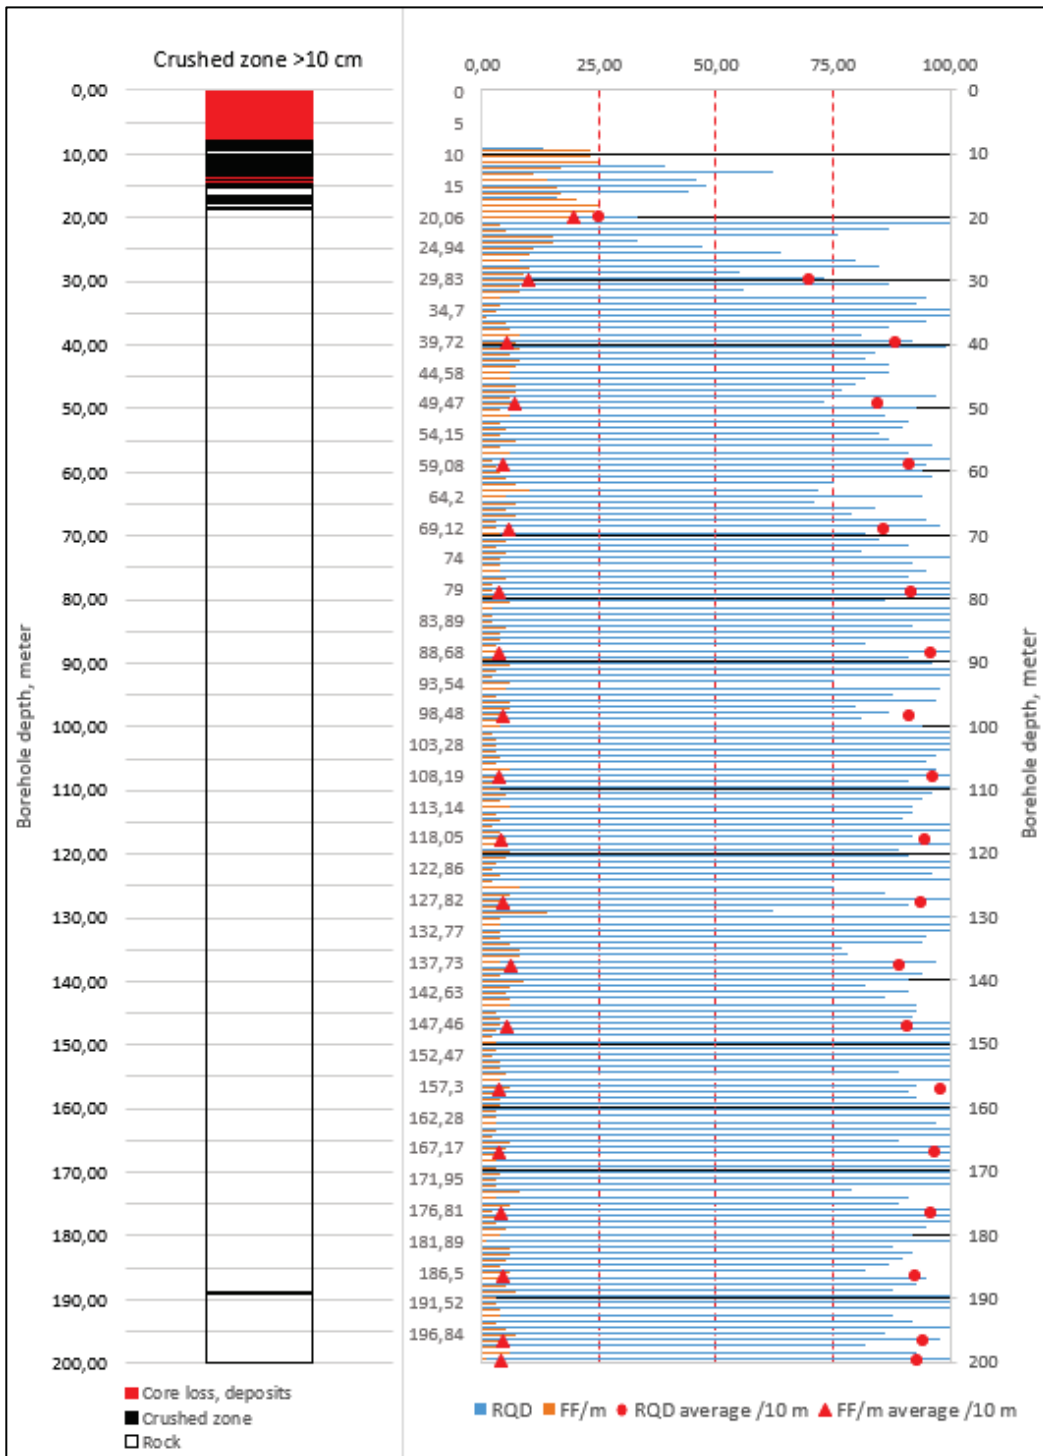
Figure 3. Simplified overview of RQD, average RQD every 10 meters, FFm, average FFm every 10 meters, crushed zone >10 cm and core loss distribution in KH-02-18.

A simplified overview of RQD, average RQD every 10 meters, FFm, average FFm every 10 meters, crushed zone >10 cm and core loss distribution in the bore hole is shown in Figure 3.

The upper 20 meters of the bore hole is intensely intersected with crushed zones, and 3 sections with core loss is registered. The average RQD value from 0 to 20 meter depth is 25 and the FFm value is 19.5 (Figure 3).

From 20 meter down to 69.1 meter the presence of crushed zones decrease, and crushed zones >10 cm is absent, however RQD and FFm values are varying. The average RQD value from 20 to 69.1 meter depth is 84 and the FFm value is 6.4 (Figure 3).

From 69.1 meter to end of bore hole the rock mass is considered solid with a rather massive character. Crushed zones are sparsely registered and the rock mass is generally considered good, evaluating RQD- and FFm values. The average RQD value from 69.1 to 199.87 meter is 94 and the FFm value is 4.3 (Figure 3).

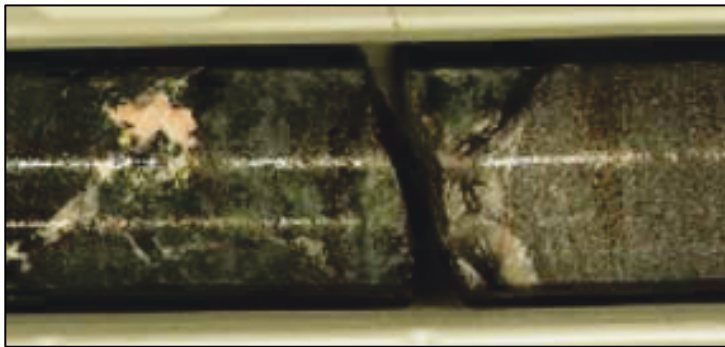
Figure 7. Low friction joint at 91 meters.

The rock is dark, partly greenish at the low friction joint at 91 meter. The rock has high mica content (Figure 7).

Figure 5 and Figure 6 show distribution of  $J_r$  - and  $J_a$  values in relation to bore hole depth.  $J_r$  value 1 represent smooth and planar joints, and  $J_a$  values 3 and 4 represent coating or infill on joints. I.e. joints registered with  $J_r$  value 1 and  $J_a$  value 3 and 4 could represent low friction joints. An analysis of joints with such characteristics show that it is only registered one joint with such characteristics, at 91 meter depth. However there are several crushed zones and core loss sections, which is not possible to analyse in detail, which also could have low friction properties.
