THE CHALLENGES OF MITIGATION MEASURES IN LONGYEARBYEN SVALBARD

ABSTRACT: The Arctic regions are facing changes in climate; warmer weather and more intense precipitations are thought to be the consequences. Longyearbyen in Svalbard is one of those places where warmer weather has been influencing the daily life of inhabitants. Changes in permafrost affects many building structures as the active layer and the temperature in the permafrost increases, so that the foundations lose their bearing capacity. It is unclear if climate change was the primary contributor to the dry snow avalanche in December 2015 which caused two fatalities, and in February 2017 with no fatalities in Longyearbyen. Structural damages were significant. The avalanche in 2015 was released from a small mountain side with about 80 m vertical drop, and damaged or destroyed 11 buildings. The avalanche in February 2017 came from Sukkertoppen mountain and hit and destroyed two buildings. After the two incidents with 14 months between them, the local and national authorities in Norway introduced a plan for mitigating measures during the spring of 2017, and shortly after a tender for the design of measures. The initial pla

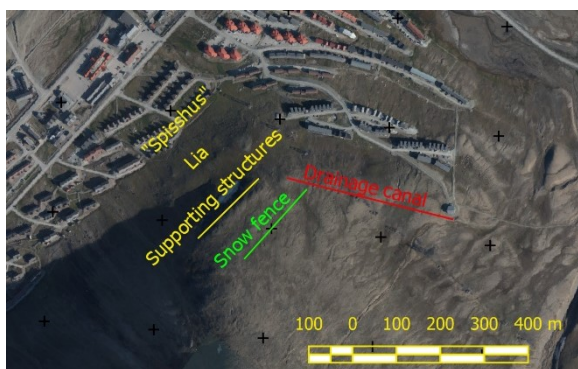
Figure 6. Schematic figure of location of mitigation measures. Aerial photo: Norwegian Polar Institute

The plan for mitigation measures was outlined in compendium prepared by Jan Otto Larsen (Larsen, 2016). The plan is more or less coherent with earlier proposals from NGI for the same area i.e. snow fences above the starting zone and supporting structures in the starting zone, Figure 6.

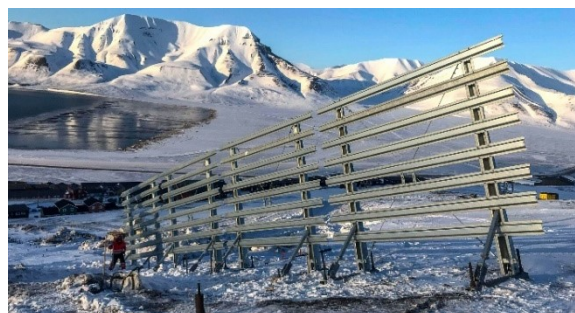
Figure 7. Snow fence under construction spring 2018. Photo: Eli Margrethe Solberg.

The terrain inclination at the snow fence varies from approx. 15° to approx. 25° and it has relatively even surface. During design the client asked for ski lift in the area which resulted in splitting the snow fence into two fences with approx. 20 m wide opening for the lift, Figure 7.
