## CO2 Flow, Alteration And Geomechanical Response In Confining Units – An Experimental Approach

E. Skurtveit<sup>1,2\*</sup>, A. Sundal<sup>2</sup>, M. Soldal<sup>1</sup>, G. Sauvin<sup>1</sup>, T.I. Bjørnarå<sup>1</sup>  
<sup>1</sup>NGI (Norwegian Geotechnical Institute), <sup>2</sup>UiO (University of Oslo)

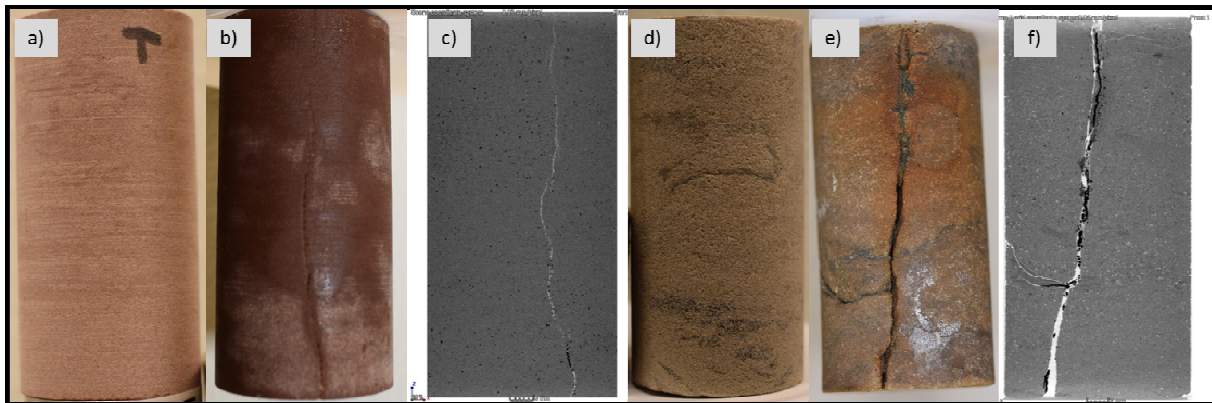
**Figure 1** Samples with 25 mm diameter used in the experimental work on an unaltered reddish siltstone and a bleached, altered siltstone. Intact unaltered host rock sample LGW2 (a), fractured unaltered sample, LGW1 (b), CT image of unaltered fractured sample LGW1 (c), intact bleached sample LGW8 (d), fractured altered host rock (LGW7) (e) and CT image of altered fractured sample LGW7 (f). In the CT images white is air and dark is dense material. A dark fracture-fill identified as oxides is observed mainly for the altered fracture in LGW7(e and f).

In total, four samples were studied, two with fractures and two intact reference samples. All samples are from the CO2W55 well in Little Grand Wash fault, Utah (Kampman *et al.* 2014). One fracture and host rock couplet from 24 m depth is from a red unaltered siltstone, whereas the second couplet from depth 45 m, is from a bleached, altered siltstone. An overview of the samples tested is shown in Table 1 and photos from each plug is presented in Figure 1 together with CT images showing fracture aperture and morphology.
