SNOW DRIFT CHALLENGES AT KLETTSHÁLS MOUNTAIN ROAD PASS IN ICELAND

ABSTRACT: Snow fences are usually used to control snowdrift problems on a relatively flat and open terrain. Snowdrift problems on mountain roads and passes are normally more challenging. The terrain is often more complex, winds can be stronger and other problems related to road construction have to be solved in joint action with snowdrift problems.

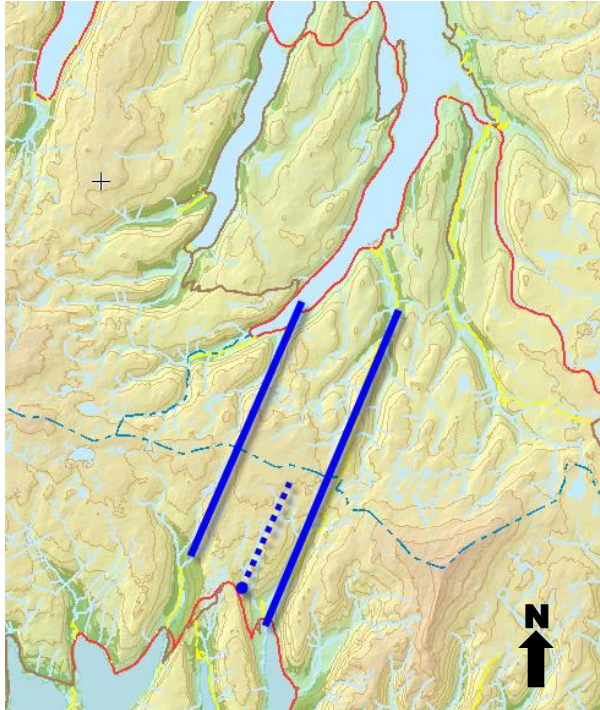
Fig. 2. The blue lines show the wind direction from north, approx. 22° (NNE-SSW). The dotted line shows wind direction to the observation site. The direction coincides with the direction of the fjords on the northern side of the mountain plateau. Map: National Land Survey of Iceland.

the fjord to the pass has a one sharp turn. The part from the U-turn to the top is exposed to strong northerly winds and snowdrift. The terrain below the road is open and it has a long fetching area for drifting snow on a relatively flat mountain plateau to the northeast (Fig. 2).

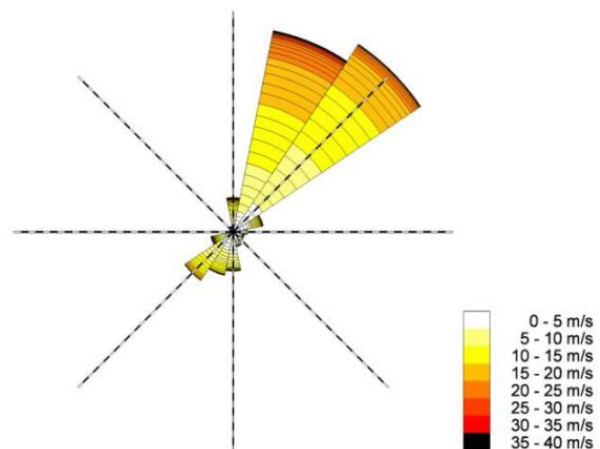
Fig. 3. The figure shows a wind rose with wind speed at Klettsháls for the period 2000 to 2006 from the beginning of November to the end of April (181 day), when temperature equal to or lower than 0 deg. C.

A comparison of the temperature at Kvígindisdalur and Klettsháls showed that the temperature was about 2.8 deg. C lower at Klettsháls for the period 2000 to 2004. This helped estimating when the precipitation was rain or snow at the Klettsháls site. From the wind rose in figure 3 we see that wind from NNE to NE is the dominant wind direction and it indicates the snow drift problem. The frequency of wind speed larger than 20 m/s for the sector N to NE is approx. 6% for this period of time which means on the average 11 days pr. winter or approx. once every second week. Wind gust is expected to be at least 1.5 times the average 10 minutes wind speeds so the wind problem is obvious.

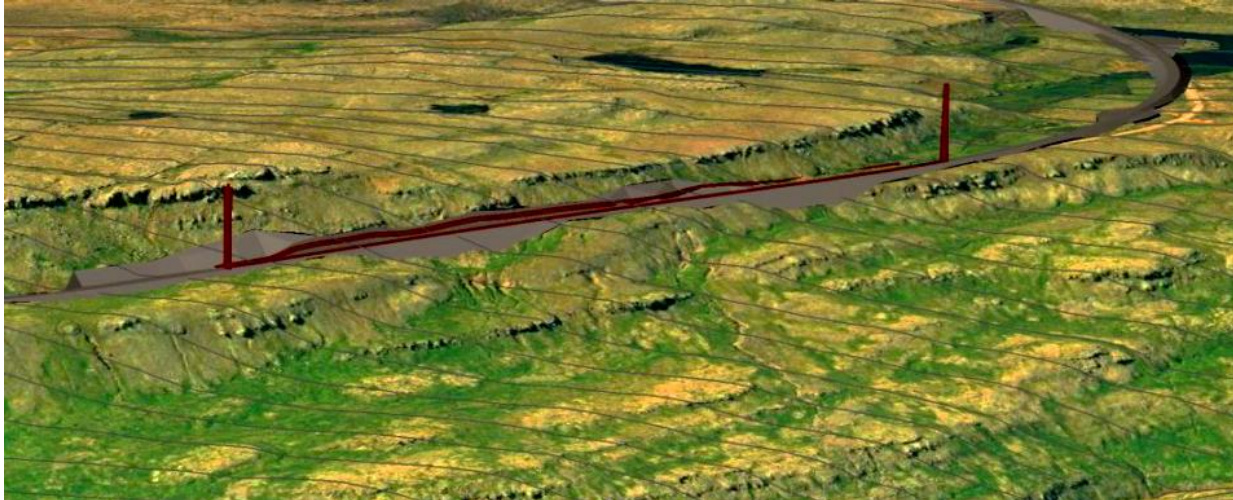
Fig. 4. This aerial photo is draped on a digital terrain model (DTM). The observation site is between the red vertical lines. Above the road is a rock wall, steep scree and cliffs; below is the road fill. Wind direction lines of 22° (NNE) are draped on the terrain model. The distance between the lines is 50 m.

The results from the test period gave valuable information for further evaluation of mitigation measures (Fig. 4).

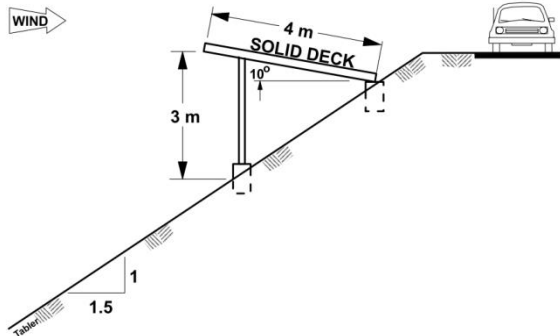
Fig. 5 A schematic figure of solid snow barrier on Nakayama Pass, Hokkaido, Japan. From (Tabler 2003).

Tabler (2003) discusses non-porous snow barriers which were built along a touristic highway near Nakayama Pass, Hokkaido Japan (Fig. 5). The main feature of this structure is that most of the snow is deposited on the slope below the barrier while remaining particles are diffused vertically by the turbulent flow over it.

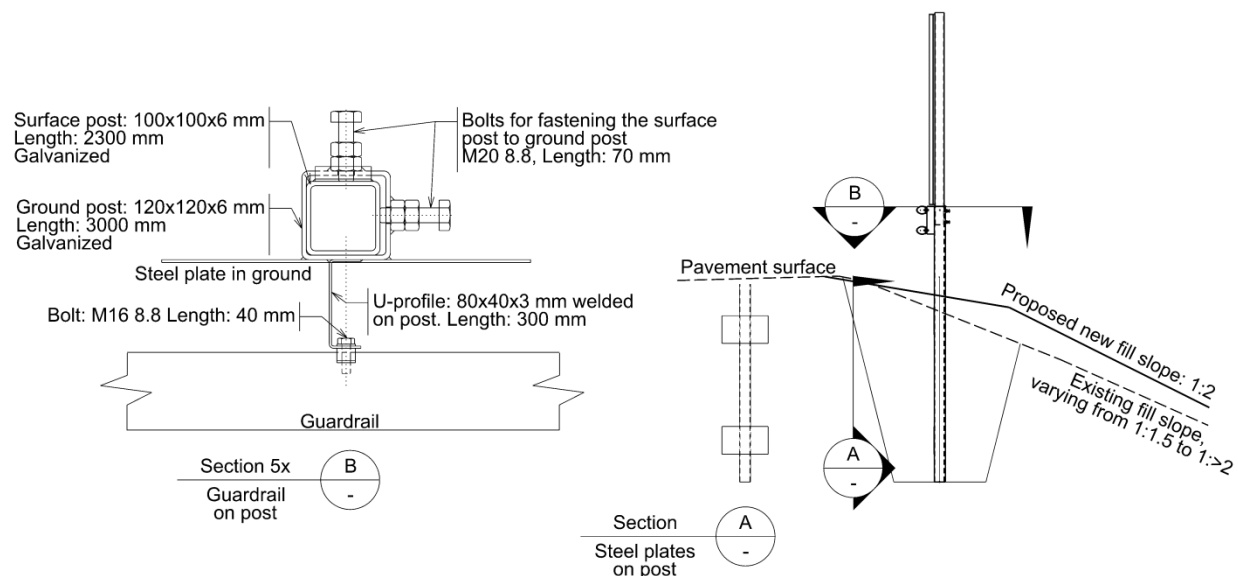
Fig. 6. The figure shows some of the details of the snow fence.

Each post is split into two; the ground section and the surface section (Fig. 6). The ground section has a 120x120 mm 3 m long profile of steel with top 0.76 m above the pavement/shoulder top and approx. 2.2 m in compacted gravel. Due to too small surface area of the profile in the gravel two steel plates were welded to the profile to increase the surface area; one close to the surface and one close to the bottom. The ground section is located 1.25 m from the edge of the pavement and is equipped with a guardrail for safety for the traffic. The spacing of the posts is 2 m.

The surface section has a 100x100 mm profile of steel, 2.3 m long of which 0.2 m are placed into the ground section and fastened with bolts.

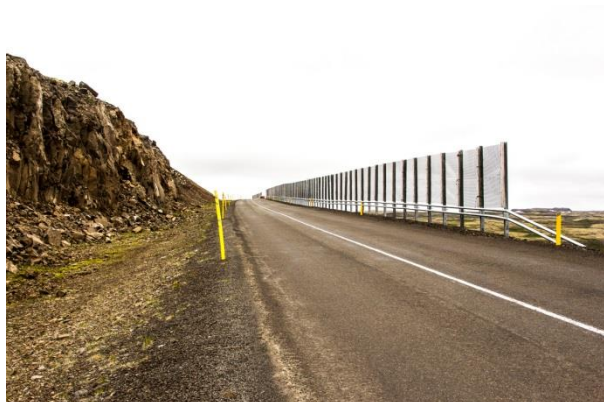
Fig. 7 The photo shows two sections of snow fences at the road side in summer time.

In 2009 an approx. 180 m long section was built at the top most part of the site (Fig. 7-9). Experience during the two first winters was very promising so a second section of similar length was built in 2011. A third section is now planned.

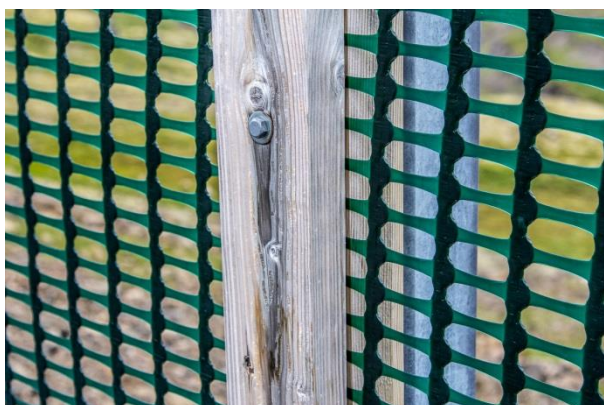
Fig. 8 This photo shows the Tenax fencing and the wood fastening system. Behind the net is the surface steel post.

The fence is built of two rows of 1 m wide synthetic Tenax "Residence" material. This synthetic material has been tested at other sites in Iceland and has proved to be the only mass produced material that has been able to withstand the wind forces. The material is made of HDPE and has 30 kN/m longitudinal tensile strength and yield point elongation of about 13%.

The fencing material is fastened between two wooden braces and bolted to the steel posts (Fig. 8).

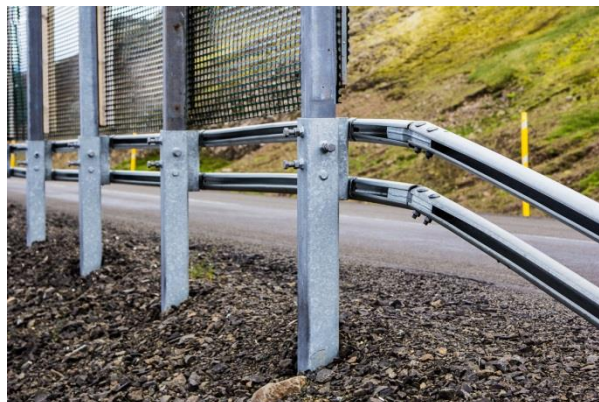
Fig. 9 A close up of one of the end posts. The guardrail end is bent down from the post into the ground.
