Glacier and Permafrost Hazards

Figure 1. Examples of observed glacier and permafrost hazards in recent years. Locations of hazard events are presented along with current glacier/ice sheet and permafrost extent, roads and pipelines, populated places (graduated circles scaling with population), and shipping routes. The three highlighted events are described in the main text.

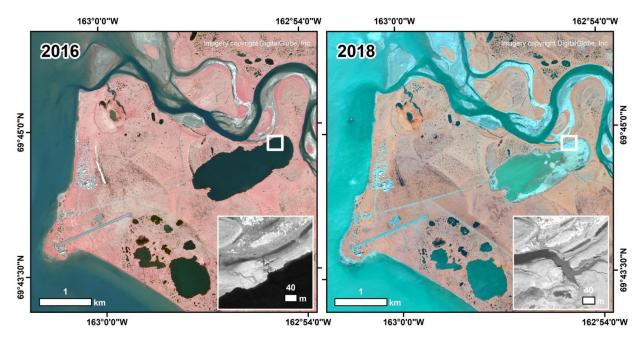
Figure 2. The drinking water source lake in Point Lay, Alaska, catastrophically drained in fall 2016 because of permafrost degradation. The drainage was a result of bank overtopping and thermal erosion of an ice wedge (surface flow as opposed to subterranean drainage). The small inset shows the thermo-erosional gully that developed during the lateral drainage event. Drainage of thermokarst lakes in the Arctic is a natural process that is increasing in frequency because of climate change (Nitze et al. 2020), which is enhancing hazards in lowland permafrost regions (Arp et al. 2020).
