Norwegian GeoTest Sites (NGTS)

HALDEN RESEARCH SITE - SITE
CHARACTERISATION AND ENGINEERING
PROPERTIES OF HALDEN SILT

DOC.NO. 20160154-05-R

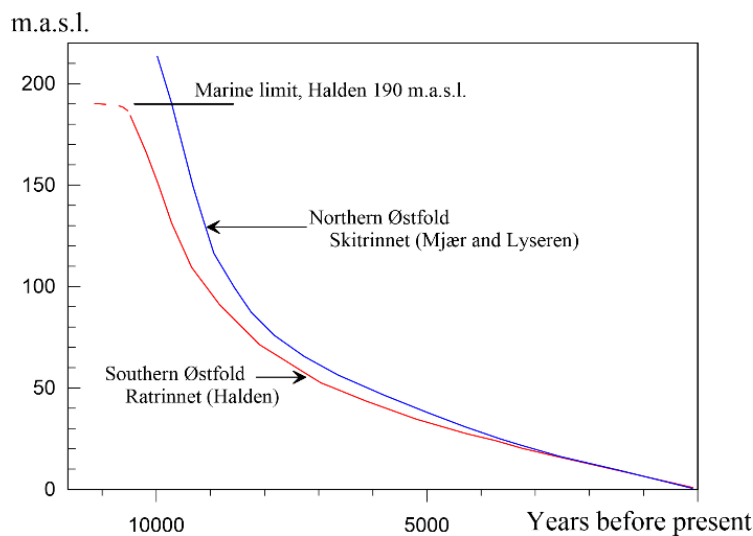
Figure 2. Shoreline reconstruction curves from Halden region (Northern and Southern Østfold), after Klemsdal [46]. The research site most likely emerged from the marine environment c. 5,000 years ago.

Deglaciation of Southeastern Norway started at c. 16–15,000 years ago. It was interrupted at around 12,000 and 11,300 years ago by colder periods that led to re-advance of glaciers and formation of frontal moraines in the region (e.g. the “Ra” moraine). As the ice melted the land was subjected to intense isostatic uplift and relative fall of sea-level. The highest post-glacial sea level in the region (marine limit) is about 190 m above the present sea level and was formed 10,700 years ago [45]. The early Holocene period was characterized by rapid sedimentation of marine clays and silts at the site as a consequence of the rapid fall in sea-level. This was followed by more placid deposition in an estuarine/distal deltaic environment associated with the prograding Tista River delta. The shoreline reconstruction curves from the region, proposed by Klemsdal [46], show that the site most likely emerged from the marine environment c. 5,000 years ago (Figure 2). Two radiocarbon (¹⁴C) datings of marine shell fragments are available from the research site (Table 2); one from the clay at about 16.3 m depth (elevation about 12 m.a.s.l), and a second from the clayey, silt at 6.4 m depth (22 m.a.s.l). The results indicate 11,820 ± 25 years before present (BP) and 6,455 ± 25 years BP, respectively. This corresponds well with earlier carbon dating results from the area [47] and the deglaciation history. The average rate of sedimentation corresponds to about 1.0–1.4 mm/year.

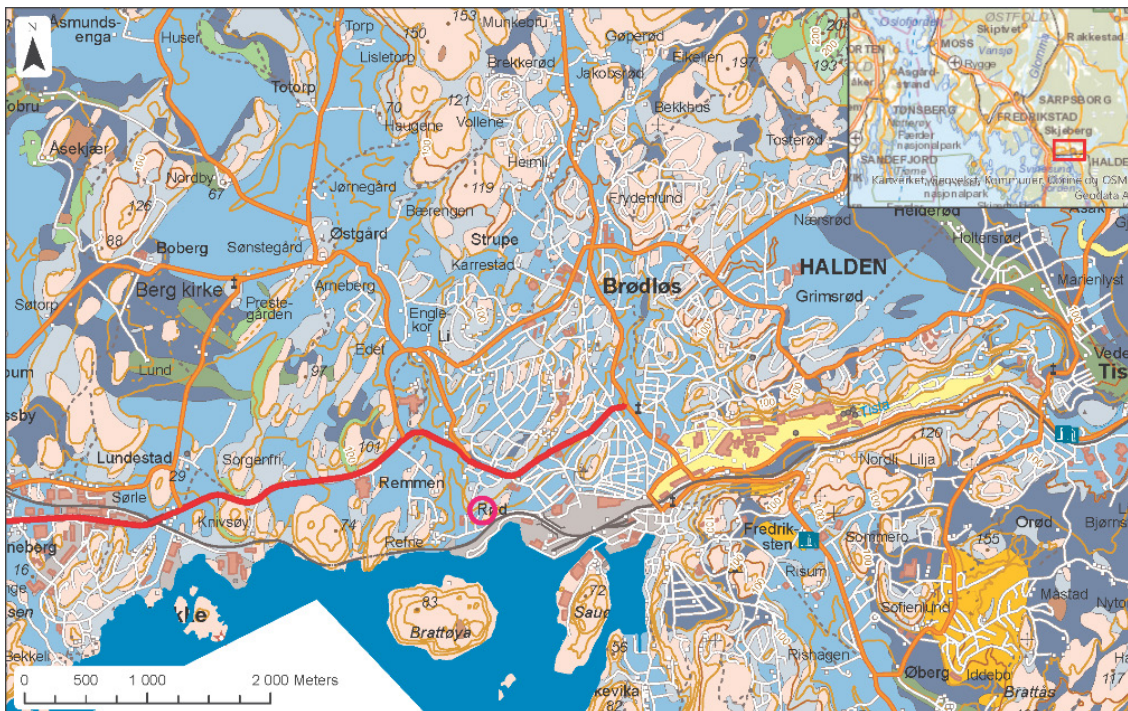
Figure 3. Quaternary map of the Halden area, Southeast Norway, with the research site circled in red. The colors reflect the geological processes and general properties of the deposits. Shades of blue indicate that the soils have been transported by and deposited in a marine environment. These deposits dominate the Halden area. Shades of green indicate soils that were deposited by the ice. Shades of yellow indicate fluvial deposits, and pink shows exposed bedrock. After [47].

Figure 3 presents the location of the research site within the regional geological setting. The Halden municipality lies within the Norwegian southeast basement area. The dominating bedrock is gneiss in the northeast and granite in the northwest and southeast [47]. Glacial striations are generally north-south and northeast-southwest and topographical characteristics such as small valleys and hills are typically oriented in that direction. The most prominent geological feature in the area is the “Ra”, an end moraine complex deposited about 11,300–10,700 years ago during the Early Younger Dryas. It traverses the region from northwest to southeast and retains the water in lakes Tvetervatn, Rokkevatnet and Korsevatnet. Earlier the moraine also retained the larger lake Femsjøen. A second zone of marginal moraine, parallel to the Ra is located south of Halden, namely the “Outer Ra”, or the Onsøy-Borge moraine. Between and outside these two features is a large veneer of clay deposits, interrupted in certain areas by silt and sand deposits, e.g. south of Halden. Areas northeast of the Ra are dominated by exposed bedrock, with clay only in local depressions. The Glomma River, Norway’s longest and largest river, runs into the Oslo fjord in the city of Fredrikstad, about 25 km northwest of the Halden research site. East of the site flows a system of lakes and rivers called “Haldenvassdraget”. This system is the second largest in Norway and runs into the Idde fjord in Halden through the Tista River (Figure 1a). During higher sea levels, the test site was likely highly influenced by both of these river systems, as Halden was inundated by the sea [48]. Thus the source of material supplied has an important contribution from the whole of southeastern Norway and has primarily been produced by glacial erosion, with secondary fluvial transport.

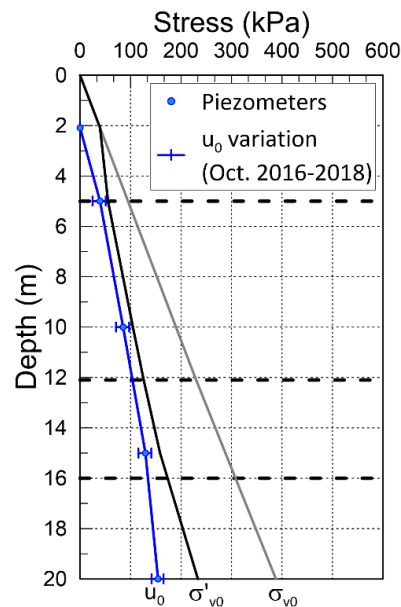
Figure 6. In-situ stress conditions (u_0 , σ_{v0} and σ'_{v0}).

From the total unit weights (γ ; Section 5.2) and the in situ pore pressure depicted in Figure 4a the total and effective vertical stress conditions (σ_{v0} , σ'_{v0}) are derived and plotted in Figure 6. The total stress profile is approximated by using $\gamma = 19 \text{ kN/m}^3$ in Units I and II, and $\gamma = 20 \text{ kN/m}^3$ in Units III and IV. Interpretation of the apparent preconsolidation stress, or yield stress σ'_p (p'_c), from oedometer tests on silt is challenging. This is discussed in Section 6.2.

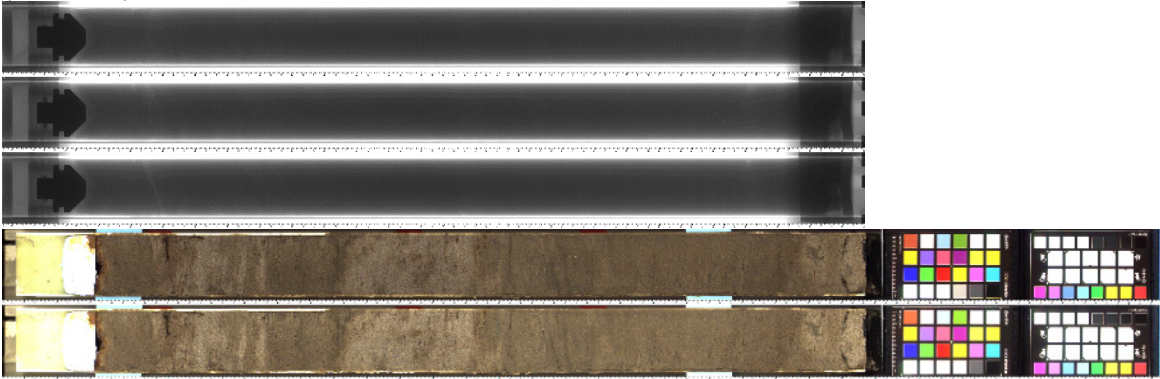
Depth range [m]	Soil description and imaging [-]	Comment [-]
0.0–4.5	<p data-bbox="465 376 1402 432">SAND, clayey, silty, fine, loose to medium dense, with organic material, brownish grey (Soil Unit I)</p>

<p data-bbox="1671 448 1984 512">X-ray and split core imaging depth: 3.0–3.9 m</p>
4.5–12.1	<p data-bbox="465 871 1599 935">SILT, sandy, clayey, low to medium strength, homogeneous, mottled, occ. shell fragments, brownish grey (Soil Unit II)</p>

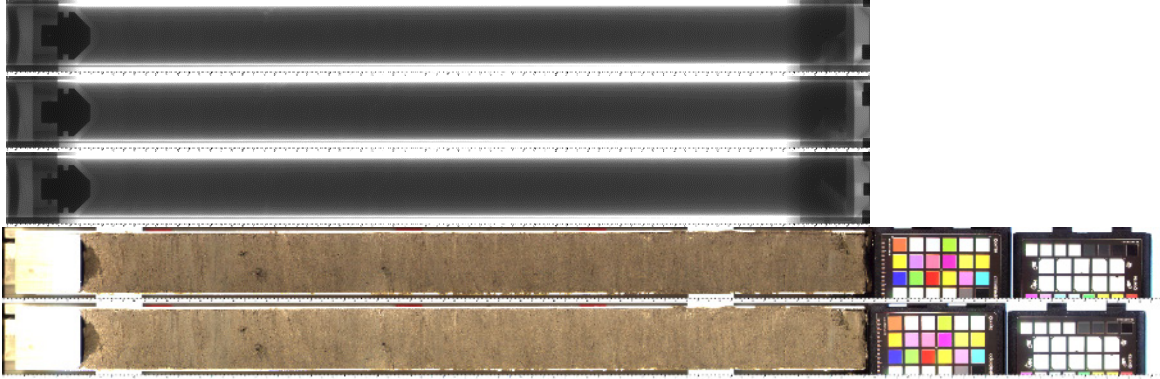
<p data-bbox="1671 871 1984 1015">¹⁴C age @ 6.4m: 6,455 ± 25 years BP X-ray and split core imaging depth: 4.8–5.6 m</p>

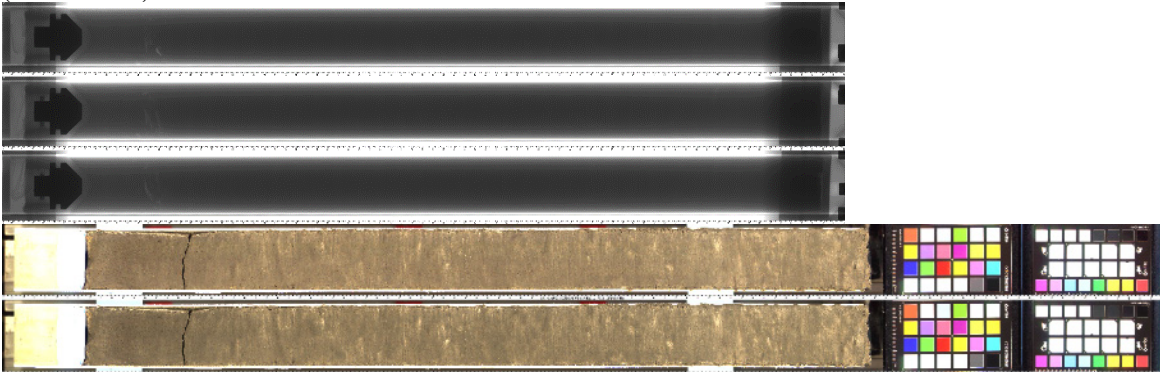
Depth range [m]	Soil description and imaging [-]	Comment [-]
12.1–16.0	SILT, sandy, medium to high strength, homogeneous, highly bioturbated, mottled, occ. shell fragments, occ. black organic material, brownish grey (Soil Unit III)

X-ray and split core imaging depth: 12.0–12.8 m
16.0–21.3	CLAY, silty, low to medium strength, slightly laminated, occ. shell fragments, occ. drop stones (Unit IV)

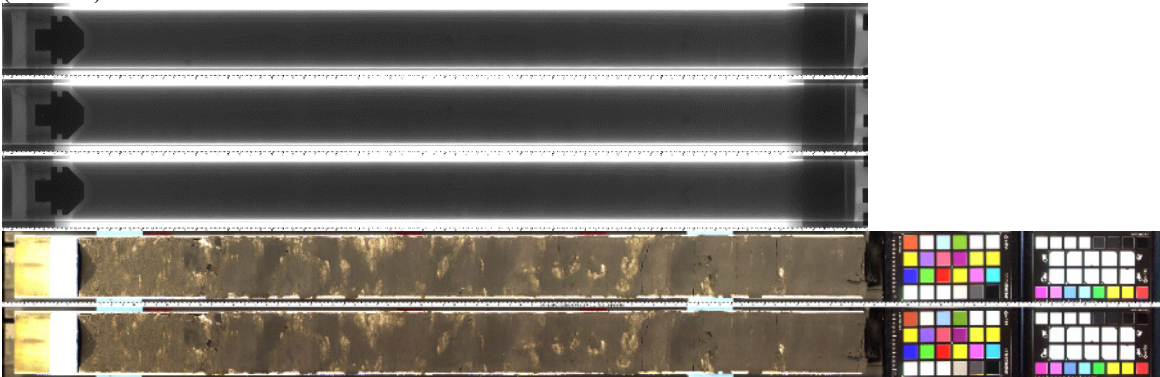
^{14}C age @ 16.3 m: $11,820 \pm 25$ years BP X-ray and split core imaging depth: 15.6–16.4
21.3	BEDROCK

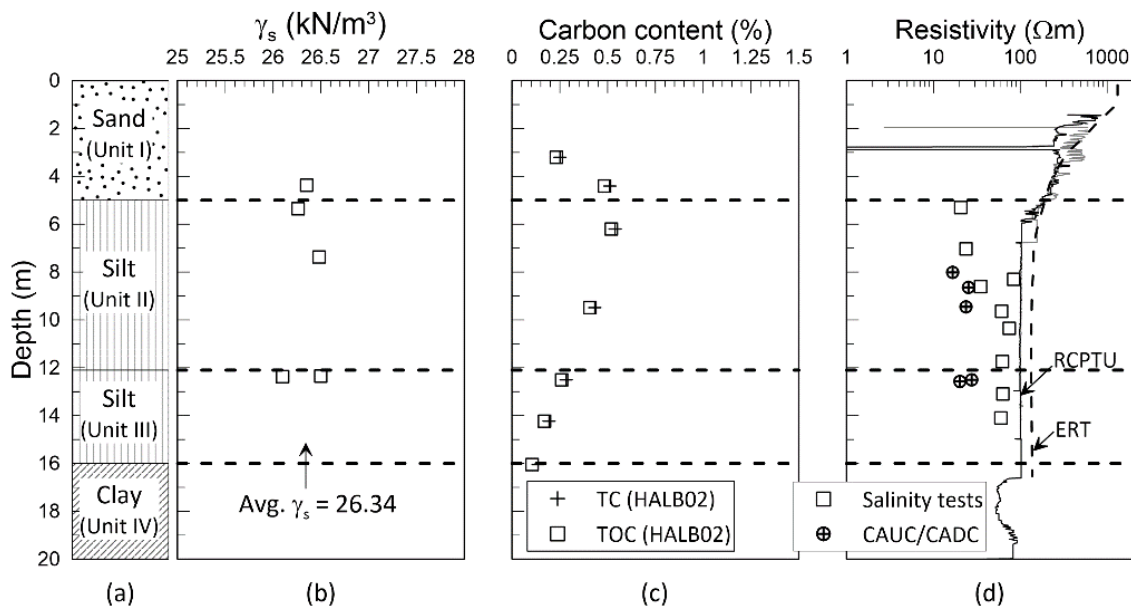
Figure 12. (a) Soil units, (b) unit weight of solid particles, (c) TC and TOC, and (d) resistivity from laboratory and field measurements.

Total carbon (TC) and Total Organic Carbon (TOC) were determined by dry combustion at NGUs laboratory using a LECO SC-632 analyzer with an infrared (IR) detector (Leco Corp., St. Joseph, MI). The carbon content in the silt units is generally low. Figure 12 shows that in Unit II the average TC was 0.49% with a range from 0.43%–0.54%. In Unit III the average TC is 0.24%, ranging from 0.19%–0.28%. Meanwhile the TOC in Unit II average is 0.46% while the average is lower in Unit III at a value of 0.22%.

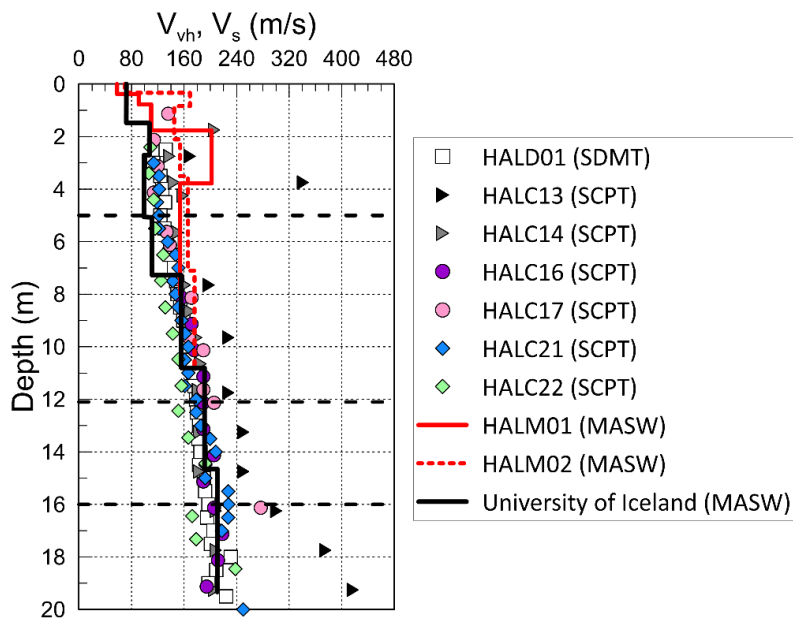
Figure 16. In-situ shear wave velocity (V_{vh} , V_s) from SCPT and SDMT, and Multichannel Analyses of Surface Waves (MASW).

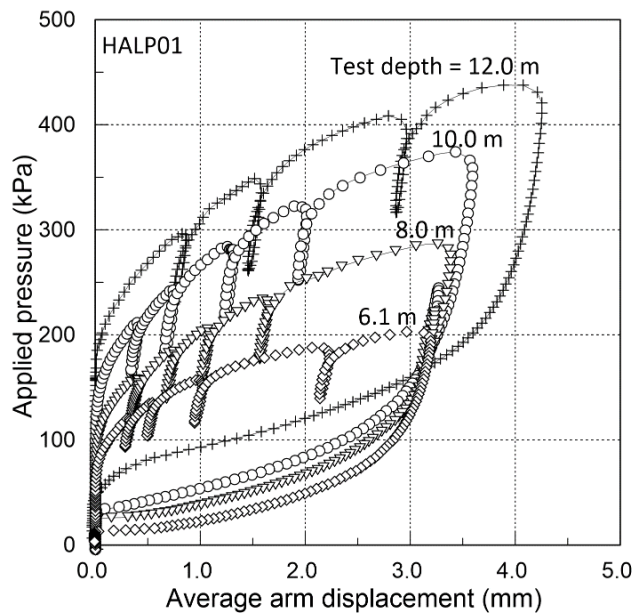
Figure 18. Typical self-boring pressure meter results. Interpretation of σ_{h0} and $S_{u,SBP}$ based on Marsland and Randolph methodology [63].

Four self-boring pressuremeter tests were conducted in location HALP01 in general accordance with ISO 22476-5 [18] using the Cambridge InSitu Ltd. six-arm pressuremeter probe. The borehole HALP01 was drilled using an auger bit with a nominal size of 120 mm using water flush. The SBPT was self-bored to the required depth with the cutter positions optimized and at a rate such that a minimum of disturbance was introduced in the soil. After the first three tests a steel casing was advanced to 11.5 m to stabilize the borehole. The probe was calibrated prior to and after testing and corrections for membrane stiffness were made upon data reduction. The four test results from 6.1 m, 8.0 m, 10.0 m and 12.0 m depth, plotted in Figure 18, are average data for each tier of strain arms. Three to four unload-reload loops were conducted at each depth.

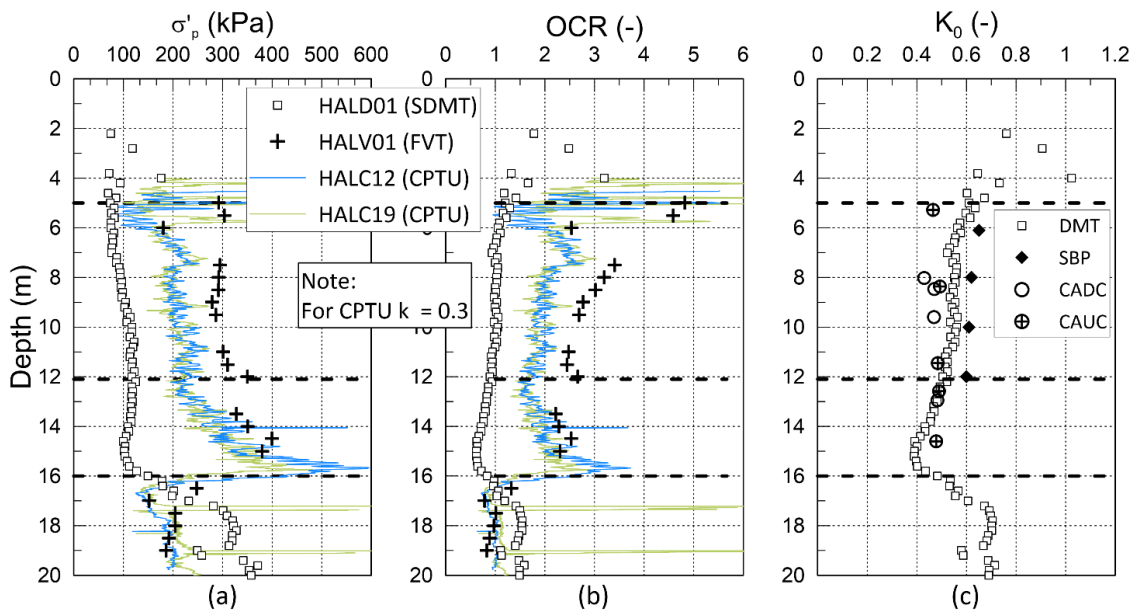
Figure 19. Stress history data from field and laboratory testing. (a) yield stress, σ'_p , (b) overconsolidation ratio, OCR, and (c) coefficient of earth pressure at rest, K_0 .

Despite uncertainties associated with the clay-based interpretation of the SBPT and DMT data there is fair agreement between the in situ and laboratory test results, and K_0 generally ranges between 0.6 and 0.45.

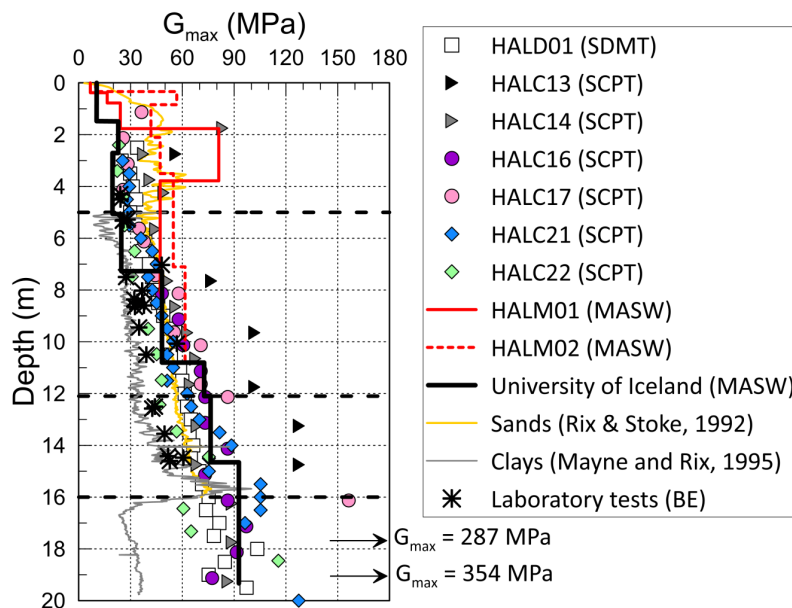
Figure 20. Small strain shear modulus, G_{max} , from field and laboratory measurements of V_{vh} and V_s (SCPT, SDMT, MASW and bender elements).

Small strain shear modulus, G_{max} , is interpreted from a number of SCPTs, one SDMT and two MASW profiles. Figure 20 presents G_{max} computed from in situ shear wave velocity measurements depicted in the previous Figure 16. Generally, the SCPT and SDMT G_{max} results increase linearly from about 30 MPa at 5 m depth to about 75 MPa at 16 m depth. Two SCPT results from location HALC13 plot outside the scale and are indicated in the figure ($G_{max} = 287$ mPa and 354 MPa). However, the results from this location are generally high, and likely a result of greater uncertainty in the shear wave velocity estimates (see Section 6.1.3). The linear increase in V_{vh} in the silt units is very consistent with the Rix and Stokoe correlation of G_{max} to cone resistance for sands [73], presented in the figure. G_{max} computed from the Mayne and Rix correlation of shear wave velocity to corrected cone resistance [74], valid for natural clays, plot below the in situ and MASW results. Bender element (BE) tests [44], performed on triaxial specimens (at $\sigma'_{vc} = \sigma'_{v0}$, $\sigma'_{hc} = \sigma'_{h0}$) and DSS specimens (at $\sigma'_{vc} = \sigma'_{v0}$), indicate that the small strain shear modulus measured in the laboratory is generally lower than the in situ test results.

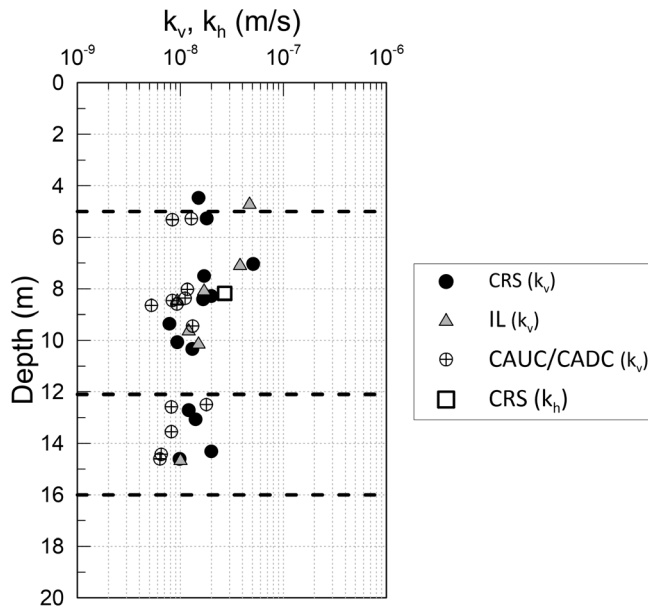
Figure 23. Hydraulic conductivity (k_v , k_h) from laboratory testing.

Constant-head hydraulic conductivity tests were conducted at different stress levels during a selected number of oedometer tests and during the consolidation stage of a number of triaxial tests. Hydraulic conductivity was determined by flowing de-aired water through the specimens, from bottom to top, by a 100 mm mercury column in a U-shaped saran tubing. The amount of water flowing in and out of the specimen was measured separately, and the tests were continued until the water inflow and outflow were approximately equal [36]. Both vertical and horizontal hydraulic conductivity (k_v , k_h) are presented in Figure 23. Values from oedometer test specimens represent the hydraulic conductivity at zero axial strain (back-extrapolated along the linear e-log k line [36]), i.e. at a void ratio near in situ conditions. Values from triaxial test specimens represent the hydraulic conductivity near the in situ effective stress state (σ'_{vc} , σ'_{hc}), i.e. after consolidation and some subsequent change in void ratio (Δe) has occurred. Due to the larger volume of soil and the greater height of the triaxial test specimen the hydraulic conductivity measurements made on these specimens are generally considered more reliable. The average k_v of the triaxial test specimens is 9.8×10^{-9} m/s.

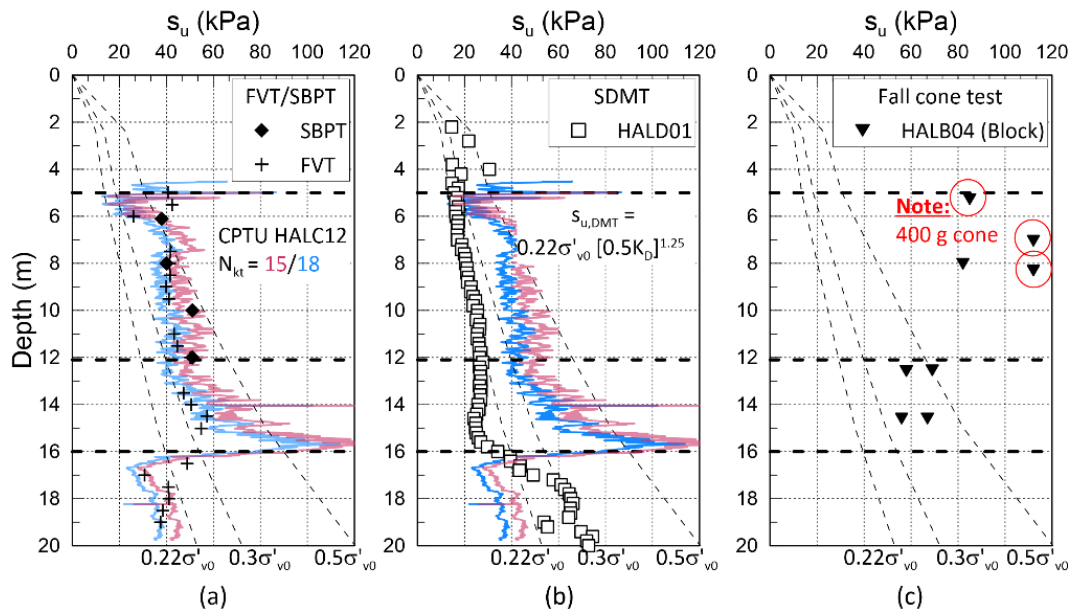
Figure 24. Undrained shear strength from (a) field vane tests, self-boring pressuremeter tests and CPTU, (b) DMT and CPTU, (c) fall cone tests.

are that the conventional rate of rotation (6–12°/min) does not provide shearing under fully undrained conditions in the silt units at Halden. Thus, the vane results between 5 m and 16 m depth in Figure 24a may not be an accurate measure of the undrained shear strength.

Figure 24a presents undrained shear strengths from the four self-boring pressuremeter tests interpreted using the Marsland and Randolph approach [63], see also Section 6.3. In this approach, undrained conditions are assumed, and the total horizontal stress (σ_{h0}) and peak cavity shear stress ($s_{u,SBP}$) at the pressuremeter boundary are estimated by iteration. The point at which the pressure-deformation curve becomes significantly non-linear should correspond to the in situ horizontal total stress plus the undrained shear strength in clays. The undrained shear strengths estimated from this approach are consistent with field vane results, and $s_{u,SBP}$ ranges from 38 kPa to 51 kPa. Assessment of undrained shear strength using the limit pressure (p_L) [63] yields values in the range of 31 kPa to 68 kPa but are associated with very large strains. A third interpretation approach, the Gibson and Anderson approach [89], is based on the assumption of an elastic-perfectly plastic material and yields significantly larger $s_{u,SBP}$ values. In clays, over predictions of undrained shear strength from SBPTs compared to laboratory tests on undisturbed soil have been observed [72,90]. This is typically explained by partial consolidation during expansion (high gradients of pore pressure in the radial direction) and strain rate effects (increased “viscosity”—shearing at strain rates much faster than

DMT results in Figure 24b show that the Marchetti correlation for undrained shear strength from DMT [61], $s_{u,DMT} = 0.22 \times \sigma'_{v0} \times (0.5K_D)^{1.25}$ has been found to fall somewhere close to the average undrained shear strength profile in some clays. It appears that at Halden the correlation provides estimates on the low side of both field vane, pressuremeter and CPTU results evaluated with $N_{kt} = 15$ –18. This is explained by the fact that the horizontal stress index, K_D is about 2 in the silt layers, and this corresponds to an interpreted OCR of 1. As a result between 5 m and 13 m the undrained shear strength interpreted from DMT fall close to the normally consolidated line ($0.22\sigma'_{v0}$), also indicated on the plot. For Halden silt, $s_{u,DMT} = 0.45 \times \sigma'_{v0} \times (0.5K_D)^{1.25}$ would provide a better fit with the FVT data.

Undrained shear strength from the Halden CPTU data was estimated using $s_u = (q_t - \sigma_{v0})/N_{kt}$, with cone factors N_{kt} of 15–18 (see Figure 24a and Figure 24b). While the N_{kt} for assessment of shear strength from undrained triaxial tests in compression (s_{uC} interpreted at the maximum excess pore pressure, u_{max}) is about 15, the N_{kt} factor for field vane strength is closer to 18. These differences are attributed to the different mode of shear between the two test methods, strain rate differences, choice of failure criteria and possible partial drainage in the field vane tests. As will be discussed in more detail in Section 6.12, the triaxial test specimens exhibit dilative behavior during undrained shear and, unlike the field vane results, do not exhibit a unique (peak) undrained shear strength. The derived $N_{kt} = 15$ for triaxial tests is fairly consistent with the B_q - N_{kt} relationship suggested by Lunne et al. [67] for several Norwegian clays, although the Halden N_{kt} values are somewhat on the low side of what could be expected from a soil with such low B_q values (typically, $B_q = 0.1$ – 0.25) [85]. But again, this is based on the reference CAUC s_{uC} taken at u_{max} which is the lowest derived value of s_u as discussed further in Section 6.12. Norwegian silts from the Brage offshore oil field (6%–15% clay size particles, $I_p = 8\%$ – 9%) and an onshore site in Stjørdal (0%–24% clay size particles) show N_{kt} values ranging from 15 to 30, according to Senneset et al. [91]. However, they point out that for soils with $B_q < 0.4$ a correlation between s_u and CPTU testing may be inappropriate due to partial drainage during penetration. Further, N_{kt} factors of 18 and 11 have been suggested for two Irish silts (5%–6% clay size particles, $I_p = 3\%$ – 17%) [78], and the Norwegian Os silt (3%–12% clay size particles, $I_p = 12\%$) [79],
