## SNOW CREEP PRESSURE ON MAST CONSTRUCTIONS

### ABSTRACT

In Norway snow-creep quite often causes damage on mast constructions on hillsides exposed to deep snow-cover. An extensive snow-creep measurement program has therefore been carried out for different constructions at NGI's snow and avalanche research station in Grasdalen during the period 1975 to 1990.

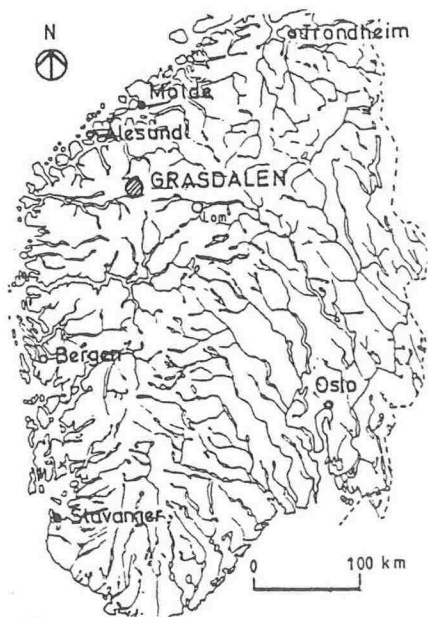
Figure 1 Map showing the position of the research field at Grasdalen

masts exposed to snow-creep. In 1975 a tubular mast with 0.42 m diameter was erected at a 25° steep slope at NGI's snow and avalanche research center in Grasdalen in western Norway (Fig. 1). A second smaller and more flexible mast with 0.22 m diameter (Fig. 2) was erected in 1983 about 10 m south of the large mast. Both masts were instrumented with strain gauges to determine the moment in different sections.

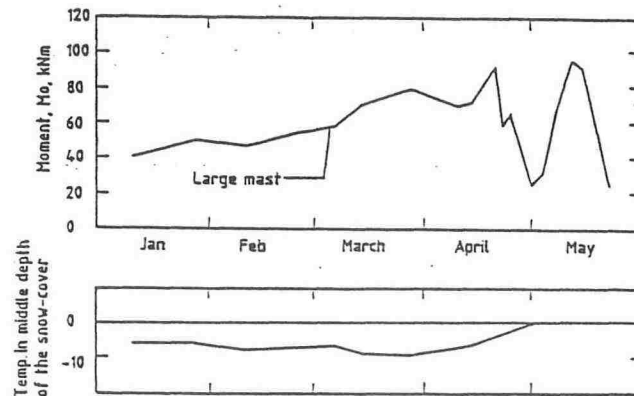
3. The snow-creep pressure increases gradually throughout the winter and reaches it's peak when the snow-pack is 0° C isothermal (Fig. 5).

Increasing air temperatures in spring warm up the mast and decrease the measured stresses.

Figure 5 The variation of maximum moments on the large mast with the temperature in the middle depth of the snow cover during the winter 1984
